AAIB Bulletin

12/2023

S2/2023: Airbus A321-253NX	G-OATW	4-Oct-23	3
----------------------------	--------	----------	---

Aircraft Type and Registration:	Airbus A321-253NX, G-OATW
No & Type of Engines:	2 CFM International SA LEAP-1A33 turbofan engines
Year of Manufacture:	2020 (Serial no: 10238)
Date & Time (UTC):	4 October 2023 at 1151 hrs
Location:	London Stansted Airport
Type of Flight:	Commercial Air Transport (Passenger)
Persons on Board:	Crew - 11 Passengers - 9
Injuries:	Crew - None Passengers - None
Nature of Damage:	Damage to several cabin windows and impact damage to the left horizontal stabiliser
Commander's Licence:	Airline Transport Pilot's Licence
Commander's Age:	54 years
Commander's Flying Experience:	4,905 hours (of which 2,300 were on type) Last 90 days - 128 hours Last 28 days - 27 hours
Information Source:	AAIB Field Investigation

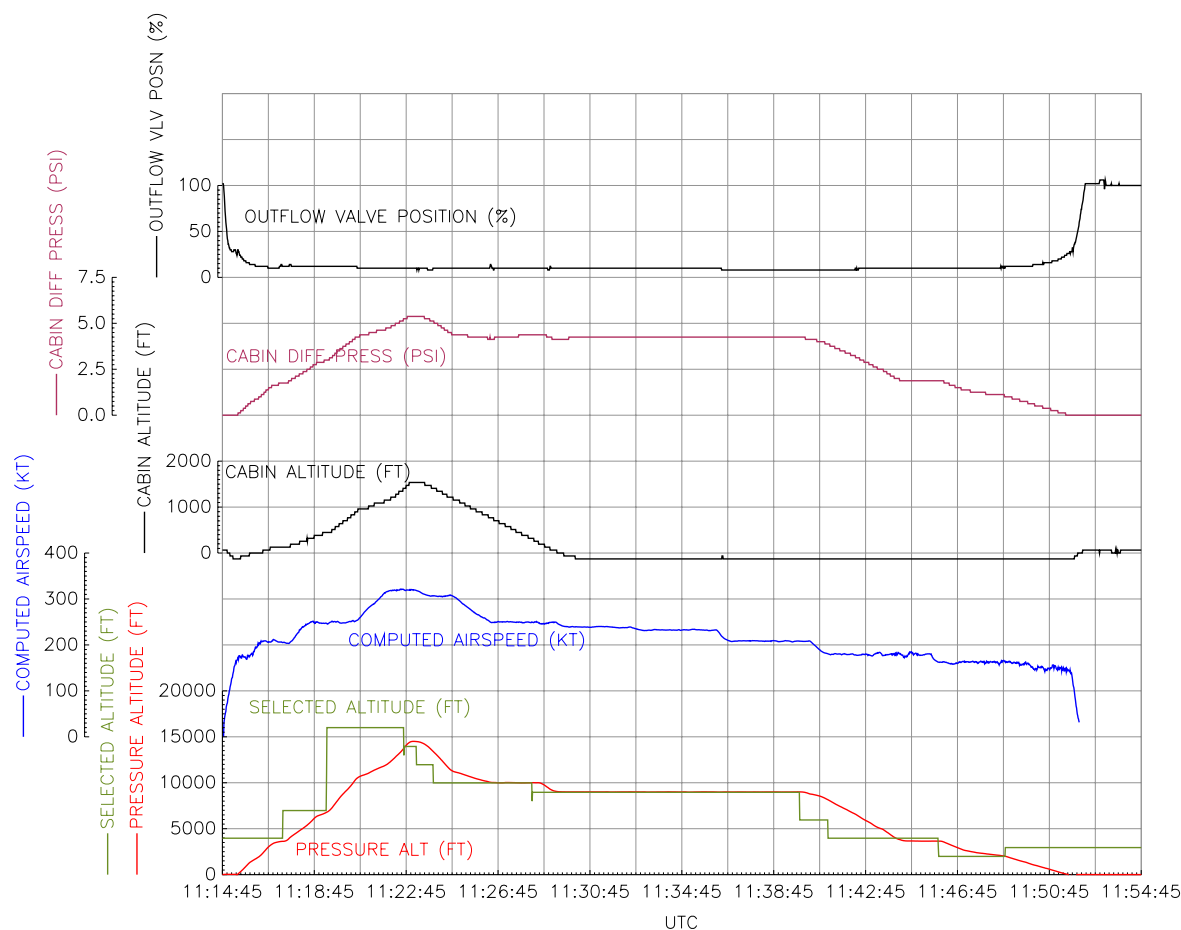
The aircraft took off from Stansted at 1115 hrs, climbing progressively to a maximum of 14,504 ft² at 1123 hrs (Figure 3). The cabin altitude increased during this time, reaching a

recorded maximum of 1,536 ft. The aircraft then descended to 10,000 ft initially, followed by a further descent to 9,000 ft while circling to the north-west of the airport. No pressurisation warnings were recorded during the flight, which landed back at Stansted Airport at 1151 hrs.

Figure 3
G-OATW FDR data

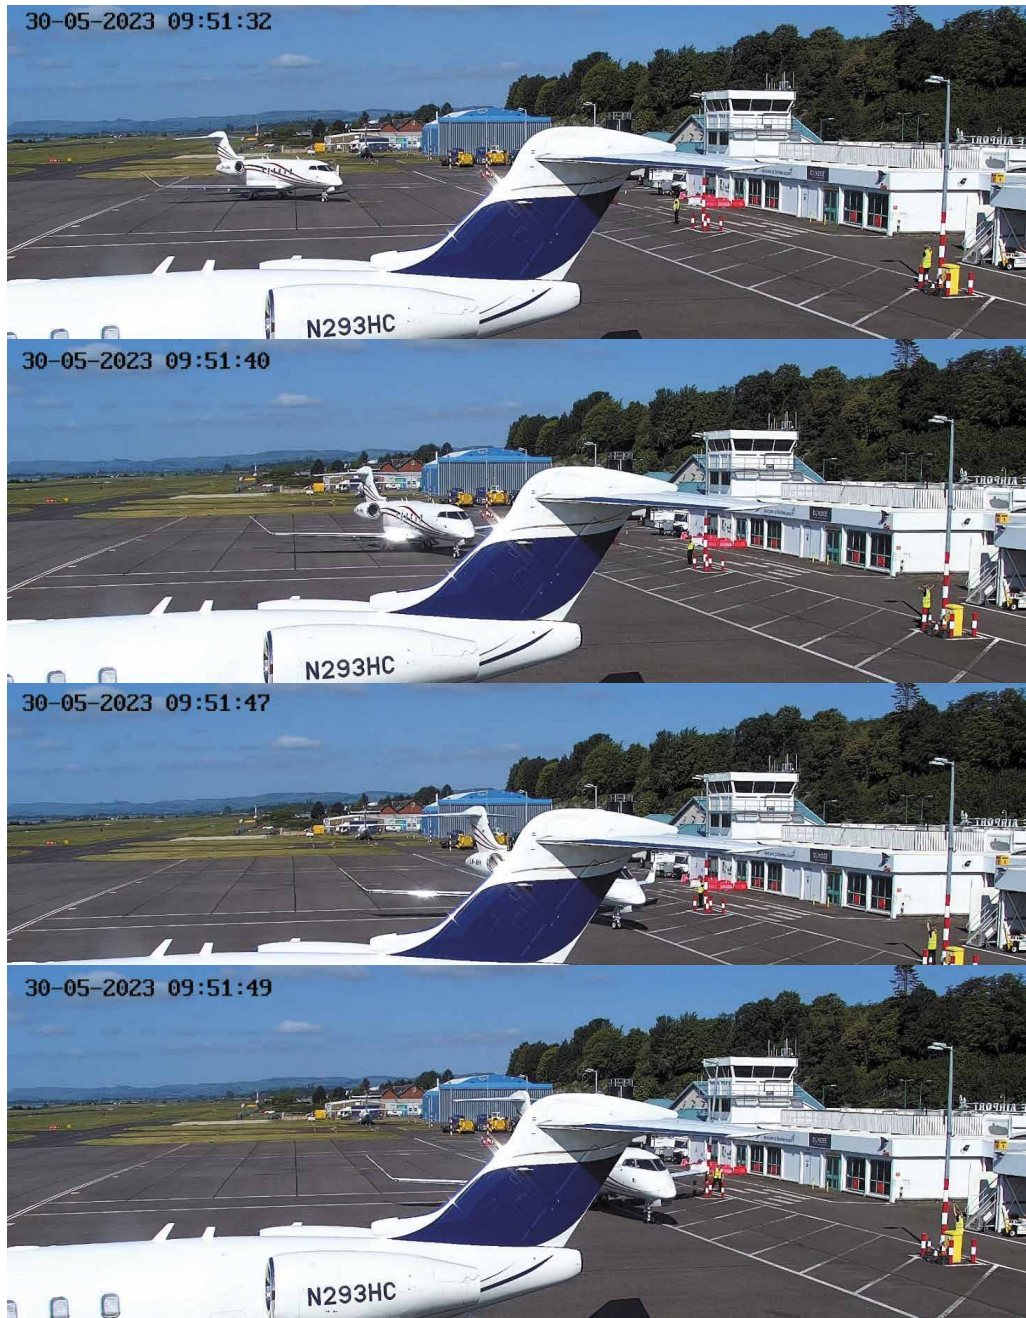
The occurrence was captured on CCTV. Figure 4 shows the sequence of events. The marshaller is out of shot on the left of the images.

CCTV footage of the occurrence (time stamps are local time)

- Conduct a review of its marshalling training package.
- Consider the introduction of direct headset communications between marshaller and wing spotters.
- Consider a two-stage marshalling process with two marshallers for circumstances similar to the accident.

The aircraft operator issued an Operational Order to all its pilots reminding them about standard marshalling signals.

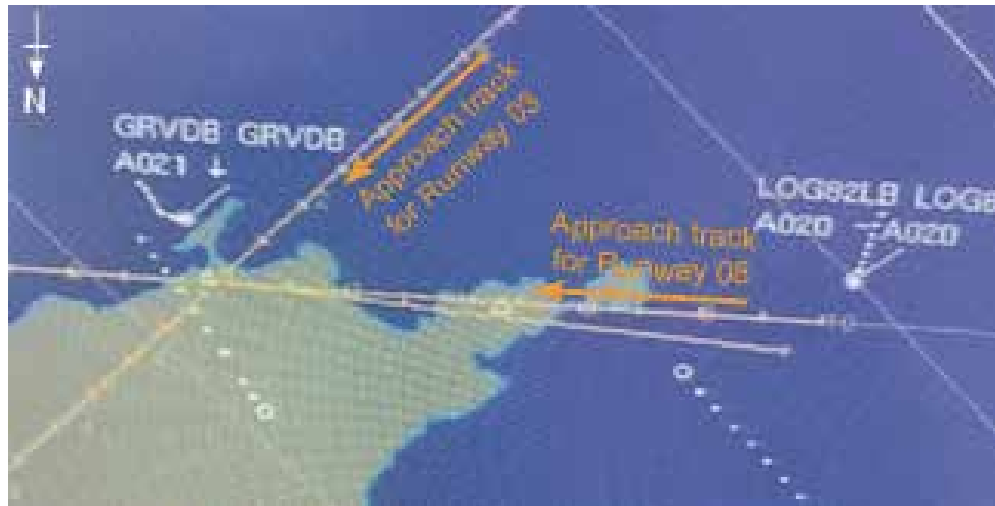
Figure 1

The pilot requested Runway 08 before being instructed to 'REPORT READY FOR RIGHT BASE RUNWAY ZERO EIGHT.' The aircraft appeared to turn downwind for Runway 08 although its position was also consistent with right base for Runway 03 (Figure 1)^{1,2}.

G-RVDB's position after pilot requested Runway 08

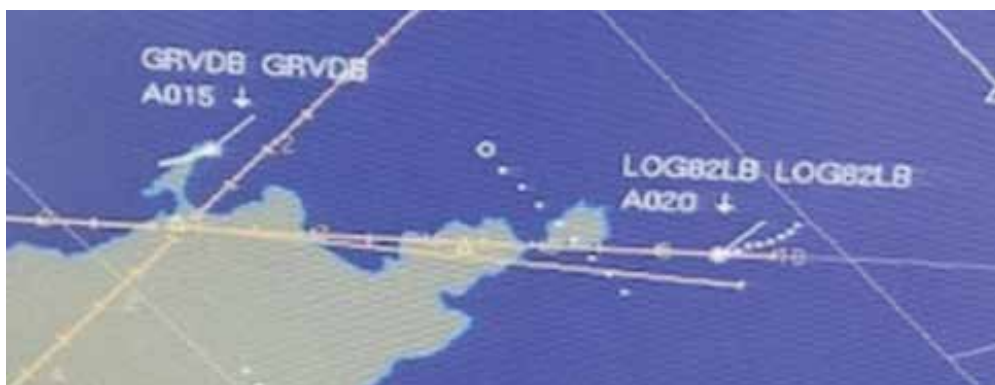
Figure 2

From there, the pilot reported ready for right base (Figure 2). He was instructed to orbit left to accommodate an ATR 76 on a commercial air transport flight that was joining final for Runway 08 at 8 nm.

G-RVDB's position when the pilot reported ready for right base Runway 08

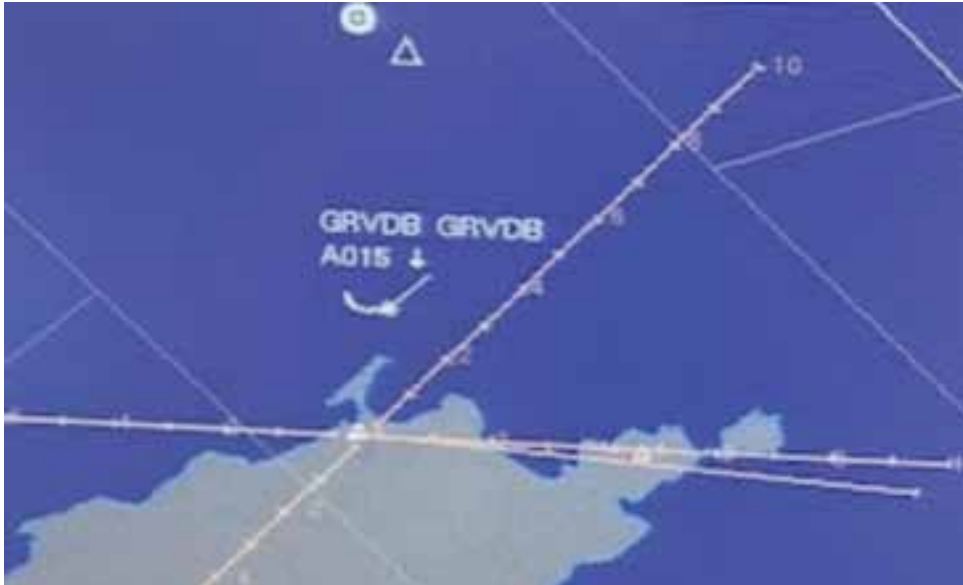
The pilot was unable to see the ATR during its approach so the ATCO advised him when it landed, and the pilot reported ready to leave the orbit (Figure 3).

Figure 3
G-RVDB leaving orbit

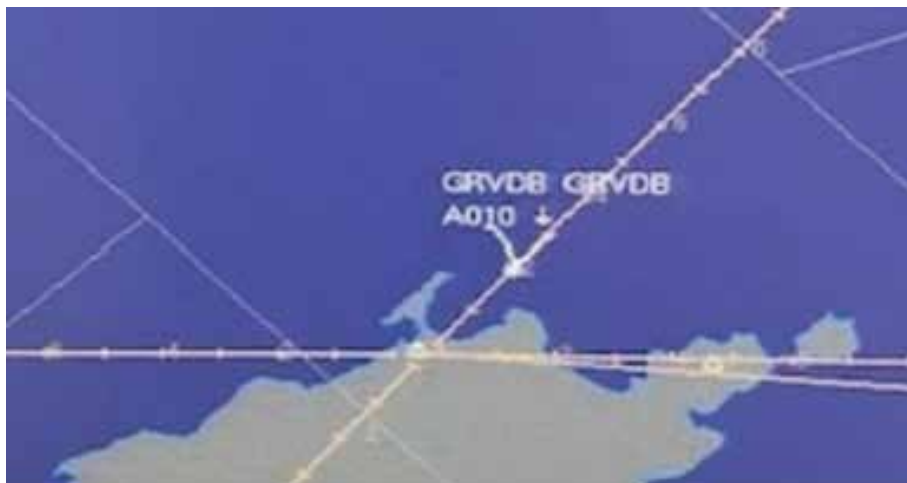
The pilot reported that he aligned the aircraft with a “large runway slightly off to [his] right”, calling ‘FINAL ZERO EIGHT’ on the radio frequency, and was cleared to land on Runway 08 (Figure 4). However, he inadvertently performed an approach and landing on Runway 03 instead.

Figure 4
G-RVDB reports turning final Runway 08

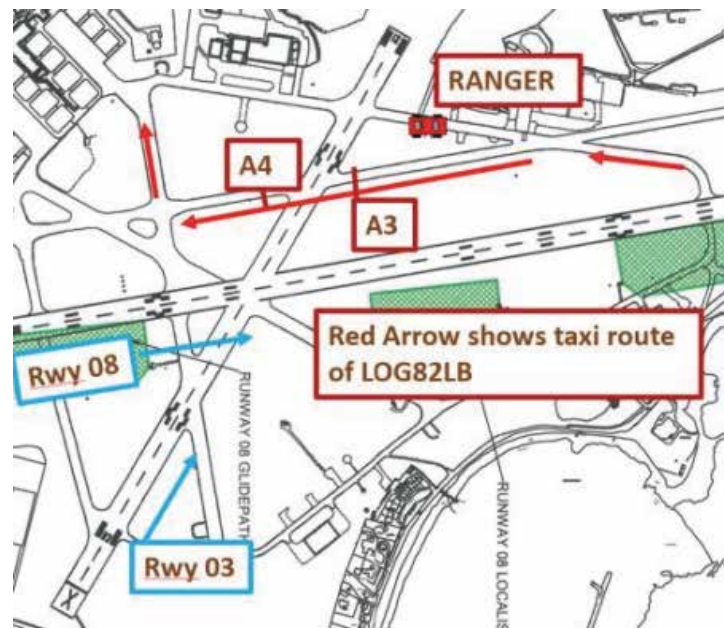
The aircraft stopped its landing roll around the intersection of the two runways (Figure 5). Confusion over taxi instructions, which the ATCO issued as though the aircraft had landed on Runway 08, led the pilot to re-orientate the airfield against the chart he was using.

Ground situation after the ATR had landed

In this case the outcome of G-RVDB landing on the wrong runway was benign. However, Figure 5 illustrates the potential for conflict with other aircraft using the active runway or taxiways.

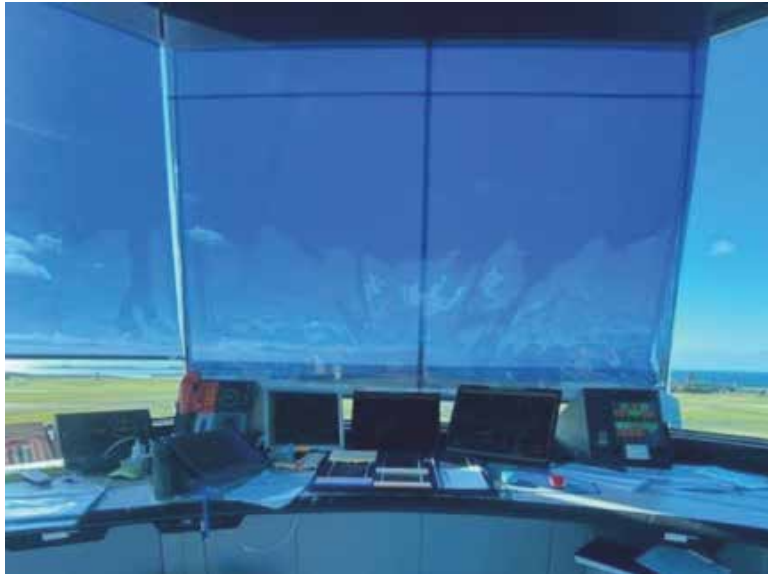
Figure 6

Both the ATCO and air traffic services assistant (ATSA) said it had been a quiet morning. Glare from the morning sun and sea made it difficult to see aircraft from the south-facing control tower, with the sunblinds themselves presenting a "margin" across the window and additional glare from their "shiny" surface (Figure 6).

View of Runway 03 approach with similar glare and sunblind position as the incident⁴
