Rail Accident Investigation Branch

Rail Accident Report

Serious injury to a passenger alighting from a train at Loughborough Central station 14 January 2023

Report 13/2023
October 2023

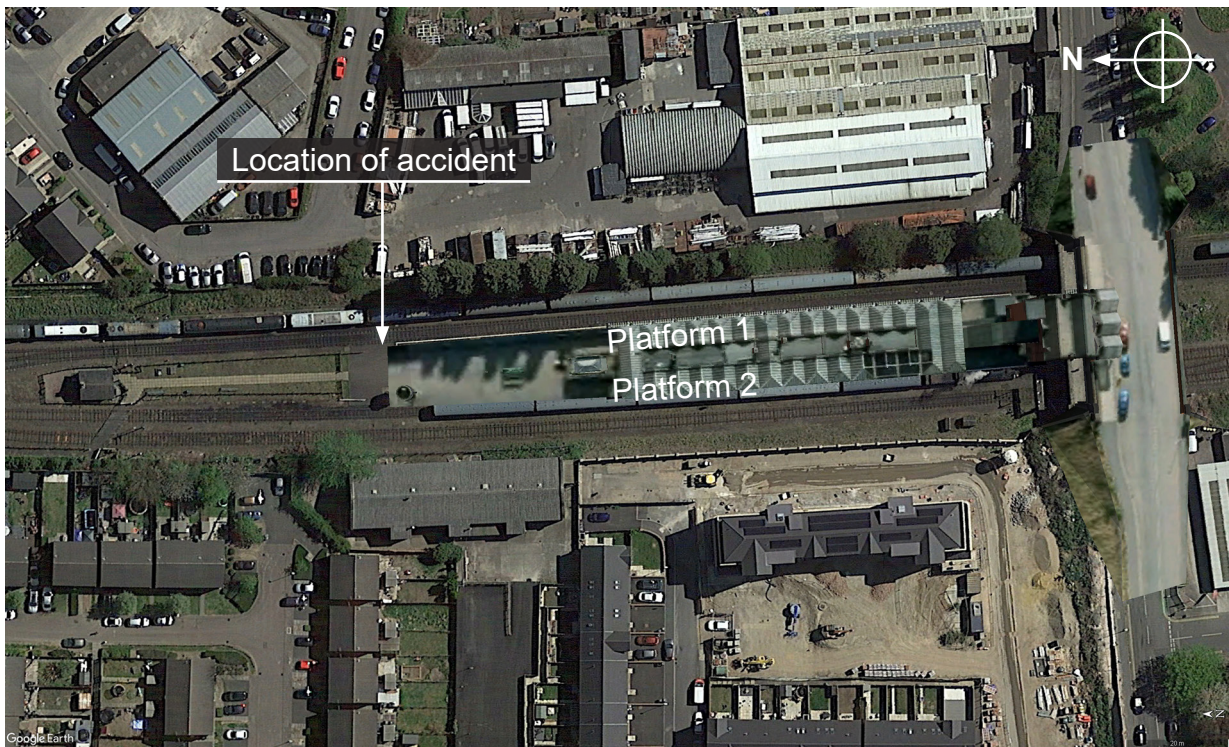
Figure 2: Google Earth image showing Loughborough Central station.

8 The north end of platform 1 at Loughborough Central was in generally good condition with the coping stones at the platform edge made from a coarse dressed stone. The area intended for use by passengers was level with no identified trip hazards. The condition of the platform surface and the level of grip it offered are not considered to be factors in this accident.

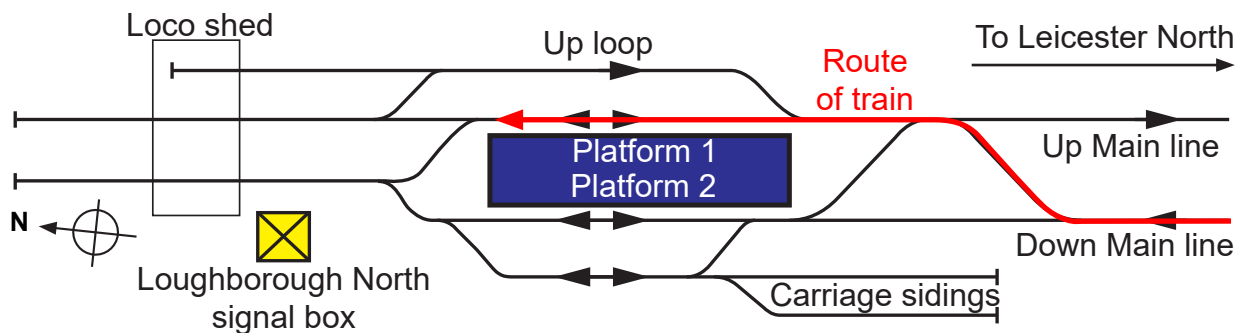
Figure 3: Layout of the track around Loughborough Central station.

- 55 Loughborough Central station has two platforms, numbers 1 and 2, located between the Up and Down Main lines (a configuration referred to as an 'island platform' (figure 3)). Platform 1 runs along the east side of the station. The horizontal length of each platform, between the ramps at each end, is 122 metres.
- 56 At the north end of the island, a ramp is provided which slopes from platform height to ground level. This ramp runs across the whole width of the platform island. Visitors can use a path down the middle of the ramp to access a walkway that leads to the Locomotive Shed and a picnic area. The level part of the platform is marked out by white lines painted on the platform edge. At each end, where the platform end ramp starts, there is a short white line perpendicular to the platform edge (figures 6 and 11).

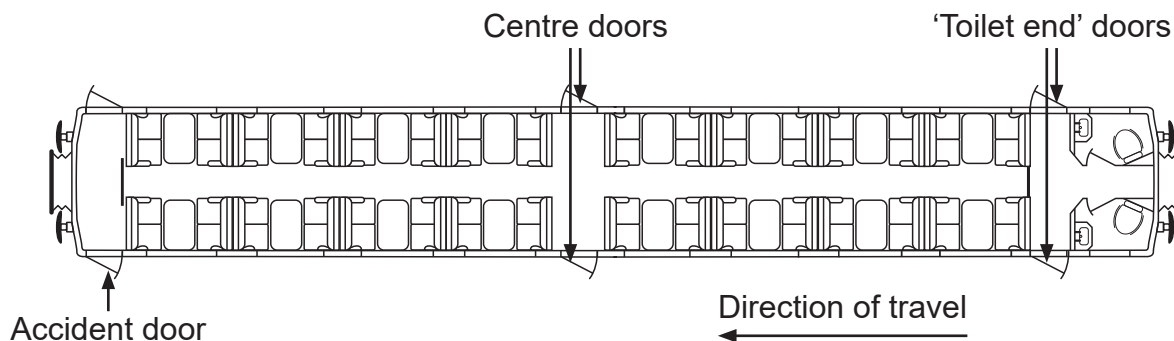
Figure 5: Layout of a Mk1 Tourist Second Open (TSO) coach.

- 14 The passenger coach involved was a Mk1 Tourist Second Open (TSO), number 4857. It has a central aisle with eight groups of four seats around tables on either side of the aisle. A pair of toilets are located at one end of the coach. Access and egress is available by three pairs of external doors, with one pair of doors at each end of the coach and one pair in the middle (figure 5). The doors are hinged so they open outwards and incorporate a 'droplight' window. Droplight windows have a simple vertical sliding windowpane which is opened by pulling down a horizontal lip attached to the top edge of the pane. To open a door, passengers inside the train have to open the droplight and reach outside to operate the external door handle. There is no internal door handle. The doors are not locked centrally using a central door locking system and individual doors are not locked by train crew in normal service unless there is an out-of-course incident (such as a fault) or the coach is not in service. Passengers and staff can move between coaches using interconnecting gangways. In common with all other coaches on the train, coach 4857 was not fitted with a public address system.

58 Coach 4857 had a pair of toilets at one end with the vestibule inboard of them (paragraph 14, figure 5). Consequently, the passenger doors at that end are around 1.36 metres further inboard than the leading end doors. When the train travelled north from Leicester North station, the toilets were at the trailing end of coach 4857. If the coach had been orientated with the ‘toilet end’ leading, the external door at that end would have been adjacent to the start of the platform end ramp.
