Report on the investigation of the accidental discharge
of a FirePro condensed aerosol fire-extinguishing system
during its installation on board the fishing vessel

Resurgam (PZ1001)

resulting in one fatality

on 15 November 2019

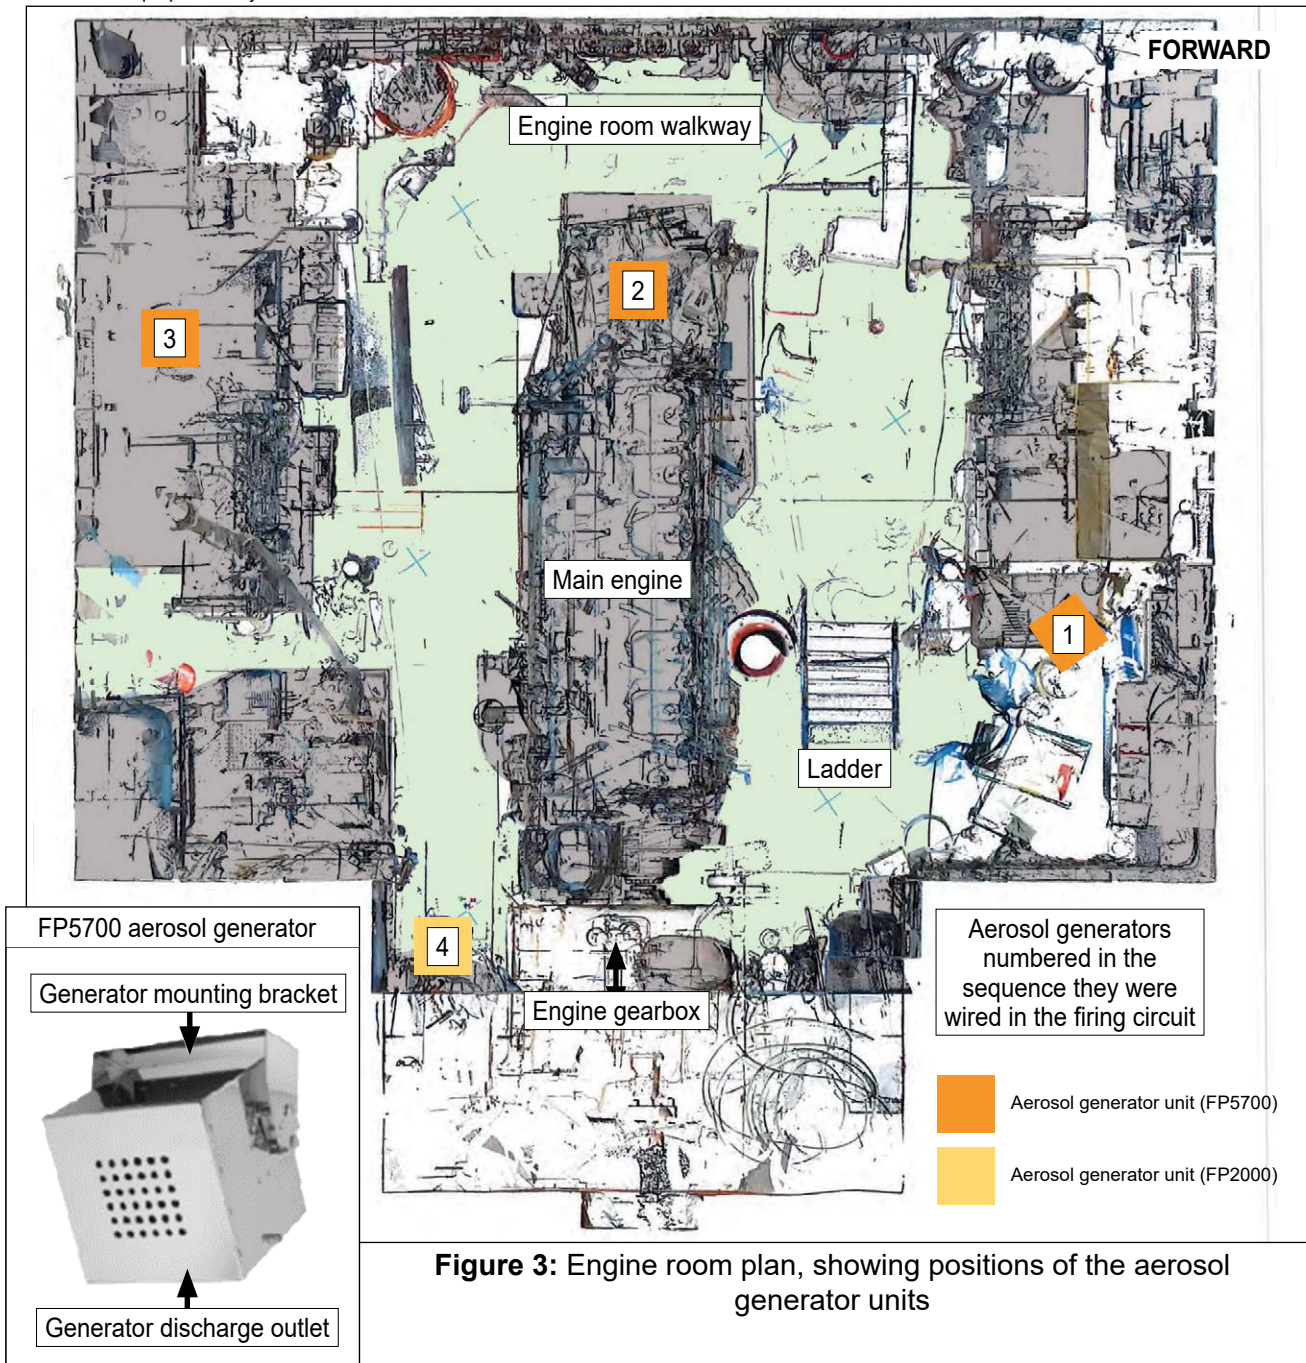
Figure 3: Engine room plan, showing positions of the aerosol generator units

FirePro manufactured various models of aerosol generator units based on aerosol generating capacity. Three FP5700⁷ units and one FP2000 unit were fitted on board *Resurgam* (**Figure 3**) and were mounted with their outlets facing down at a slight angle of approximately 15° to the horizontal. The FP5700 generator positioned next to the engine room access ladder was mounted at head height with its outlet 86cm from the closest edge of the ladder and walkway (**Figure 9**). The other generators were mounted in close vicinity to the engine room's floor plate walkways, just above head height.

- The cover for the junction box (**Figure 19**) in the engine room lobby was off. The generators were wired in series in the order 4, 3, 1, 2.
- The FP5700 generator 1 (**Figure 3**), mounted adjacent to the engine room access ladder, had discharged. Its firing cable plug/socket coupling was connected.

- The FP5700 generator 2 (**Figure 3**), mounted near the forward end of the main engine, had not discharged. Its firing cable plug/socket coupling was disconnected.

- The FP5700 generator 3 (**Figure 3**), mounted near the port forward corner of the engine room, had discharged. Its firing cable plug/socket coupling was connected.

- The FP2000 generator 4 (**Figure 3**), mounted in the port aft corner of the engine room, had discharged. Its firing cable plug/socket coupling was disconnected.

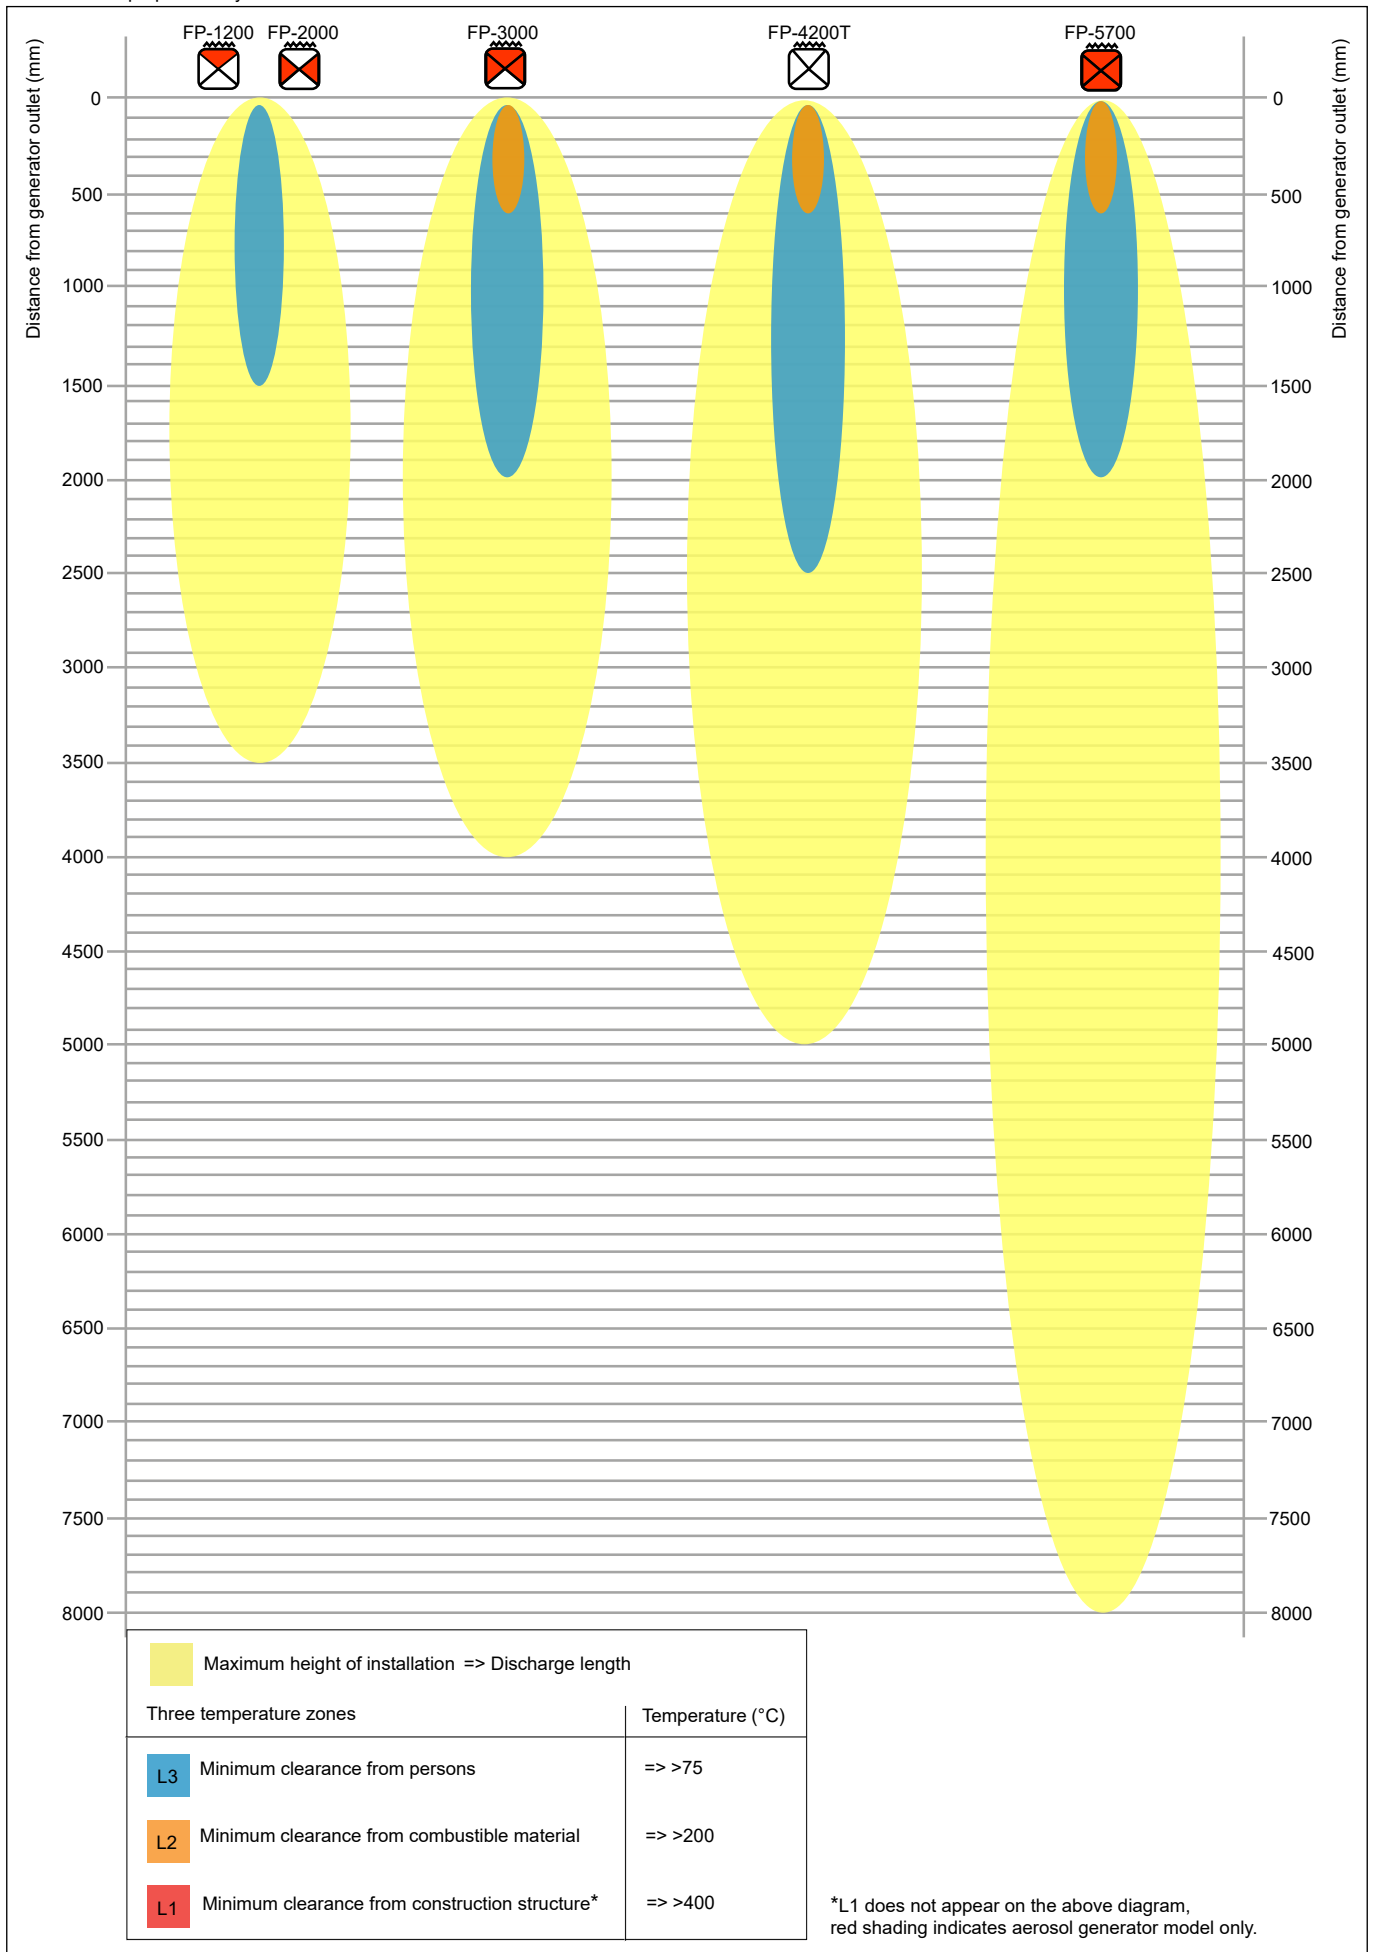
Figure 12: Condensed aerosol stream length and temperature illustration

The importance of choosing the correct generators and locating them at safe distances from structural components, combustible materials and people was explained in the manual and figures illustrating the length of the discharge streams and temperatures (**Figure 12**) were used to assist the process. The figures illustrated the total discharge stream lengths and three temperature-related discharge stream lengths for each generator model.

These results demonstrated that, for each of the temperature points, the measured temperature values in the HSE trials exceeded the distance values given in FirePro's documentation (**Figure 12**). The distance for the key temperature value of 75°C for the FP5700 generators was exceeded by 61% and measured 3.25m instead of 2.0m.

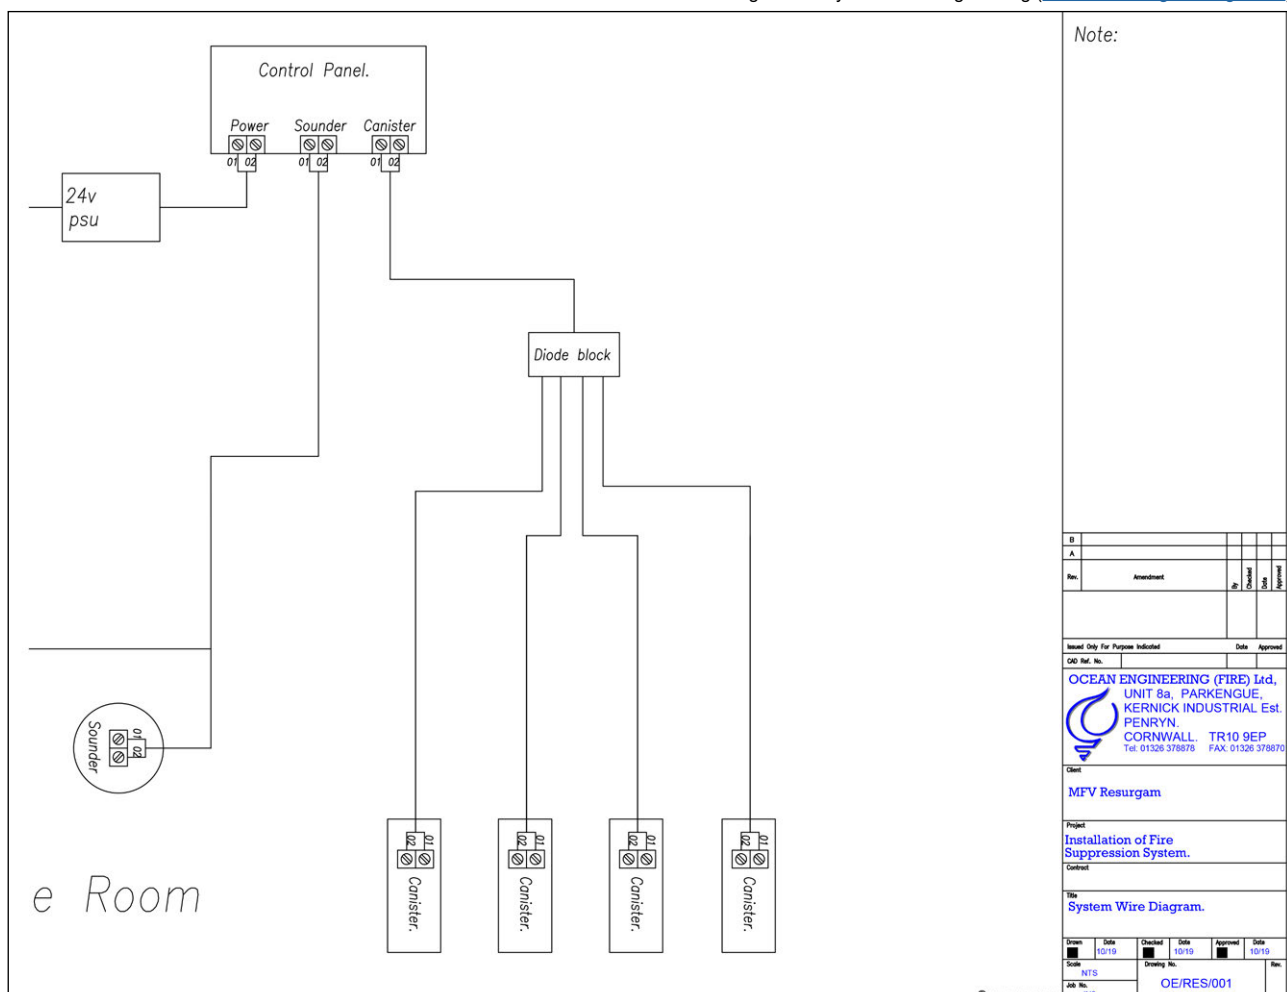
Figure 14: Ocean Engineering wiring drawing for *Resurgam* installation

Stevenson was not given a copy of the manual or wiring diagram before the installation started and the installers did not have copies of them when they arrived on board.

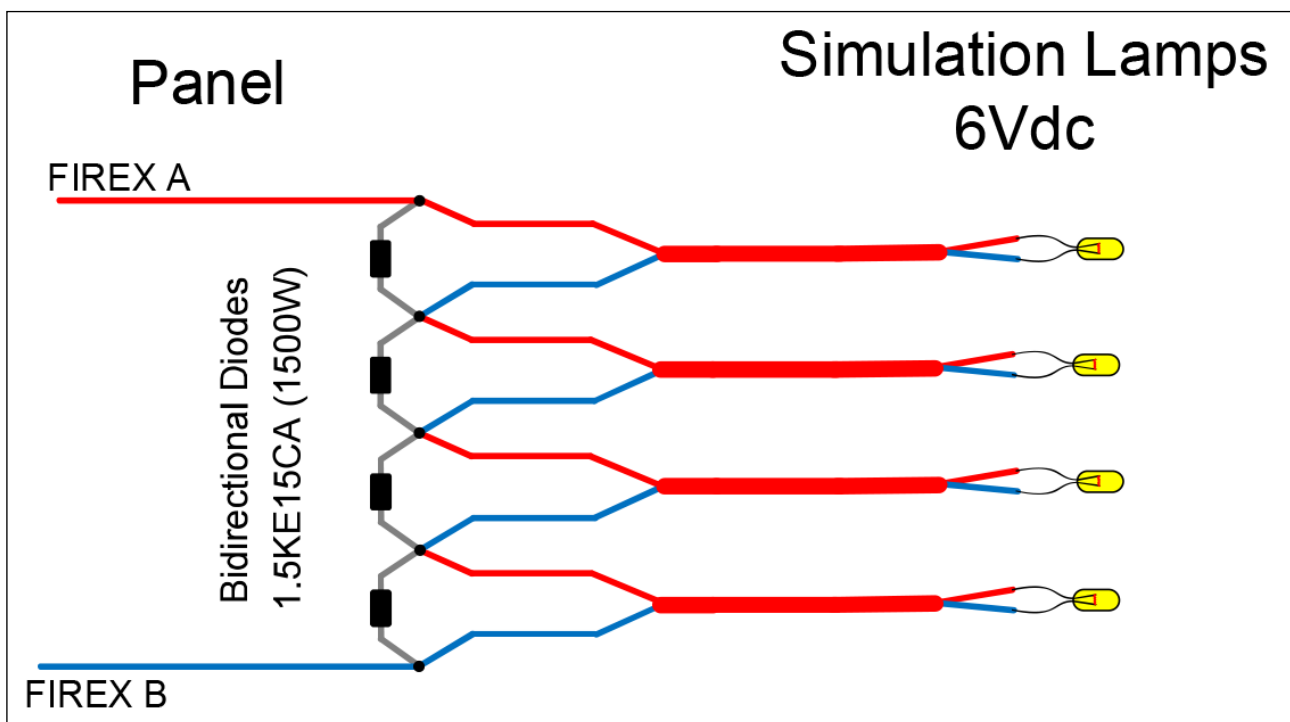
Figure 16: Aerosol generator firing circuit simulation lamps

The commissioning instructions also detailed how to return the panel to its normal operating condition after the tests and simulation were complete. To do this, the panel had to be reset to normal operating conditions and the power isolated completely before removing the simulation lamps and reconnecting the generators.

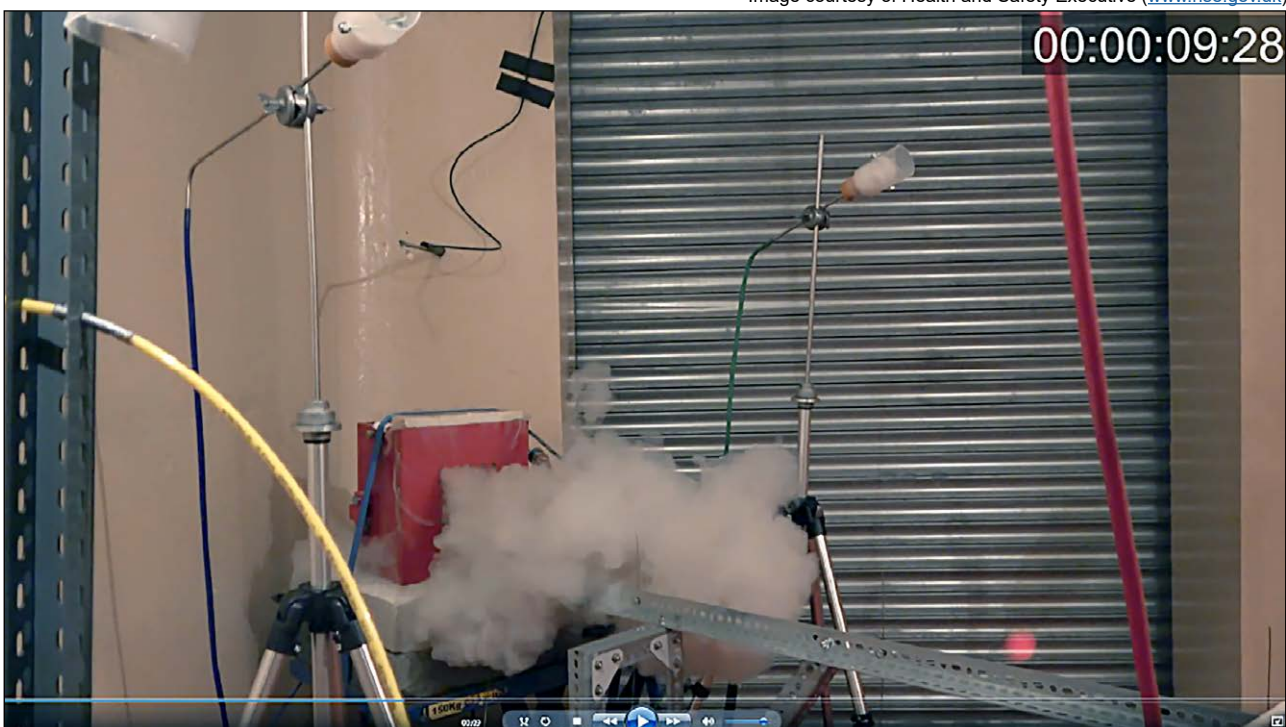
Figure 20: Set up of HSE condensed aerosol generator test

Oxygen levels within the test cell were also monitored and fell to 19.1 percent by volume.
