AAIB Bulletin

1/2024

Bombardier CL-600-2B16 Challenger 604	N999PX	31-Jan-22	3
---------------------------------------	--------	-----------	---

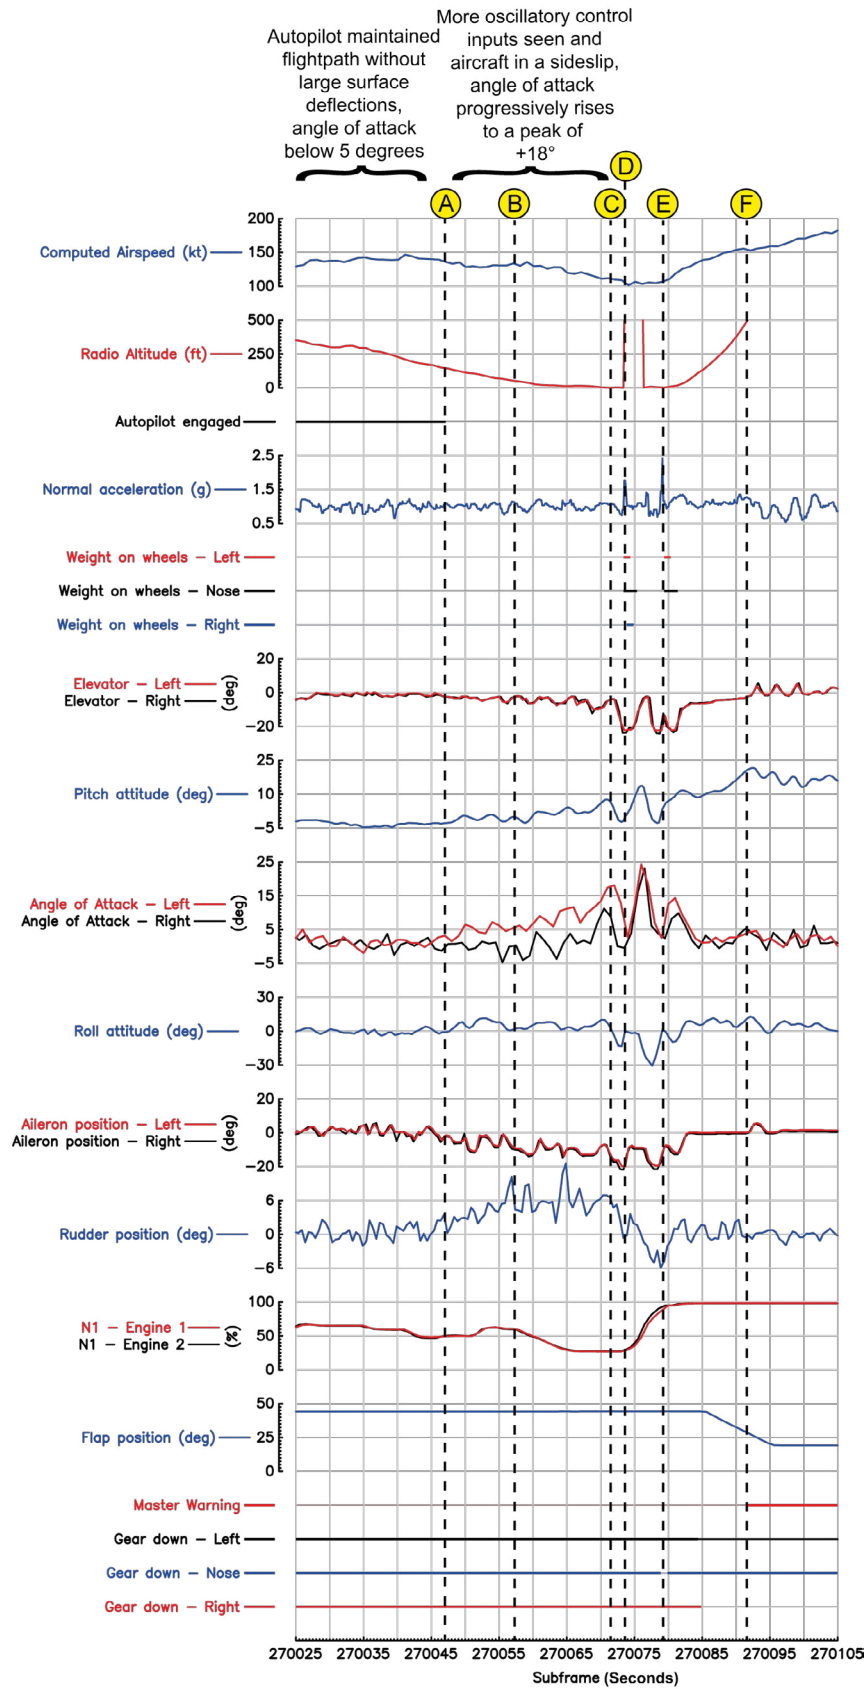
Figure 4

Data from the FDR is shown in Figure 4, each square on the x-axis representing five seconds. This shows that N999PX's autopilot was disconnected at 150 ft agl at an IAS of 136 kt, the landing gear was down and FLAPS 45 selected. Both engines were set at approximately 50% N_1 (Point A on Figure 4). Before this there are mostly only minor modulations in control surface deflections, with slightly larger rudder deflections. The autopilot maintained the aircraft's flightpath without the application of large surface deflections. The angle of attack (AOA) vanes agreed and remained below $+5^\circ$.

The aircraft went around and the flightpath stabilised in the climb, but the position of the individual landing gear disagreed and, subsequently, a master warning was triggered (Point F). At about 550 ft agl during the GA the aircraft's pitch reached a maximum of 21.6° nose-up.

Data from the FDR showing N999PX's approach and GA at London Stansted

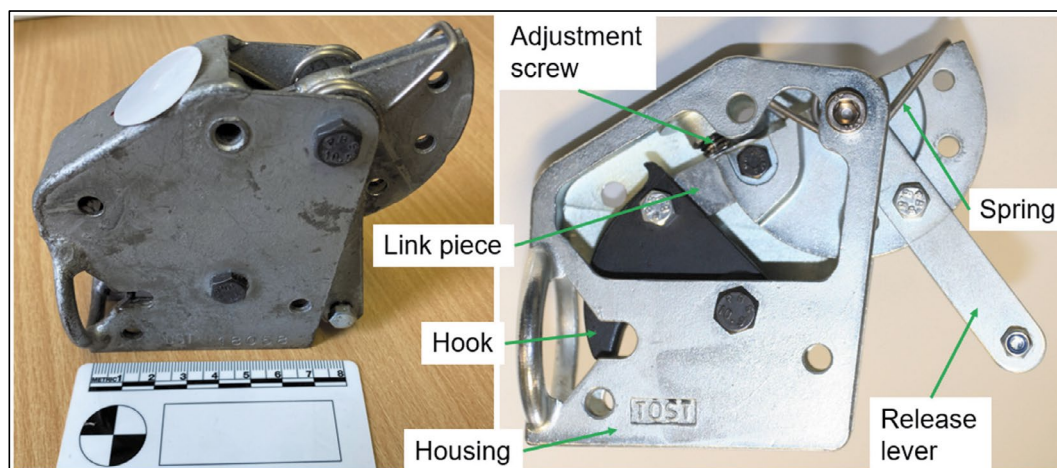
**Figure 3**

The nose tow release fitted to G-DCMK at the time of the accident was a Tost E72, serial number 18058 (Figure 3 left). Figure 3 right shows a sectioned E85 tow release, which differs from an E72 in having a cast instead of welded housing. The tow release comprises the housing, adjustment screw, hook, link piece, release lever and a spring.

Left – Tost E72 tow release fitted to G-DCMK

Right – Example E85 tow release. Internal mechanism similar

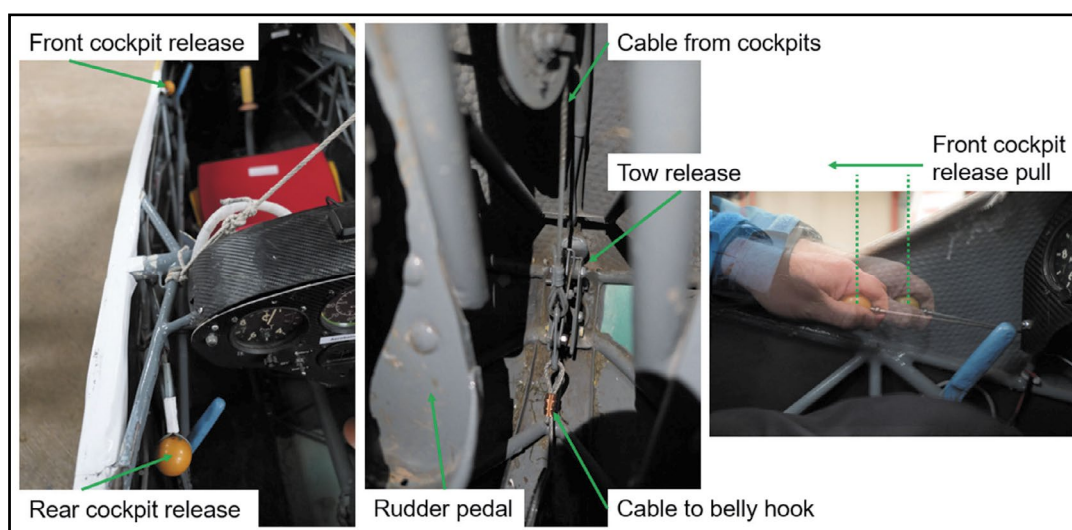
**Figure 4²**

It was operated by either pilot pulling on a plastic release knob attached to a steel cable in the cockpit (Figure 4 left and right). The steel cable passed through a series of guides and was attached to the release lever (Figure 4 centre), and another cable attached to the release lever continued under the cockpit area to the belly hook.

Left – Cockpit releases

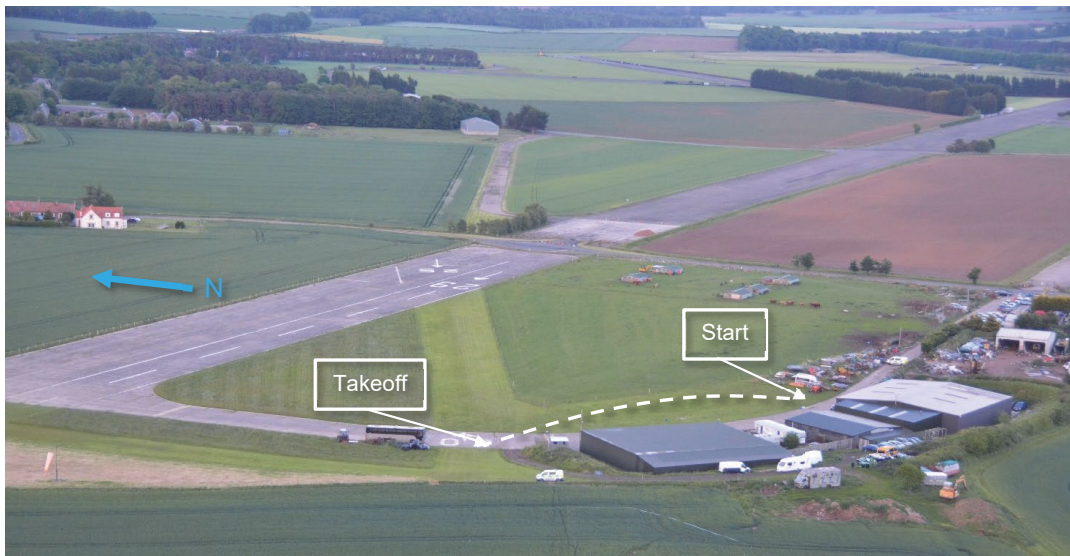
Figure 1

The flying club has multiple CCTV cameras from which recordings show the pilot putting on a helmet and entering the aircraft, which was parked on a grass area immediately in front of the club hangar. The recordings, one of which included audio, showed four engine start cycles and on the fifth cycle the engine started and immediately accelerated to a high rpm. This was at approximately 0940 hrs. Club staff, who were alerted by the sudden “abnormal” sound of the engine, ran out of the hangar and saw the aircraft accelerating rapidly over the grass and collide with a runway marker sign. The collision caused the aircraft to bounce as it crossed the taxiway and become airborne (Figure 1).

Approximate path of aircraft across the grass area (image used with permission)

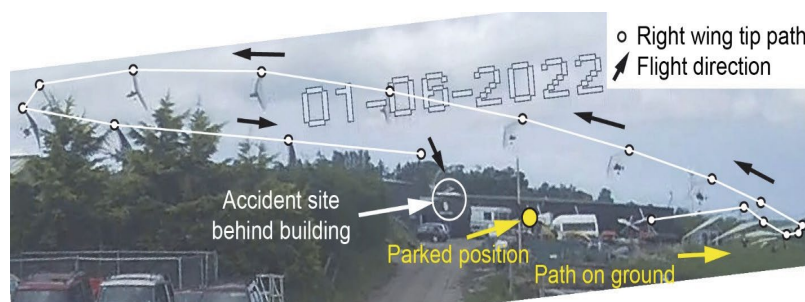
Figure 7

After taking off, the microlight flew in a low-level, tight, left turn (Figure 7). The images are not clear enough to determine whether the base bar was against the front strut after takeoff.

Cropped CCTV snapshots, rotated to horizontal, and overlaid to show the aircraft position at one second intervals

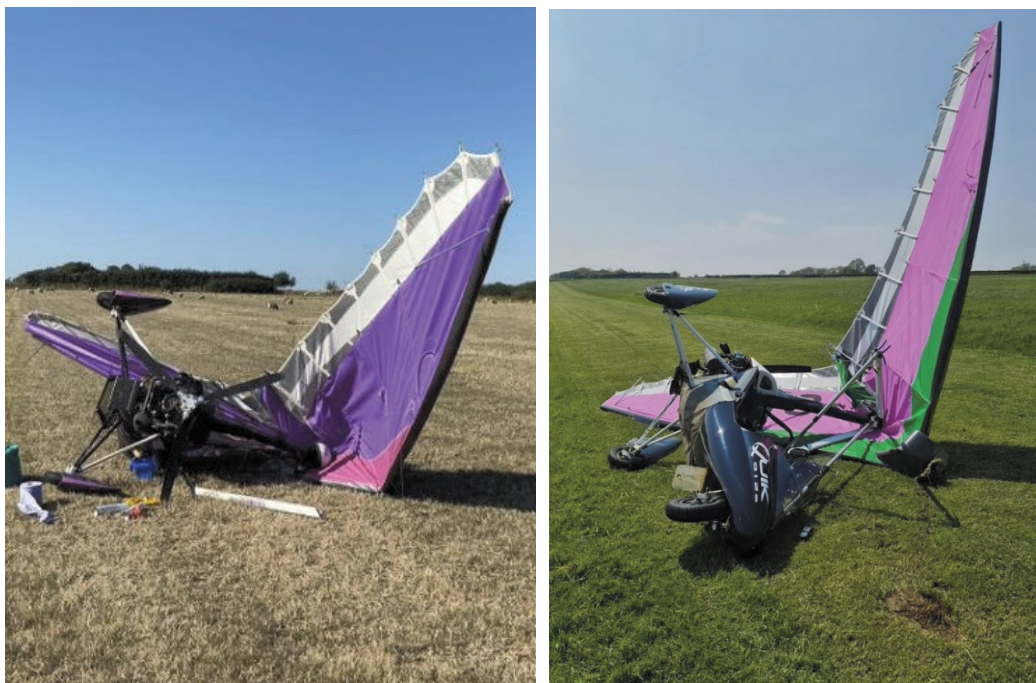
Figure 10

The AAIB investigated two similar accidents to Pegasus Quik aircraft that both occurred at Harringe Court Farm airstrip; one occurred on 6 August 2022 (G-CGRR) and the second on 14 May 2023 (G-CDPD)¹². In both accidents the aircraft veered on landing and rolled onto their side (Figure 10).

Pictorial comparison of G-CGRR (left) and G-CDPD (right)

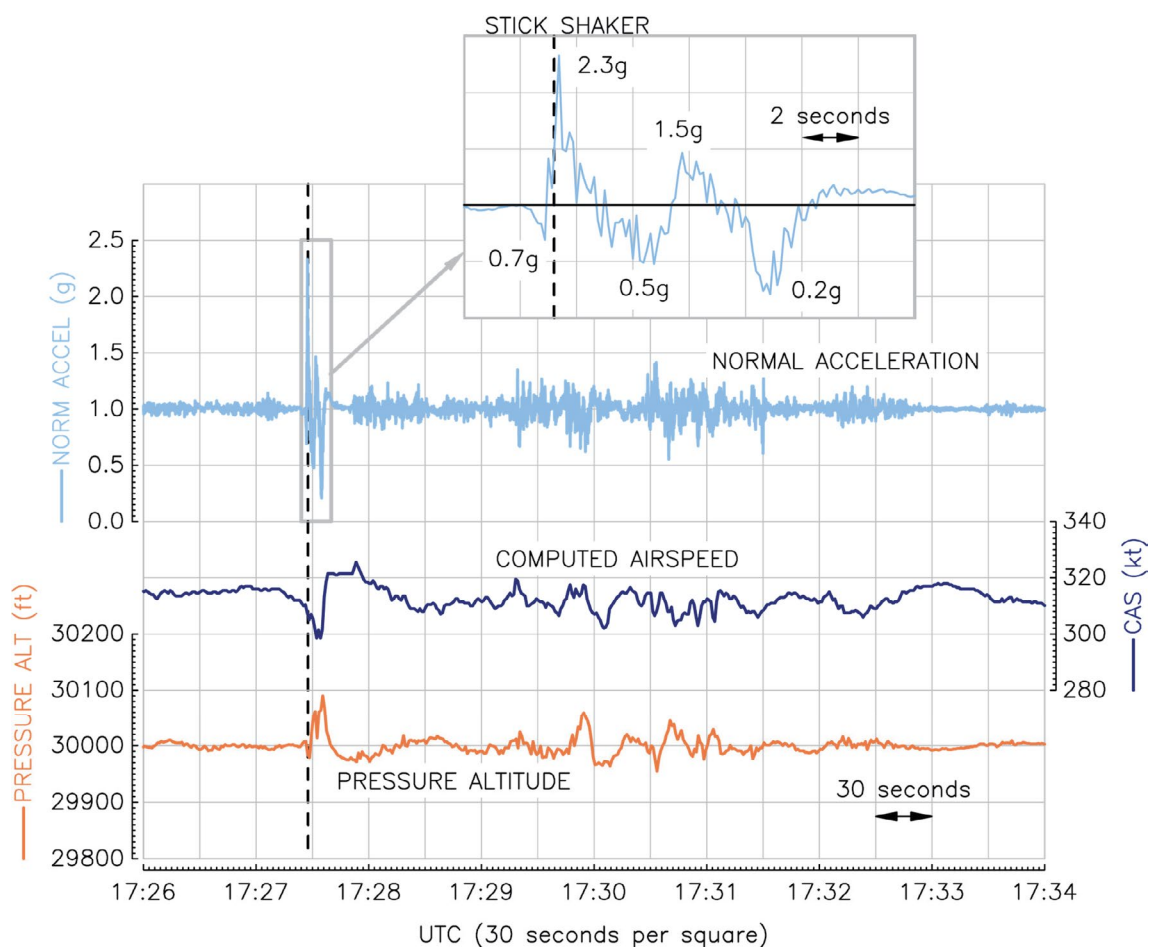
For G-STBL (Figure 1), the aircraft was cruising at FL300 and 315 kt CAS at the start of the event. The minimum and maximum recorded normal acceleration for the duration of the event (about five minutes) was 0.2 g and 2.3 g. These occurred within the first 10 seconds where the normal acceleration initially dipped to 0.7g and then spiked at 2.3 g in less than one second. A stick shaker activation was recorded during the 2.3 g spike. The recorded normal acceleration was between 0.5 g and 1.5 g for the remaining time during the event.

Figure 1
G-STBL flight data for turbulence event

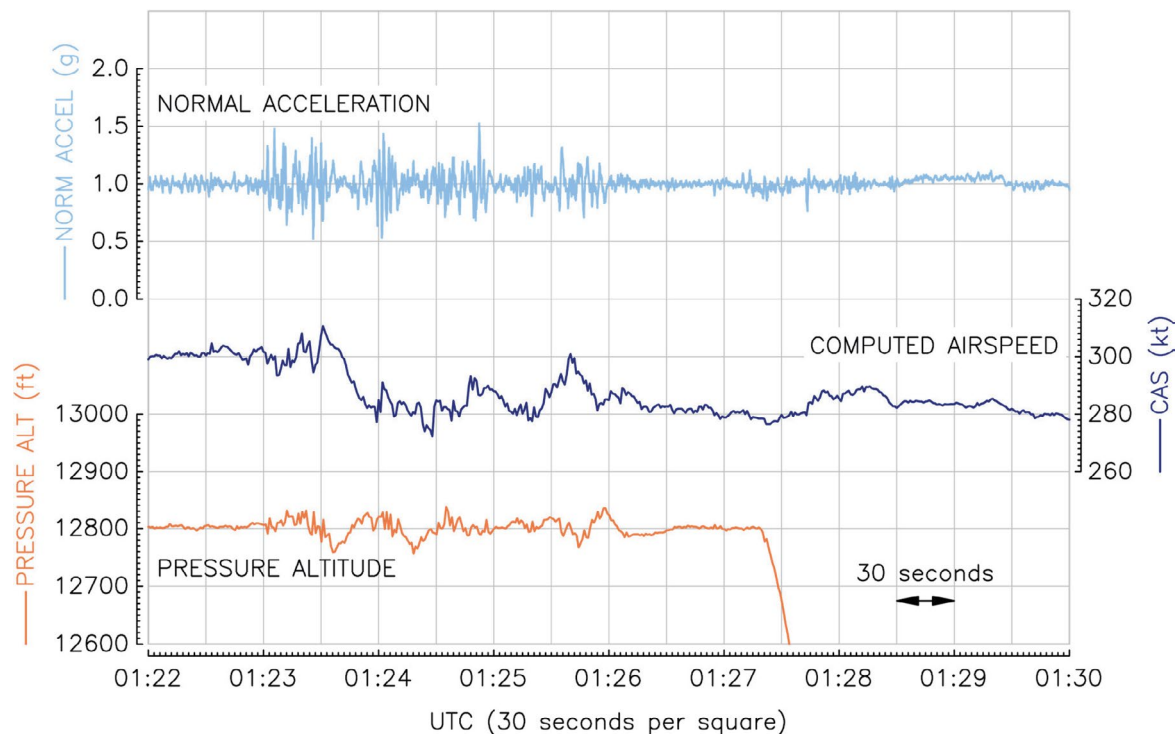
For G-YMML (Figure 2), the aircraft was level at FL128 and at about 300 kt CAS at the start of the event. The minimum and maximum recorded normal acceleration for the duration of the event (about three minutes) was 0.5 g and 1.5g.

Figure 2
G-YMML flight data for turbulence event

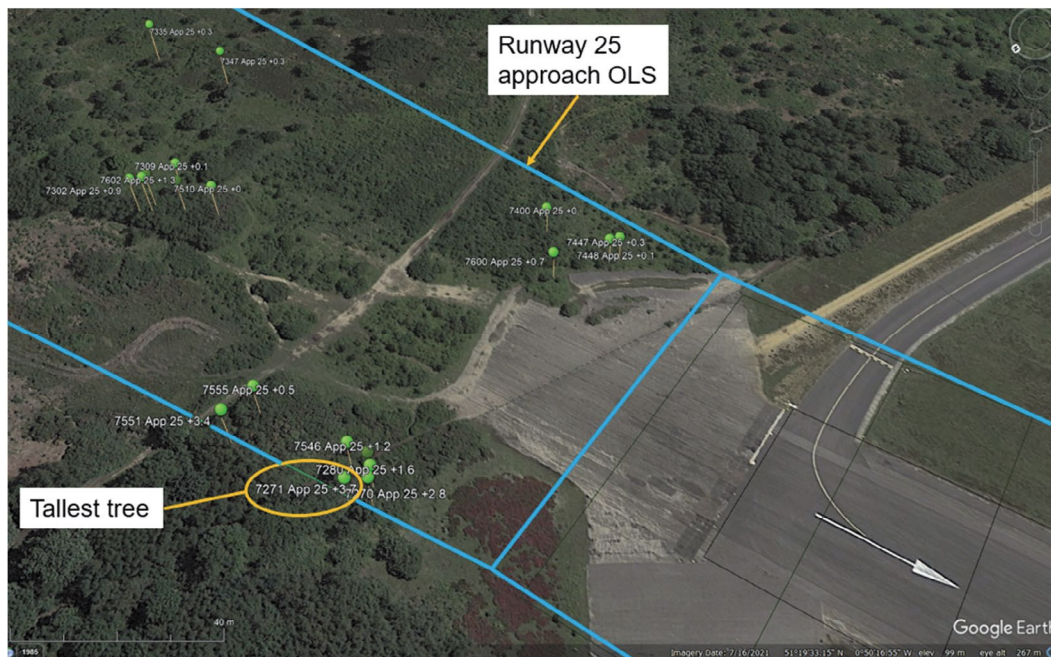
Figure 3

The airport undertook a tree survey every two to three years, the last of which in 2021 identified many trees penetrating the Runway 25 approach OLS. Following the 2017 survey, a discussion between the airport and HCC identified those trees as a hazard to the approach and arranged for their removal. Although HCC undertook extensive works on the common during the winter of 2017-2018, the airport did not follow up with HCC and verify their removal. Furthermore, they did not formally engage with HCC again, apart from some incidental verbal conversations after the 2021 survey. A further survey was completed in March 2023, and the results for the Runway 25 approach OLS are shown in Figure 3.

The tree survey also identified trees penetrating the Runway 07 approach and takeoff OLS, and the Runway 25 takeoff OLS. The survey was conducted from the runway thresholds using optical instruments and so it is possible that other trees may be penetrating the OLS but were hidden by taller trees in the foreground. The current survey may therefore not include all penetrations of the OLS and so a further survey would be required to ensure all the trees are identified.

2023 Obstacle survey results for the Runway 25 approach

Following this incident, the airport will survey the trees which have been identified as penetrating the OLS with works starting in autumn 2023 after the ground bird nesting season has finished.

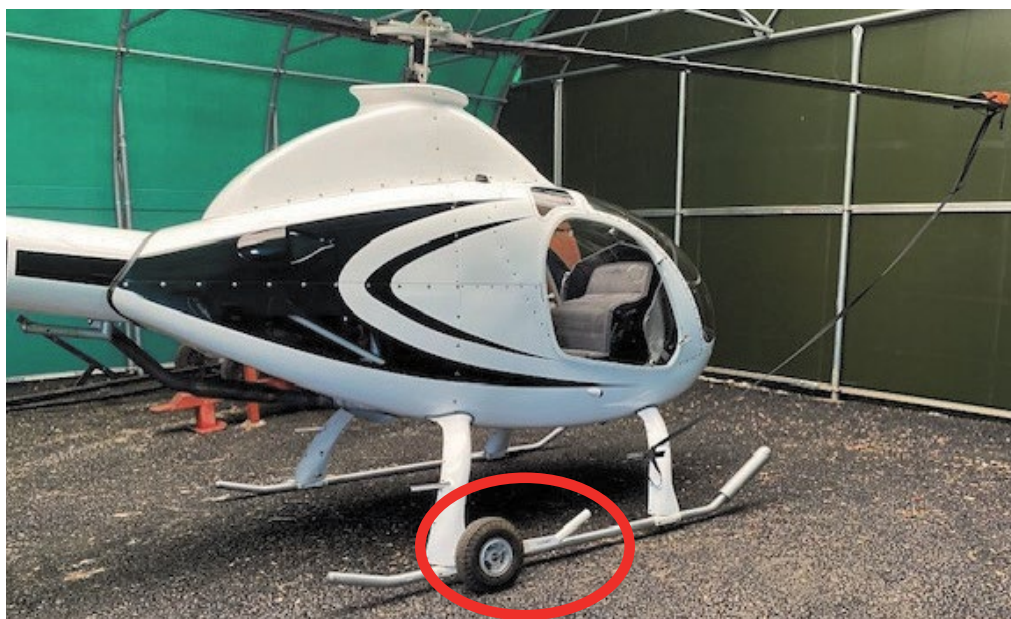
The pilot stated that he was on a local flight from a private site where the helicopter was kept. Prior to moving the helicopter out of its hangar, he completed the pre-flight inspection. He then self-manoeuvred it out of the hangar on its ground handling wheels. Each wheel weighs about 12 lb (5.4 kg). Figure 1 shows the helicopter with a wheel fitted. However, once the helicopter was in a position for startup and takeoff he became distracted by his dogs, which he had to take into his house. Upon returning to the helicopter the pilot forgot to remove the wheels and subsequently took off with them on. He only realised this after landing when he found one wheel attached and one missing. Realising the missing wheel had fallen off in flight, he immediately notified the local ATC unit and police but there had been no notification of any damage or injuries caused by the wheel falling off in flight.

G-ZHWH with ground handling wheel fitted

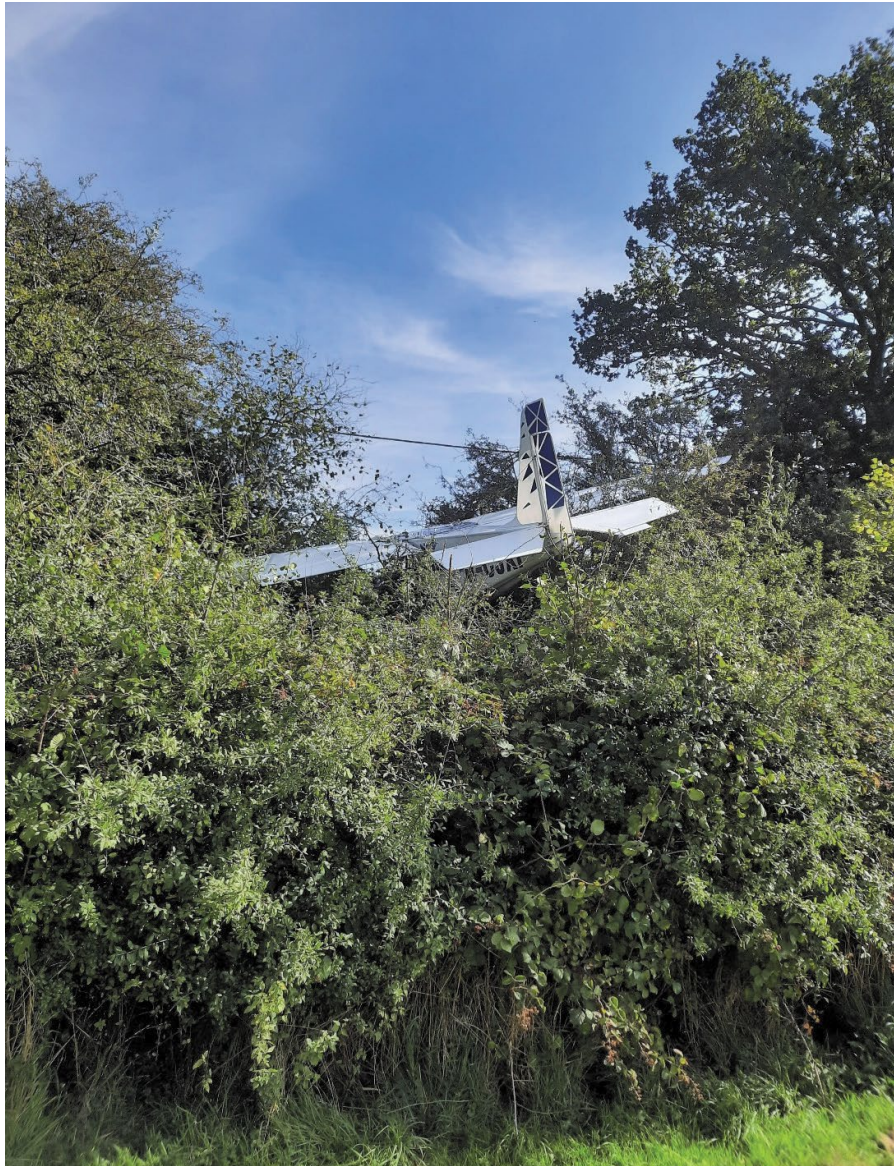
Figure 1

The pilot was taking off from a large field approximately 1 nm south of Dunstable. Shortly after becoming airborne he saw a heron flying on an intercepting course. He was expecting the bird to change course but when it became obvious they were about to collide, the pilot banked the aircraft to the left to avoid it. He estimated that the heron missed the aircraft's windscreen by 100 mm, but as the heron passed over the windscreen he heard another bird hit the propeller. The engine coughed for a few seconds but continued to run. However, he realised the loss of power meant he was not going to clear the trees ahead. He turned slightly to the right to avoid the tallest trees and focused on maintaining airspeed. Just prior to contact with bushes he switched off the engine. The aircraft settled into the hedgerow. The pilot was not injured and was able to exit the aircraft via a ladder.

G-CJXF after the accident

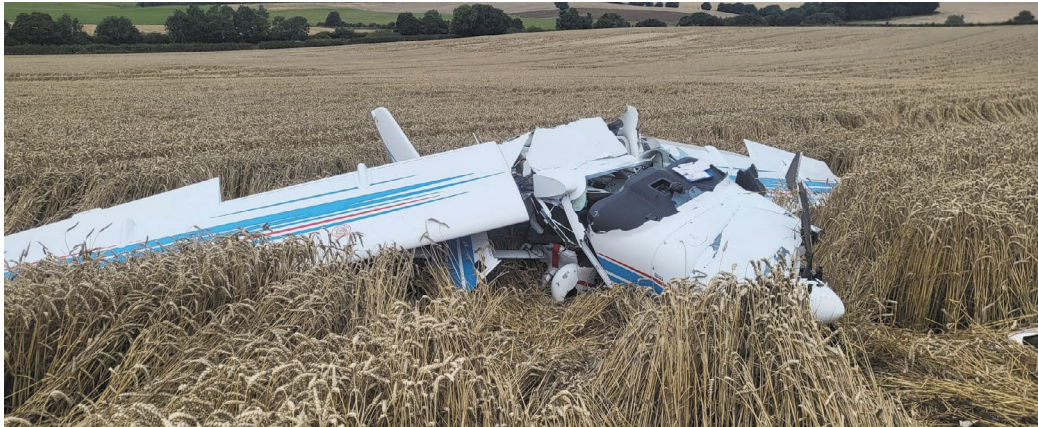
Figure 1

On application of full power, the pilot reported that the engine rpm indicator and engine sound were consistent with the engine delivering full power, but he noticed that the acceleration along the runway was "somewhat impaired". Despite the poor acceleration, the takeoff was continued and G-SBOI briefly left the ground but re-settled twice, before becoming airborne much further down the runway than anticipated. However, once airborne G-SBOI would not accelerate and the stall warning horn sounded continuously. Having only attained a height of 10 to 15 ft, the aircraft rolled to the left and struck the ground.

Damage sustained to G-SBOI (used with permission)
