Defence
Safety Authority

Service inquiry

Death of a service person in an
accident with a Warrior
armoured vehicle on Salisbury
Plain Training Area

21 June 2022

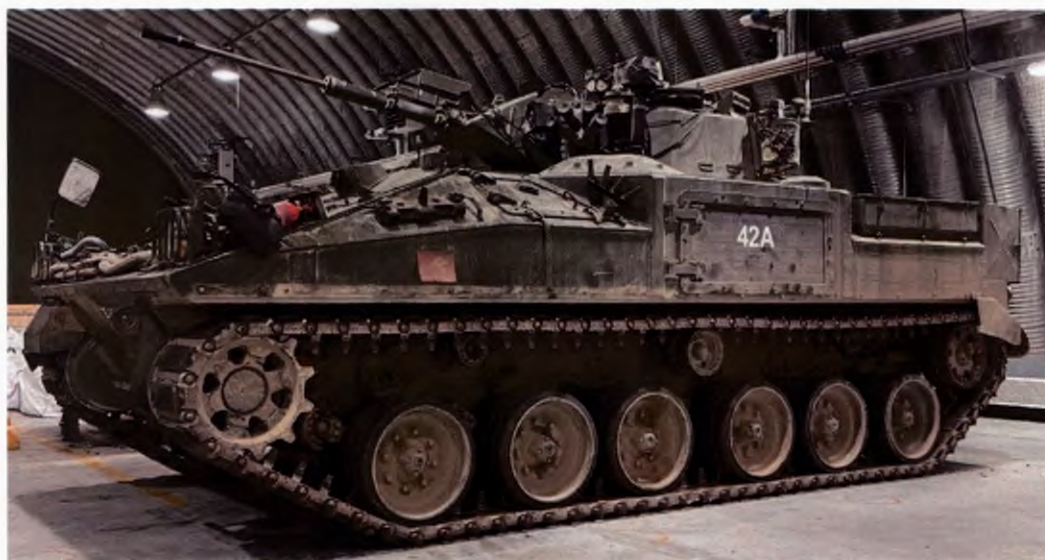
Figure 1.3.1 – FV511 – equipment registration mark (ERM) [REDACTED]

1.3.1. At approximately 10:24 on 21 June 2022, during a military exercise on Salisbury Plain Training Area (SPTA), a service person (SP) was run over by a reversing Combat Vehicle, Infantry Command, Tracked Warrior (FV511) from which they had just debussed (see figure 1.3.1).¹ The SP, Second Lieutenant (2Lt) Max George, from D Company, 5th Battalion The Rifles (5 RIFLES), was pronounced dead at the scene shortly afterwards.

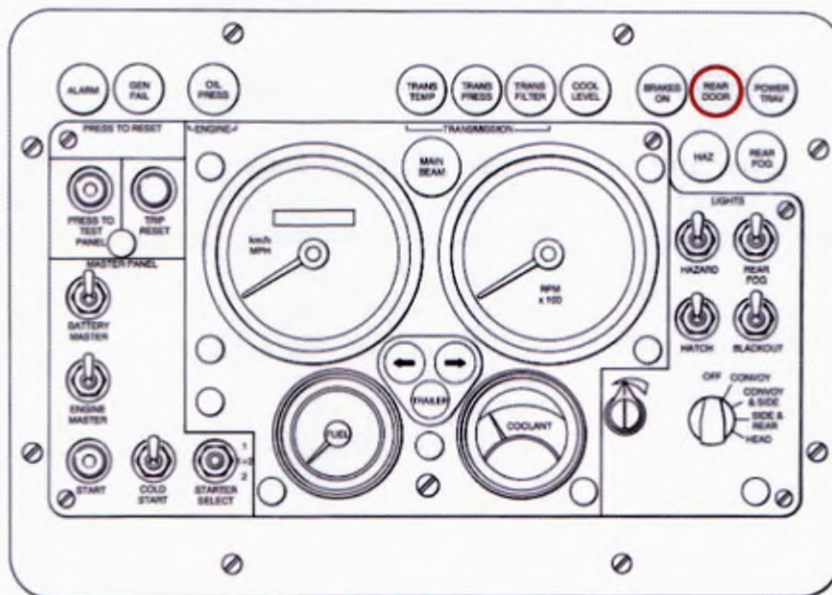
Figure 1.4.14 – Warrior driver's instrument panel (DIP)

g. **Driver's instrument panel (DIP).** The DIP provided essential vehicle information to the driver, including a rear door lamp that would indicate if the rear door was open (see figure 1.4.14). The rear door lamp worked in parallel to a two-tone audio alarm that would sound if a driving gear was selected when the rear doors were open.

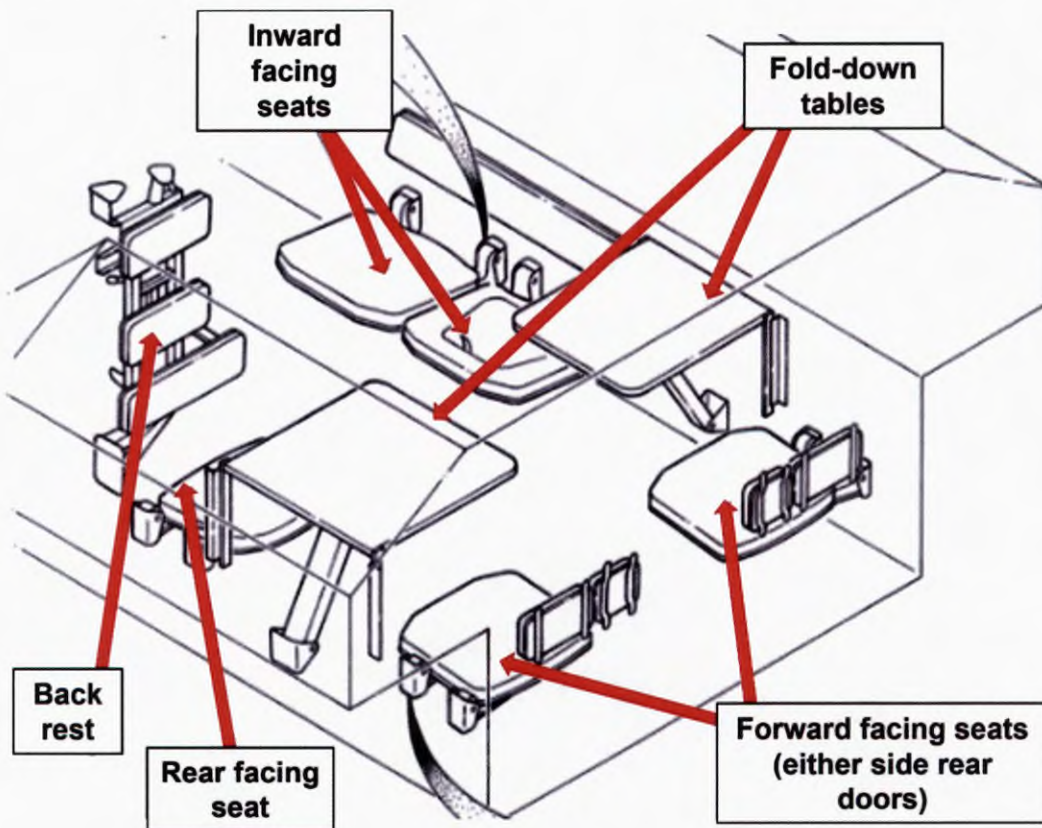
Figure 1.4.18 – Warrior FV511 rear seating

- a. **Section working compartment seating.** There were five single seats fitted in the section working compartment. Two front facing seats mounted to the compartment rear wall (next to the rear doors – see figure 1.4.18), two inward facing seats mounted to the right wall and a rear facing seat mounted to the rear of the driver's tunnel. The two inward facing seats were fitted with lap strap harnesses, the other three seats were provided with inertia type shoulder and lap strap harnesses.

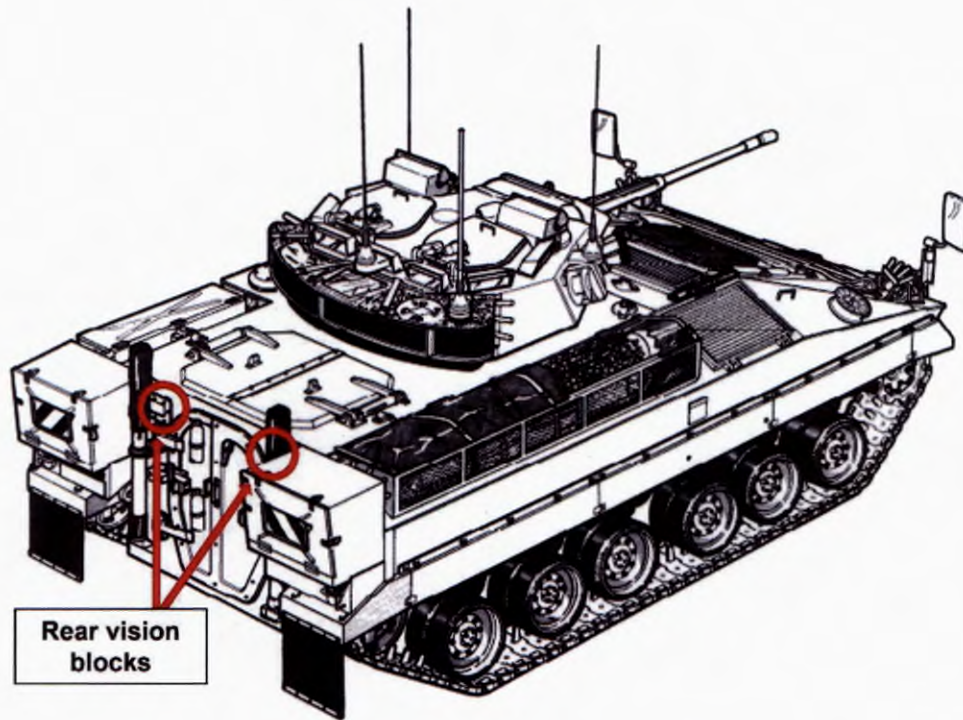
Figure 1.4.19 – FV511 rear vision blocks

- b. **Section working compartment exterior vision.** Two vision blocks mounted in the rear hull plate of the vehicle enabled occupants to view the area behind the vehicle (see figure 1.4.19). There were no periscopes mounted in the roof of the hull.

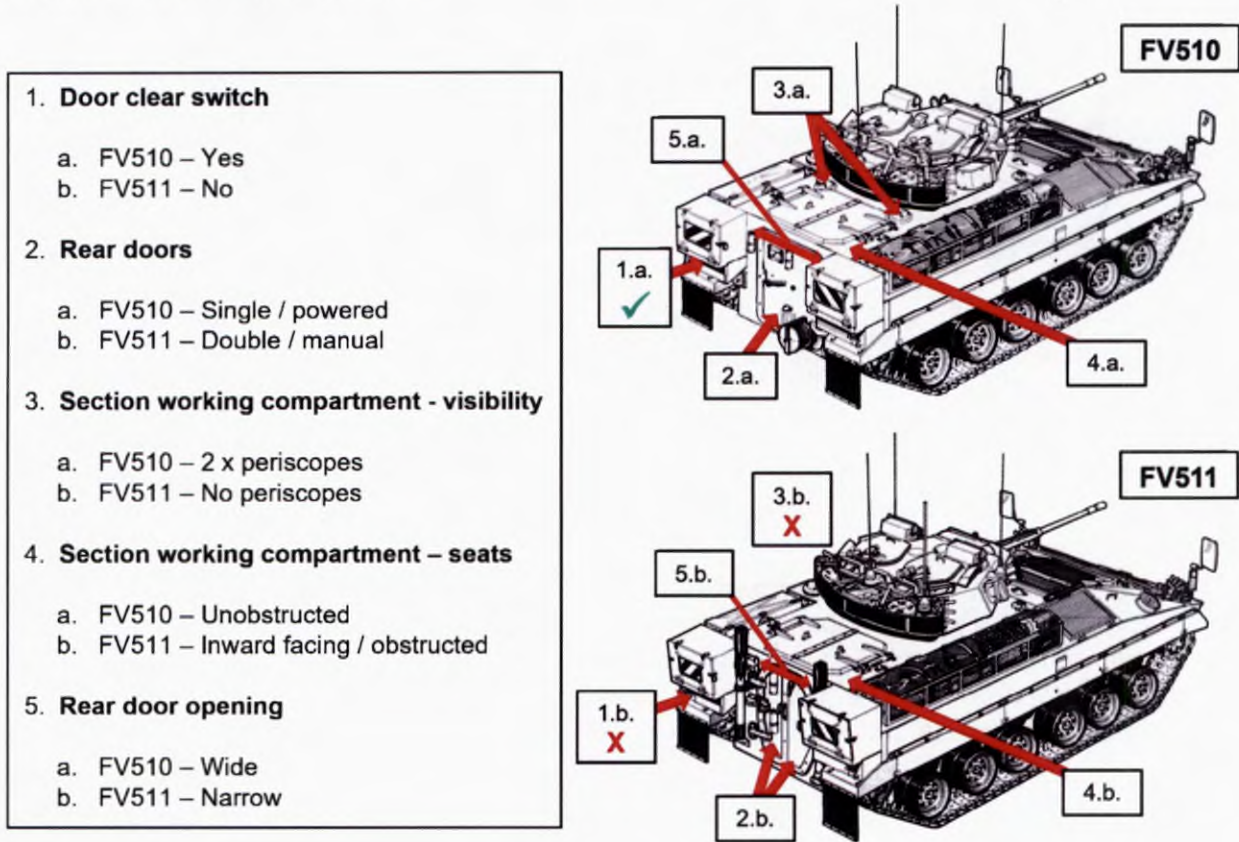
Figure 1.4.21 – FV510 and FV511 comparison

1.4.302. At the time of the accident due to a lack of vehicle availability, an FV511 was being used as the platoon commander's vehicle instead of an FV510. This section analyses the key differences between the variants (shown in figure 1.4.21) to determine whether the use of an FV511 made the accident more likely to occur.

a. **Door clear switch.** The FV510 had a 'door clear' switch. This was pressed by those exiting (debussing) the FV510 to indicate to the driver via a light in the driver's compartment, that personnel had exited the vehicle and the door was clear and safe to close. The FV511 did not have a door clear switch and there was no method to inform the driver that personnel had exited the vehicle.

1.4.305. **Recommendation. Director Land Equipment should, where practicable, ensure that technical devices are fitted to all armoured vehicles that are capable of carrying passengers, to allow passengers to indicate they have exited the vehicle.**

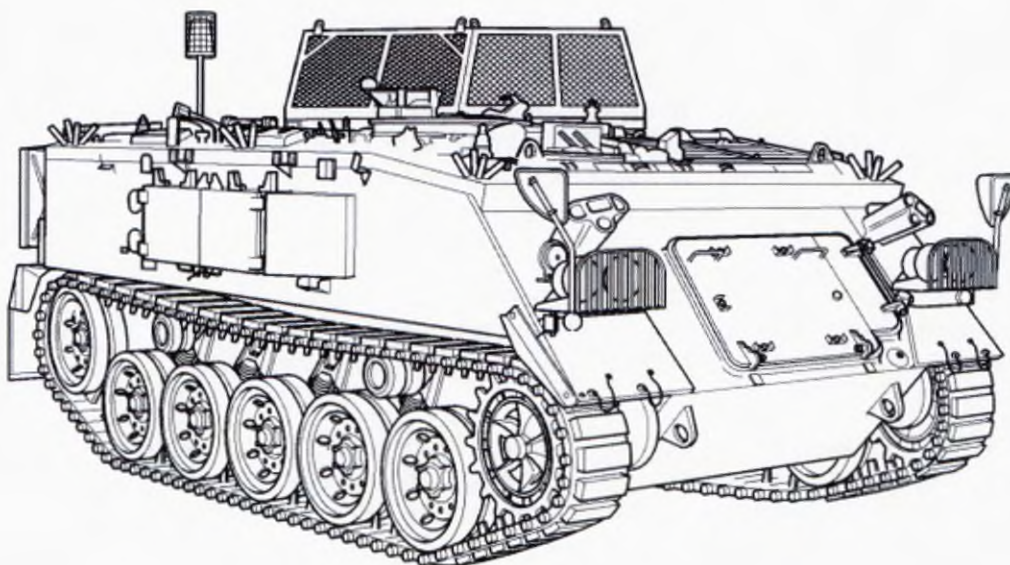
Figure 1.4.25 – Bulldog 2

1.4.367. At the time of the incident both Bulldog ambulances had technical issues that delayed their arrival at the accident location (see section 6). The armoured infantry's (5 RIFLES) Bulldog ambulance was unable to move due to a failed IC system and the crew could not communicate with each other. In accordance with AVSOs, if crews of an AV could not communicate with each other, the vehicle should not be driven. The armoured squadron's (QRH) Bulldog had a severed engine throttle control. The latter was rectified after a short period.

1.4.368. This accident highlighted a reliability issue with the Bulldog ambulance. Although one was quickly repaired and arrived at the scene approximately 10 minutes after the accident, had it not, and had the casualty been in a condition where they may have benefitted from rapid intervention by a CMT, the reliability of the Bulldog ambulance could have been a factor.

1.4.369. The panel **observed** that the delayed arrival of the CMT due to serviceability issues with the Bulldog ambulances did not impact on the outcome of this accident.

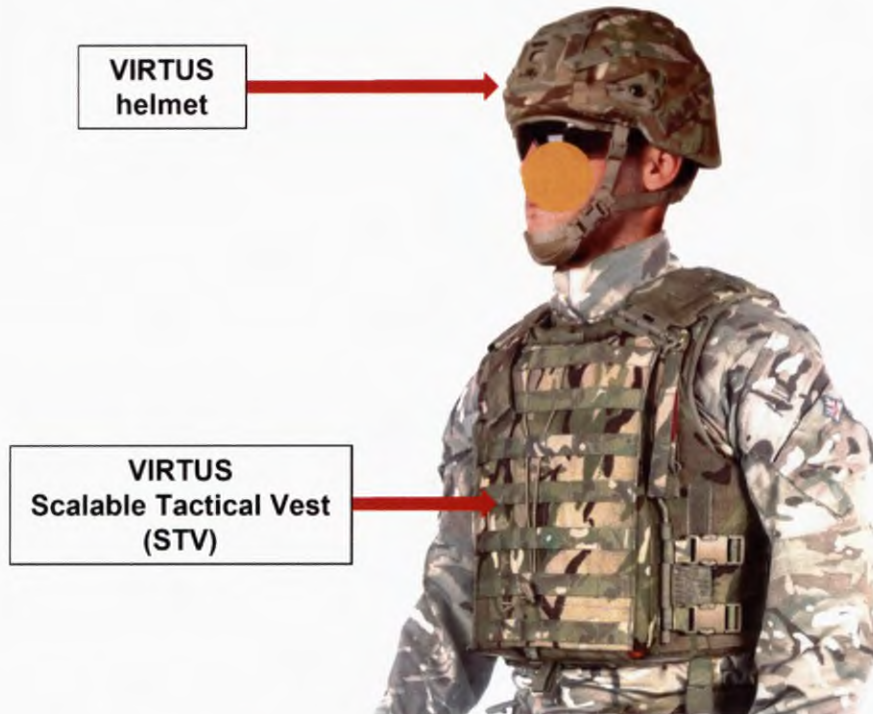
Figure 1.4.26 – VIRTUS Scalable Tactical Vest (STV) and helmet

1.4.394. The VIRTUS body armour (SAF and ballistic plates) and VIRTUS helmet were designed to protect the wearer from blast, fragmentation and blunt impact injuries. They were not designed to protect the wearer from crush injuries. Accordingly they offered no protection for the type of injuries sustained by 2Lt George.

1.4.395. The panel concluded that the combat protective equipment (body armour and helmet) worn by 2Lt George would not have prevented their death and was **not a factor**.

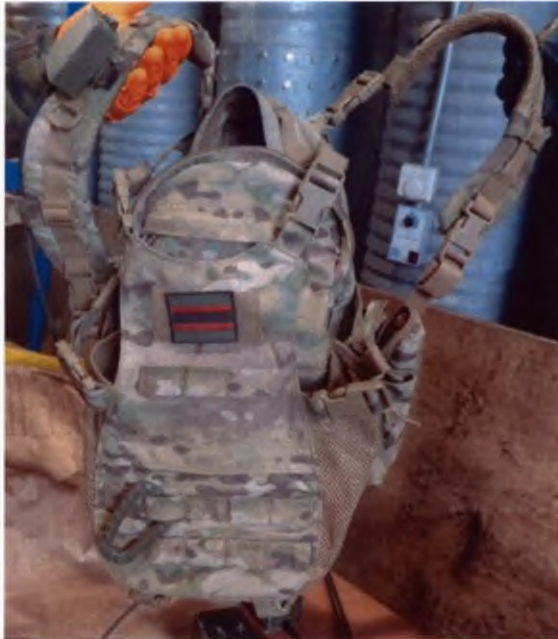
Figure 1.4.29 – Daysack used by 2Lt George

1.4.401. 2Lt George was playing the role of the platoon sergeant and had been tasked to debus from C/S 42A and control two dismounted sections. For the task they had a PRC 354 radio which was carried in a non-issued 'Warrior Assault Systems' daysack (see figure 1.4.29).

1.4.402. The panel were unable to determine why 2Lt George opted to carry the PRC 354 radio in a non-issued daysack rather than an issued VIRTUS PRC 354 pouch. The panel identified the following issues with the use of the non-issued daysack instead of using an issued VIRTUS PRC 354 pouch.

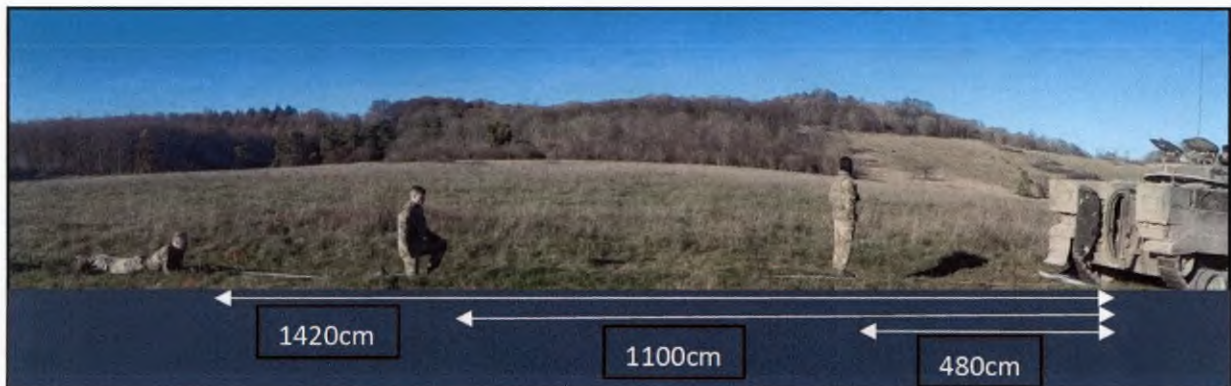
Figure 1.4.36 – Warrior commander's rear 'blind spot'

d. Paragraph 21 stated, 'Always check behind an AFV before you order your dvr to reverse'. In the panel's opinion, this was an ambiguous statement and was unclear as to what the commander was to check. A blind spot analysis was conducted by ATDU in support of this service inquiry. The analysis identified that a 'closed down' FV511 commander in similar conditions to when the accident occurred, had a blind spot that extended 14.2m behind the Warrior (see figure 1.4.36). Therefore, there was no certainty that it was safe to order the driver to reverse even though the commander had checked to the rear of the Warrior and no persons were visible to them.

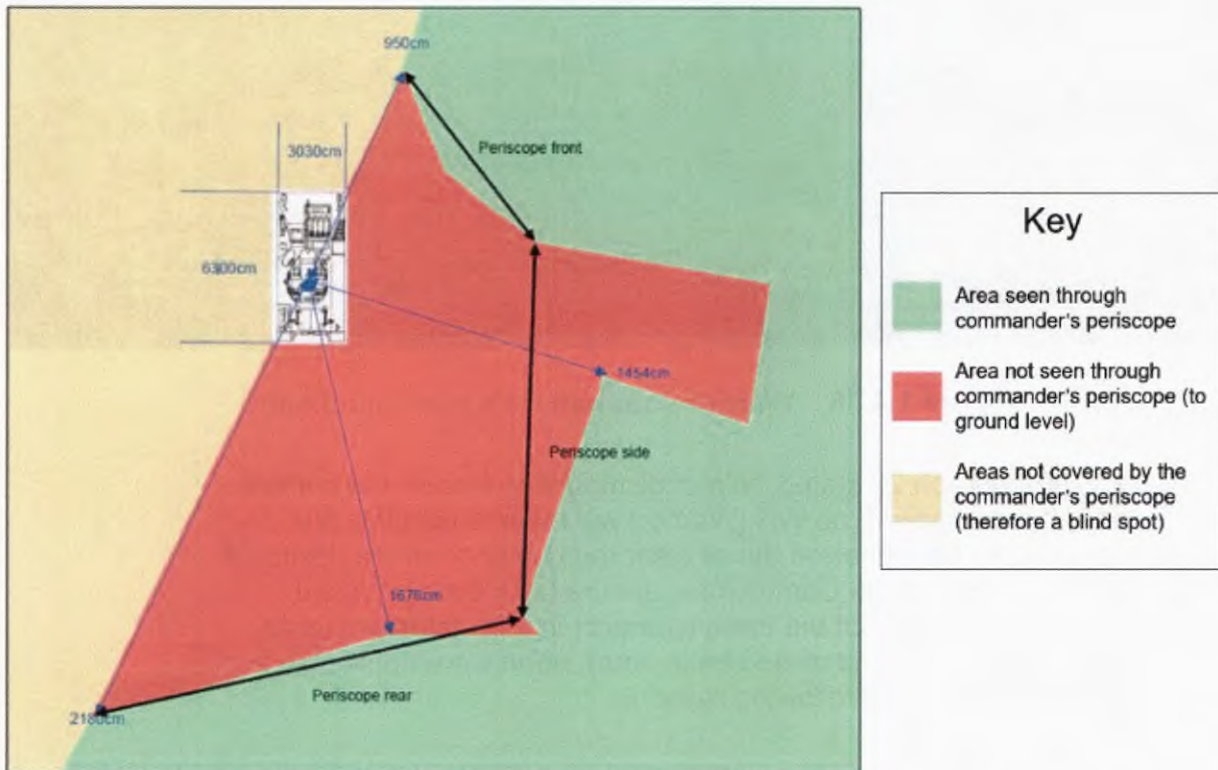
Figure 1.4.37 – Warrior commander's field of view (closed down)

f. Paragraph 23 stated, 'If any Comd is unaware of his dismounts position, he is to stay firm until he is certain of safe manoeuvre.' In the panel's opinion, had this direction been adhered to, it is unlikely the commander would have ordered the driver to reverse. However, as part of the inquiry, a trial was undertaken by the ATDU to determine a Warrior commander's field of view when 'closed down'. The diagram at figure 1.4.37 is taken from the trial report and shows the limited fields of view through a Warrior commander's periscopes. In the panel's opinion, based on the extent of the areas that cannot be seen by the commander surrounding a Warrior (which extend out to 21m) it was unlikely that a Warrior commander could have been certain of dismounted troop positions when operating 'closed down'.

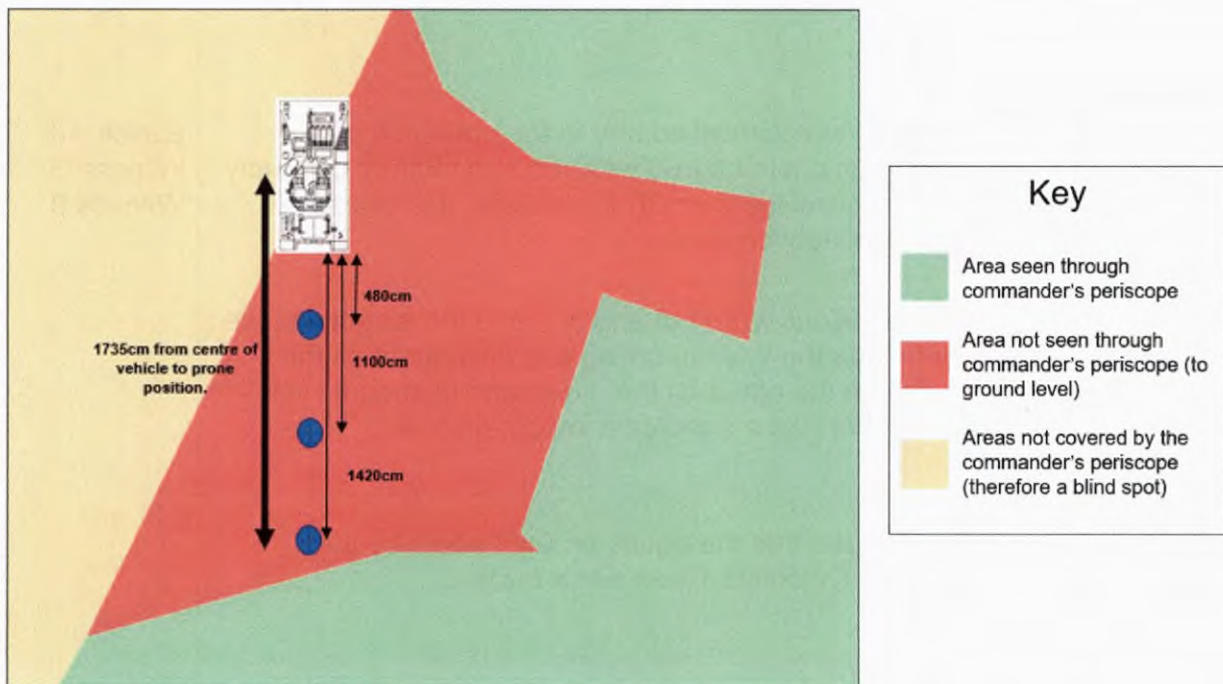
Figure 1.4.38 – Warrior commander's field of view and rear blind spot (closed down)

1.4.588. The trial confirmed that a Warrior commander's visibility, and thus their situational awareness, was significantly restricted when 'closed down'. For the AIPCC student commanders, the situation was exacerbated as they had not experienced commanding Warrior 'closed down' during the D&M module despite it being one of the conditions listed in the TPS for that module. Their experience of commanding 'closed down' was limited to the seven days preceding the accident. Whilst this gave them some exposure to the challenges of commanding 'closed down', they had not formally proven their competence in this configuration prior to undertaking the more complex tactical training.

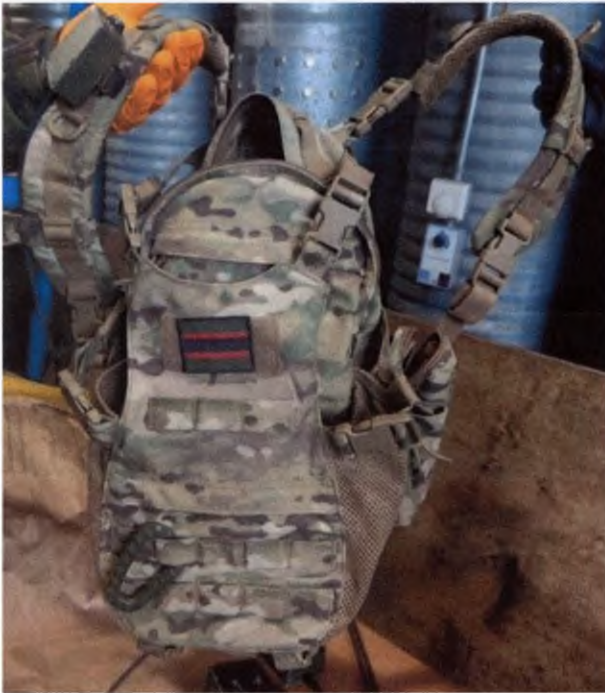
Figure 1.4.40 – Daysack used by 2Lt George

1.4.615. The daysack (see figure 1.4.40) containing a PRC 354 radio with a folded 1.5m whip antenna (see figure 1.4.41) was found intact near 2Lt George immediately after the accident. It was not clear if 2Lt George was wearing the daysack when they exited C/S 42A (and subsequently

removed it prior to the accident), or if they were trying to put it on after exiting the vehicle.

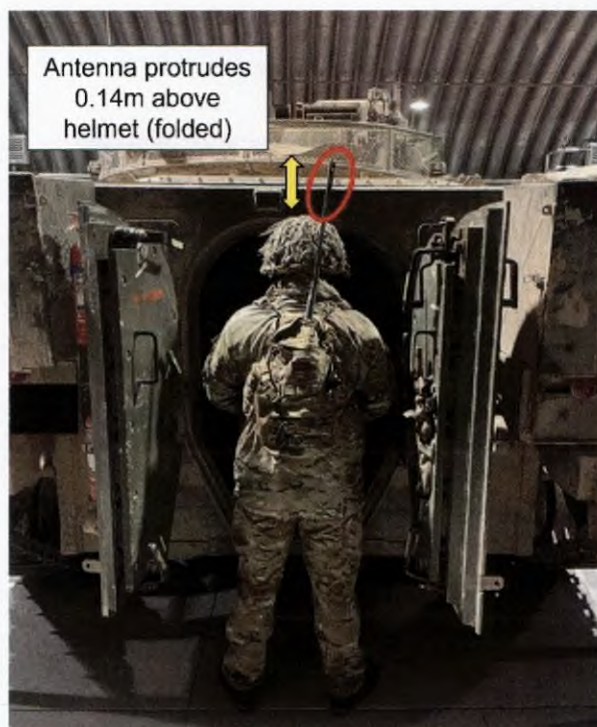
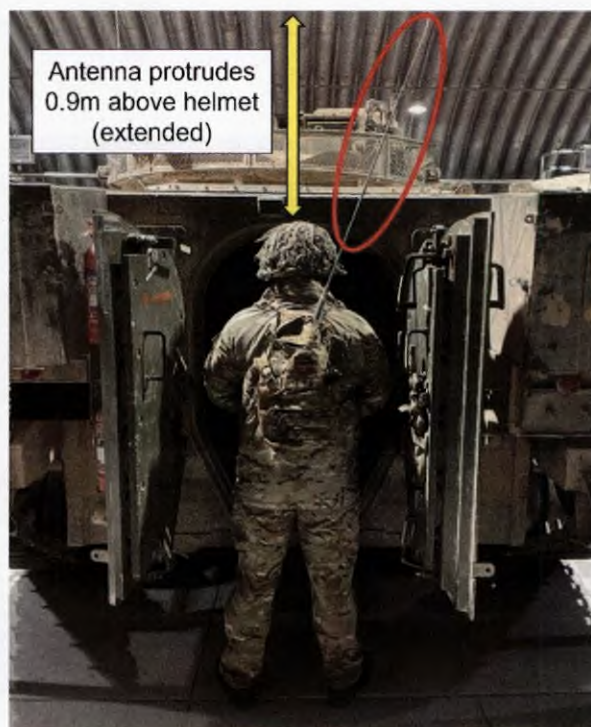
Figure 1.4.42 – Radio antenna folded

1.4.616. Had 2Lt George been wearing the daysack, the folded antenna would have protruded approximately 0.14m above the top of their helmet (see figure 1.4.42). It was normal procedure to have antennas folded whilst in vehicles as it was impractical to have it fully extended due to their length (extended the antenna would have protruded approximately 0.9m above the helmet - see figure 1.4.43).

Antenna protrudes
0.14m above
helmet (folded)

Antenna protrudes
0.9m above helmet
(extended)

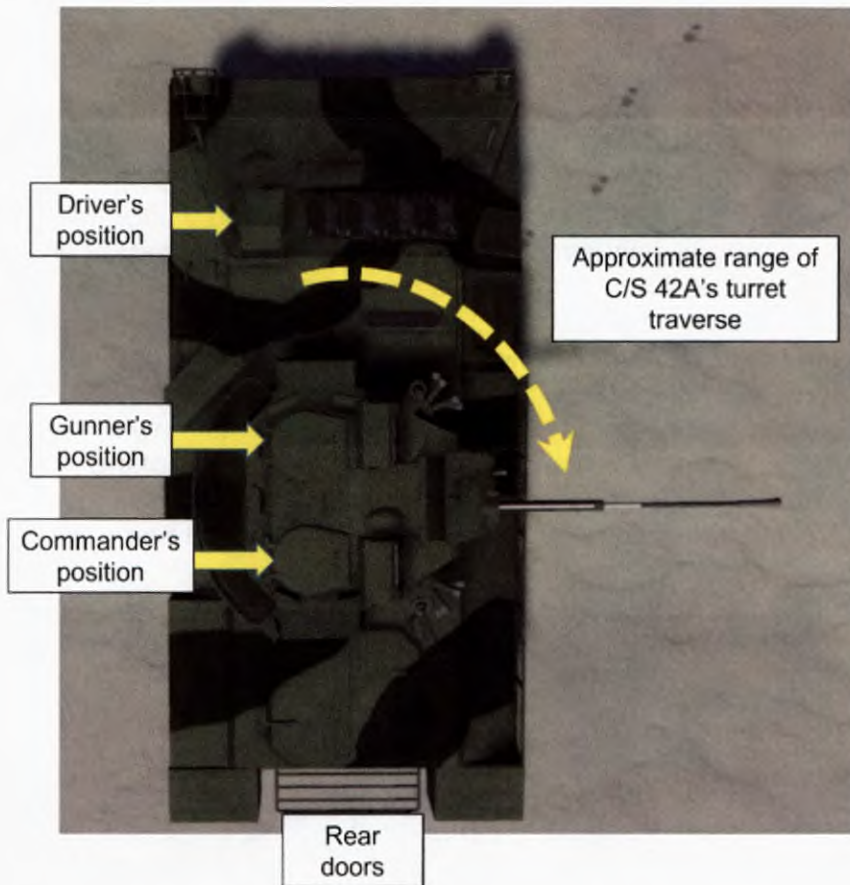
Figure 1.4.44 – C/S 42A's turret movement

(2) **Rear doors prematurely close.** The faulty mechanism that was meant to lock one of the rear doors in the open position would not have prevented it from inadvertently swinging shut as 2Lt George was debussing. It was also reported that 2Lt George appeared to inadvertently close then reopen the doors. As the rear doors were armoured and weighed 141kg and 143kg respectively, it is almost certain that, had they momentarily swung shut or inadvertently been closed and reopened, a distinctive clunk would have been heard. ATDU also identified during their trial that, 'The door slam with changes to the air pressure inside the vehicle is easily noticed by the crew. This has the potential to be misconstrued by an inexperienced commander or only familiar with operating the WR [Warrior] FV510.'

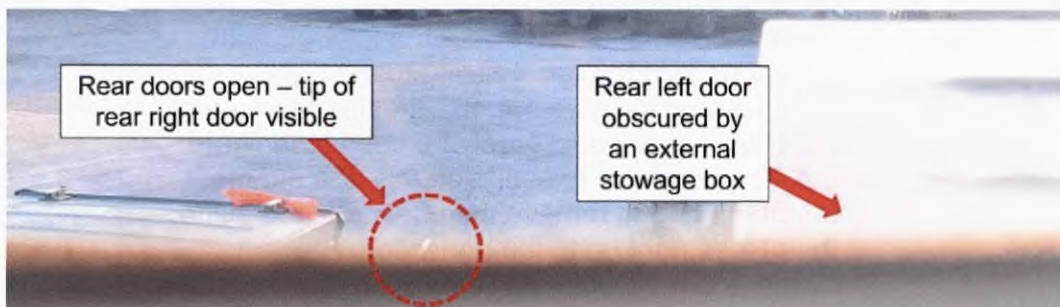
Figure 1.4.49 – An FV511 commander's view through a front right periscope with rear doors open (turret facing right)

iv. The panel explored one other plausible explanation for Student Commander 1 not being able to see the rear doors open. The movement of the turret may have momentarily disorientated them. Had they been looking out of the turret's rear periscope, they may have believed they were looking to the rear of C/S 42A, but actually would have been looking to the left-hand side of the vehicle (see figure 1.4.50). The panel discounted this as Student Commander 1 was clear that they looked to the right, which meant that they would have been looking out of the right-hand periscope as shown in figure 1.4.48.

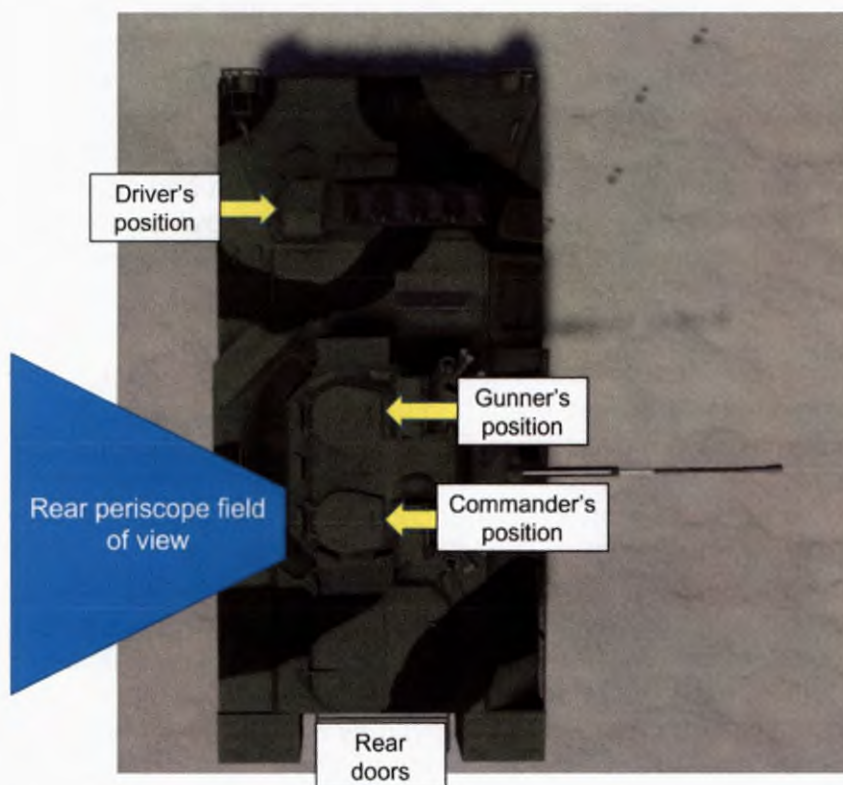
Figure 1.4.50 – An FV511 commander's field of view through rear periscope (turret facing right)

(b) **Dismount.** The ATDU blind spot analysis showed that a 'closed down' commander of an FV511 would not have been able to detect a standing person up to approximately 4.8m from the rear of the vehicle. For this reason, and because 2Lt George was reaching for their rifle inside the section working compartment at the time of the accident, it is almost certain that Student Commander 1 would not have seen 2Lt George at the rear of the vehicle, which led them to assume that 2Lt George had moved away.
