## Accident

<b>Aircraft Type and Registration:</b>	Quik GT450, G-CEVW	
<b>No &amp; Type of Engines:</b>	1 Rotax 912ULS piston engine	
<b>Year of Manufacture:</b>	2007 (Serial no: 8314)	
<b>Date &amp; Time (UTC):</b>	17 May 2023 at 1215 hrs	
<b>Location:</b>	Lundy Island Airfield, Bristol Channel	
<b>Type of Flight:</b>	Private	
<b>Persons on Board:</b>	Crew – 1	Passengers – None
<b>Injuries:</b>	Crew – Minor	Passengers – N/A
<b>Nature of Damage:</b>	Extensive damage to wing and airframe	
<b>Commander's Licence:</b>	National Private Pilot's Licence	
<b>Commander's Age:</b>	59 years	
<b>Commander's Flying Experience:</b>	134 hours (of which 107 were on type) Last 90 days – 11 hours Last 28 days – 9 hours	
<b>Information Source:</b>	AAIB Field Investigation

## Synopsis

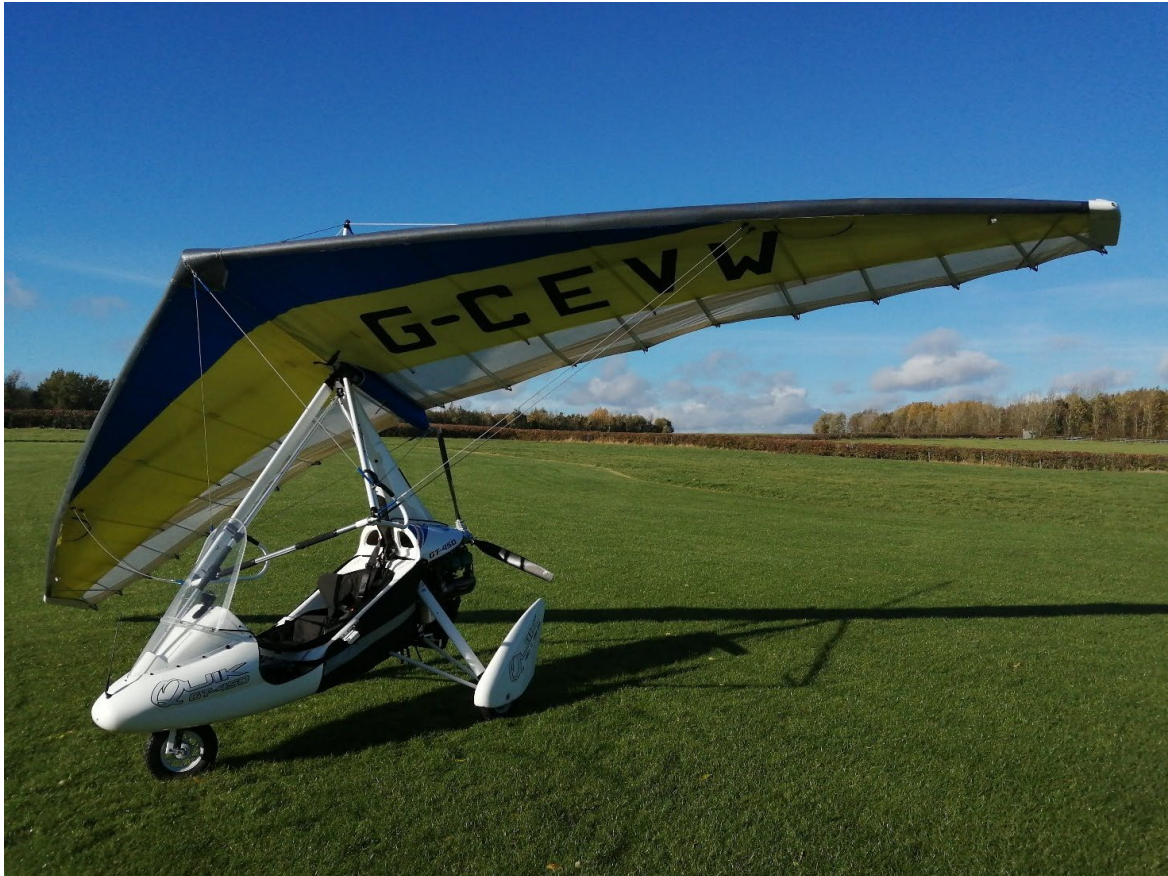
**Figure 1**  
Quik GT450

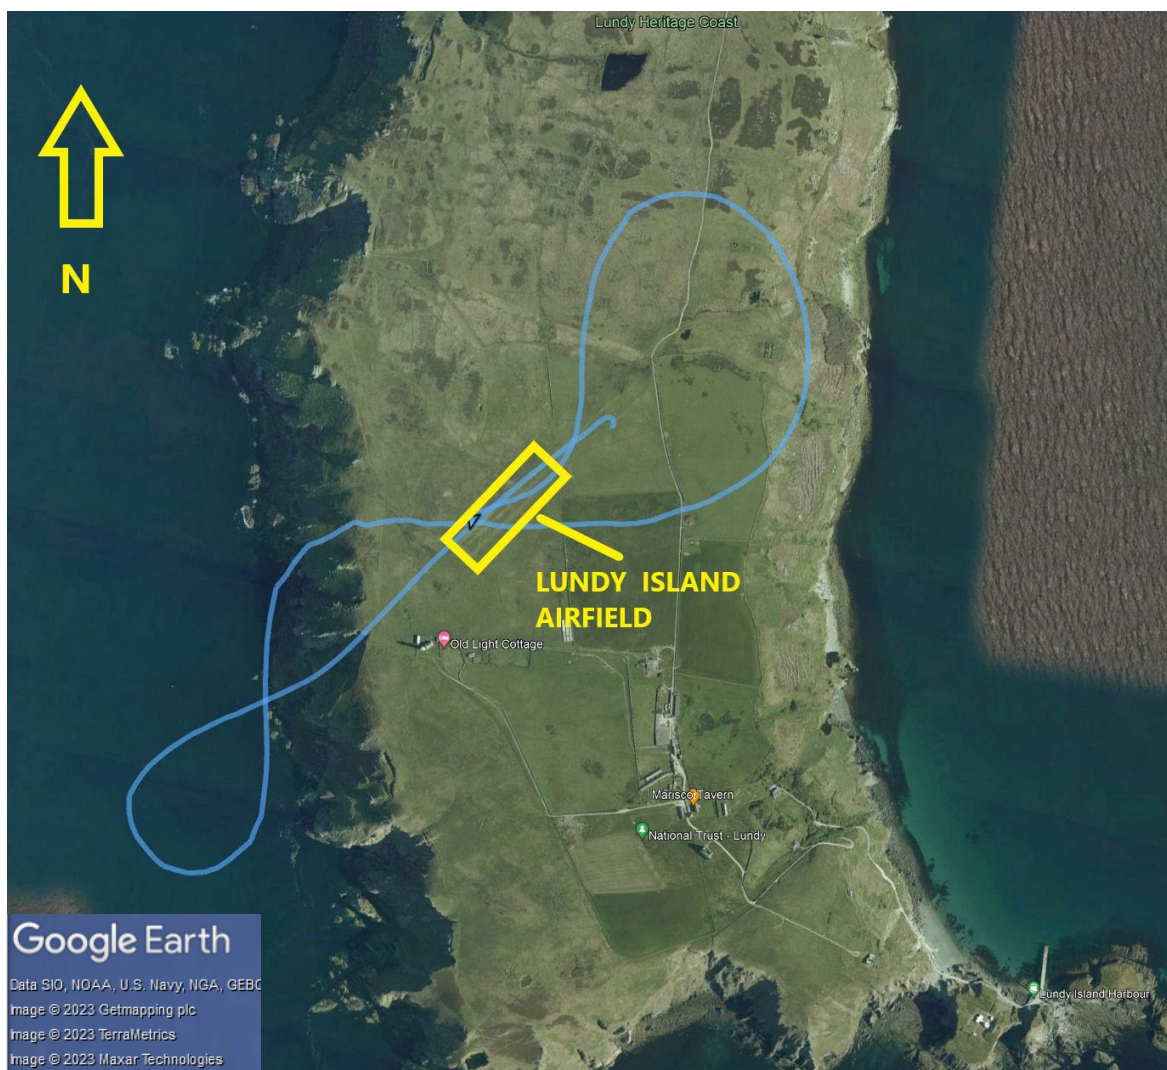
The aircraft turned through approximately 270° and flew north along the west coast of Lundy Island until abeam the airfield (Figure 2). The pilot then flew over the airfield and made a left turn to position for an approach to RWY 24. During these manoeuvres the pilot described control forces so high that he had to wedge the control bar under his arms to sustain the load. The pilot made a wide slow left turn to final approach for RWY 24. During the turn the aircraft came very close to the ground and the pilot added power to regain height. He described the final stages of the approach as follows:

**Figure 2**  
Aircraft track

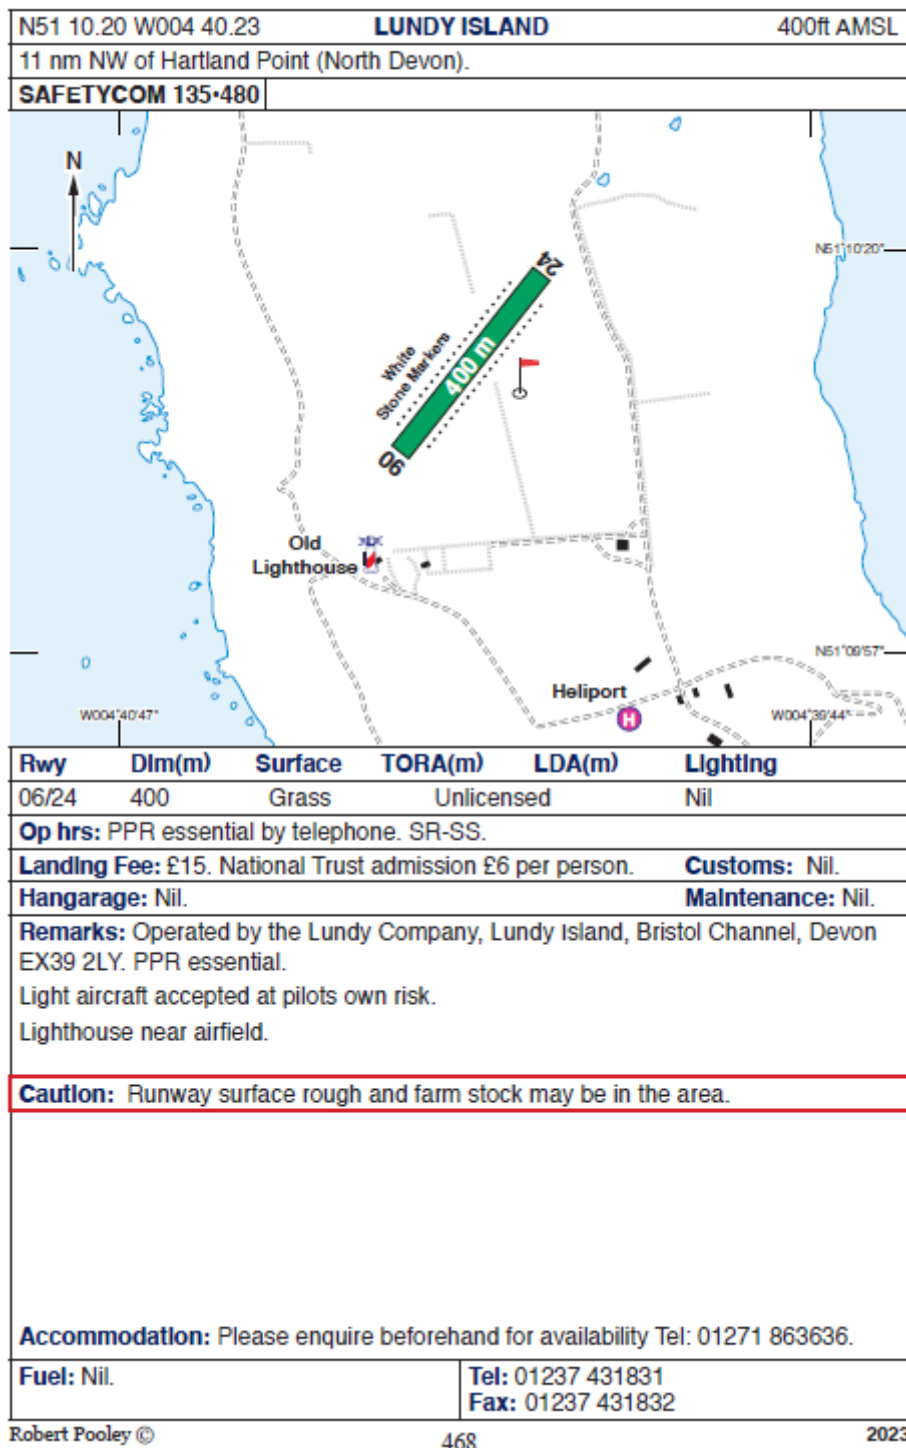
Figure 4

The accident occurred at Lundy Island Airfield. It has a grass runway 400 m long orientated 060/240°. Details are shown at Figure 4.

Lundy Island Airfield information

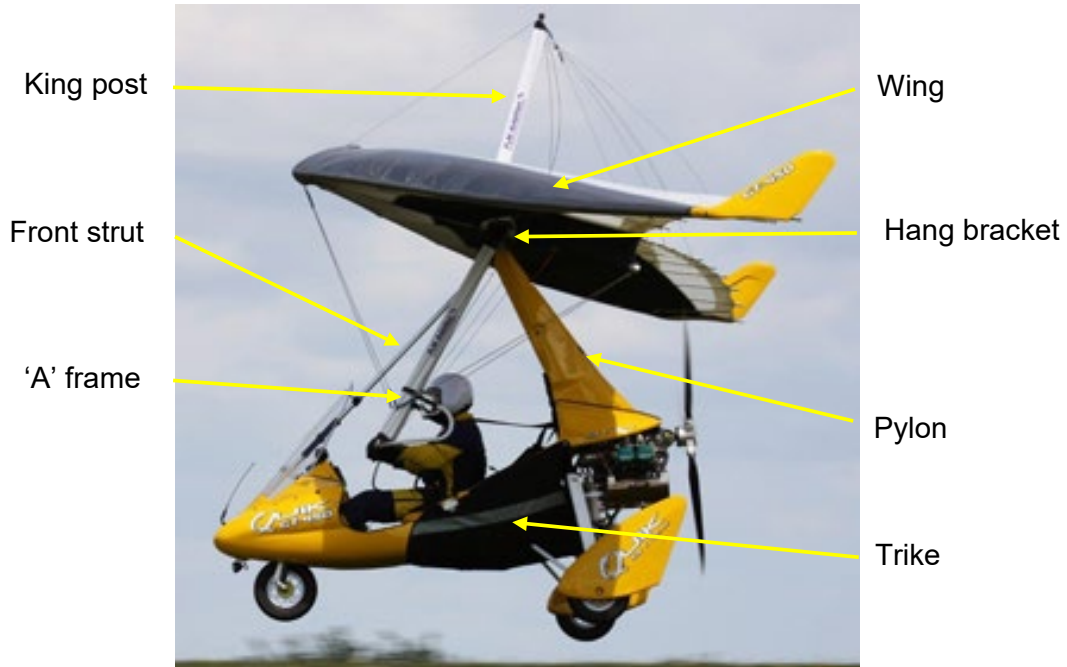
**Figure 5**  
P&M Aviation GT450

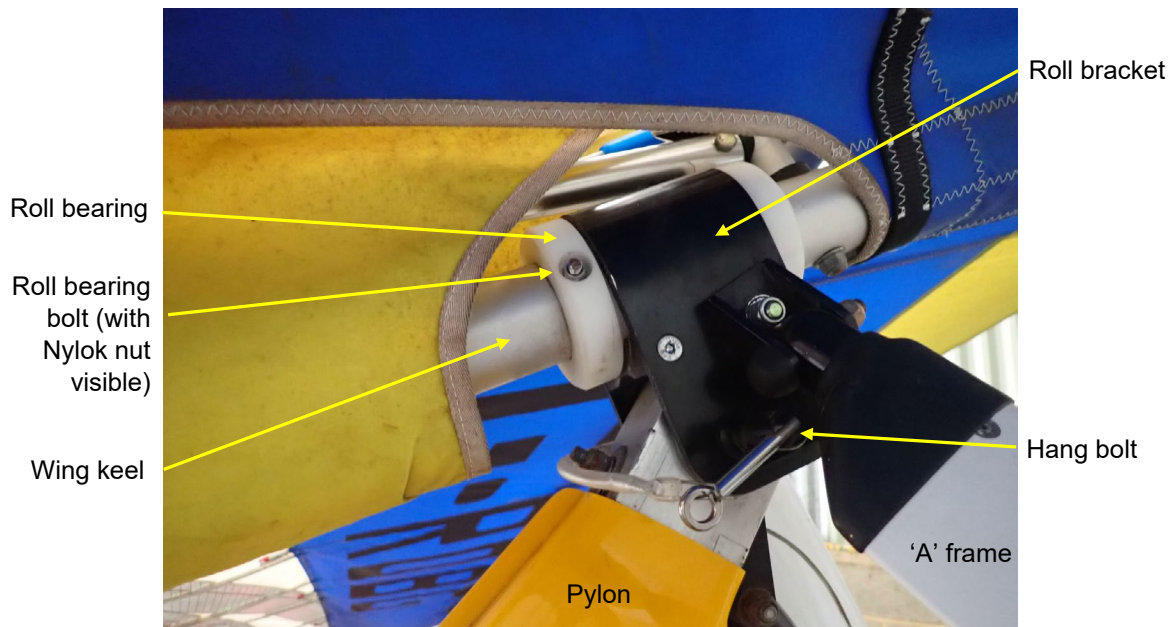
**Figure 6**  
GT450 wing keel and hang bracket viewed from the right

Examination of the wing keel confirmed that the roll bearing had migrated rearwards. The M6 cap head bolt, which retained the roll bearing in position, and its associated Nylok nut were missing and were not recovered. Fretting was observed on the bolt head side of the bushing through which the bolt would have passed through the wing keel (Figure 8). The trim cable attachment bracket was deformed and the inner diameter of the roll bearing had worn, indicating that the roll bearing had moved rearwards down the wing keel and struck the trim attachment bracket during flight (Figure 9).

The trike roll bracket slid aft by approximately 300 mm due to the loss of the securing bolt. This induced very large pitch control loads for the pilot which jeopardised safe control of the aircraft. The pilot was able to return to the airfield but control was lost during landing and the aircraft was extensively damaged. The pilot was able to extricate himself from the aircraft and sustained only minor injuries.

*If not already fitted, it is strongly recommended to fit the longer bolt, item 13, part no. FCM6-80 with securing M6 T type Nylok nut, item 10, part no. FNM6-NT.'*

The manufacturer also introduced, via SB 160, a clamp that is fitted to the wing keel aft of the roll bearing to prevent its rearward movement in the event of a roll bearing bolt failure or loss.
