Rail Accident Report

**Train striking debris at Yarnton near
Hanborough, Oxfordshire
10 February 2023**

Report 01/2024
February 2024

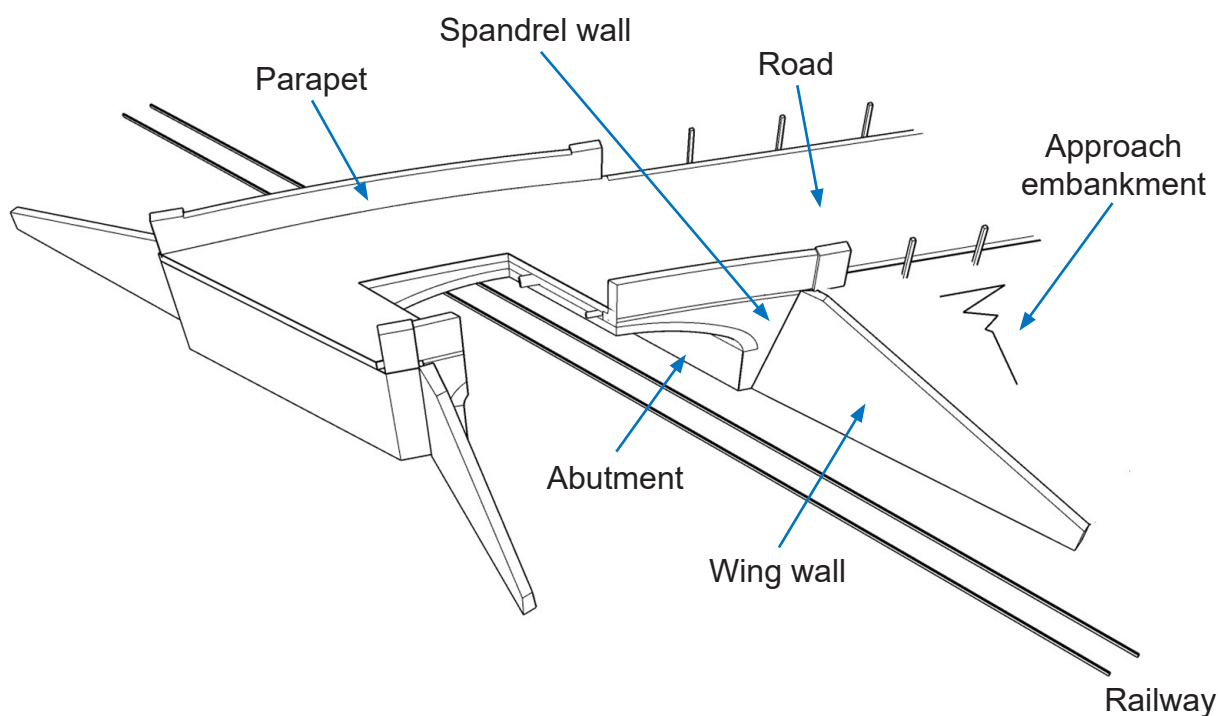
Figure 4: Diagram showing components of the bridge.

- 21 The bridge is of brick construction throughout, with a wing wall at each corner supporting the road and *parapets* at road level (figure 4).
- 22 It was part of the wing wall at the south-west corner of the bridge that collapsed (figures 5, 6a and 6b). This wall (referred to as the 'downside high mileage wing wall'² in examination reports, but the 'south-west wing wall' in this report) was 13 metres long and up to 5.3 metres high. The lateral clearance between the wall and the railway was about 2.3 metres, making it almost inevitable that debris would fall onto the track if part of the wall collapsed. The south-west wing wall had been reported as being in poor condition, with *drummy*, or hollow-sounding, brickwork and a large bulge (see paragraph 48).
