AAIB Bulletin

2/2024

Aircraft Type and Registration:	Bombardier CL-600-2B16 (604 Variant), D-AAAY	
No & Type of Engines:	2 General Electric CF34-3B turbofan engines	
Year of Manufacture:	2004 (Serial no: 5602)	
Date & Time (UTC):	10 August 2022 at 1640 hrs	
Location:	In the climb after departing Farnborough Airport, Hampshire	
Type of Flight:	Commercial Air Transport (Passenger)	
Persons on Board:	Crew – 3	Passengers – 7
Injuries:	Crew – None	Passengers – None
Nature of Damage:	Damage to the No 1 flap retract relay	
Commander's Licence:	Airline Transport Pilot's Licence	
Commander's Age:	56 years	
Commander's Flying Experience:	13,091 hours (of which 5,655 were on type) Last 90 days – 102 hours Last 28 days – 41 hours	
Information Source:	AAIB Field Investigation

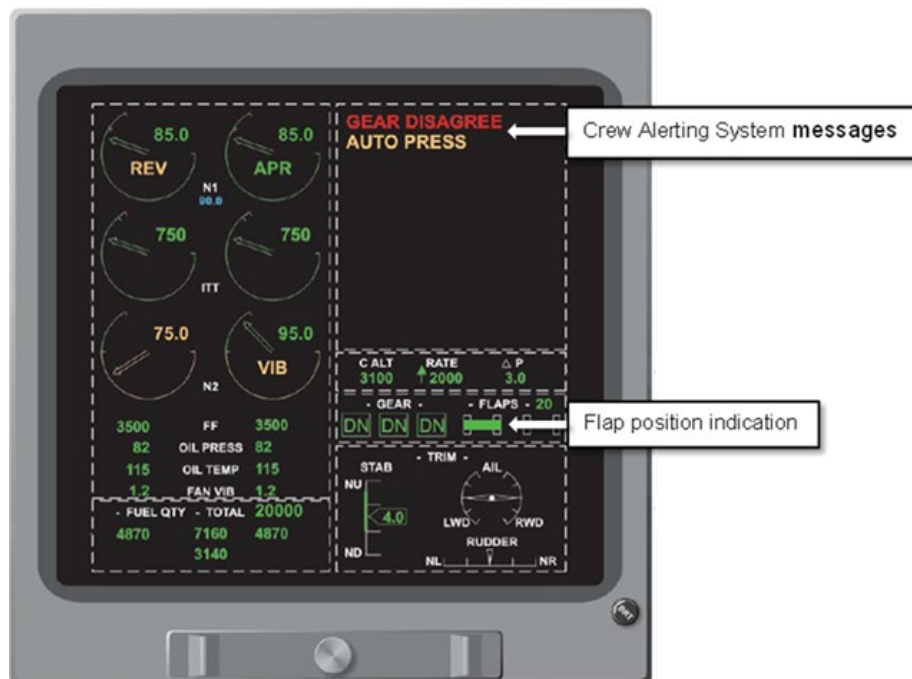
Figure 1

The crew arrived at Farnborough Airport at 1300 hrs to operate a private charter flight to Málaga – Costa Del Sol Airport, Spain. The aircraft took off at 1618 hrs from Runway 06 using flap 20, after which the crew selected flap 0 and the flaps fully retracted. Following a standard instrument departure to the south-west, the flight was cleared to climb to FL350. As the aircraft passed through FL190 at approximately 300 KIAS, with the autopilot engaged, the crew saw a FLAPS FAIL caution⁴ on the EICAS display primary page. The copilot, who was the PF, reported that the aircraft pitched nose-up slightly and started to decelerate. The EICAS primary page also displays a flap position indicator which indicated to the crew, by an animated green bar extending from left to right on the display, that the flaps were extending (Figure 1). The crew reported that the flap overspeed audio warning did not operate, which was contrary to their expectation⁵. The crew checked the flap control lever and noted that it was still in the flap 0 position.

Illustration of EICAS primary page information

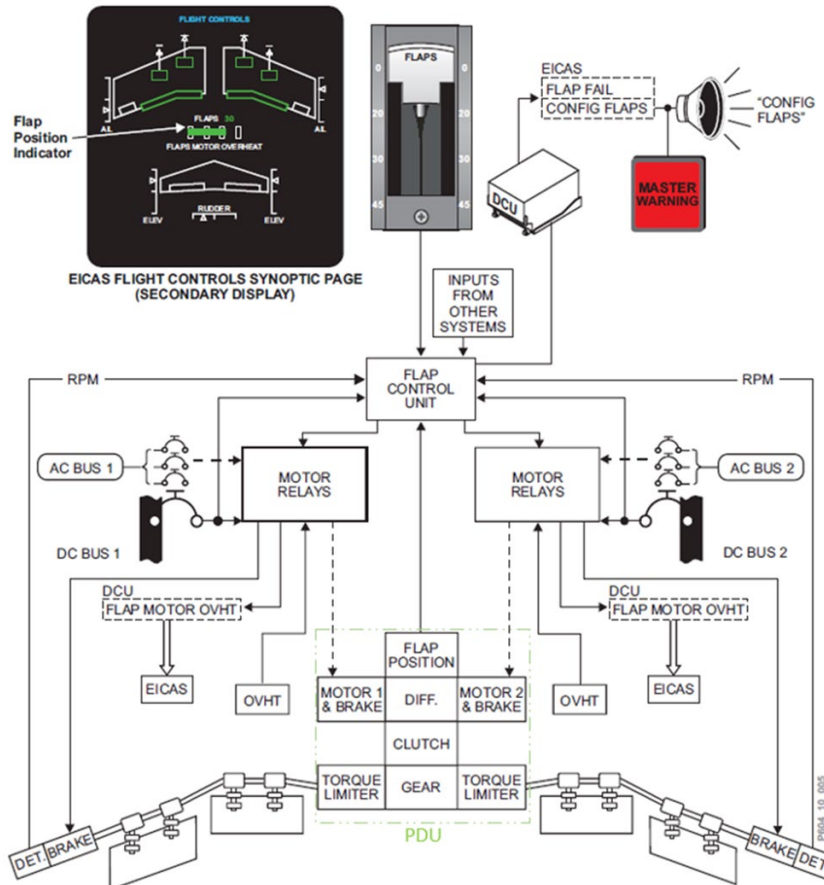
Figure 2

When the FCU commands a change in flap position, the flap brakes in the Brake Detector Units (BDU) are released, and two 200 V 3-phase AC-powered motors mounted on a flap gearbox are energised by relays located in junction boxes. The motors and gearbox, which are part of the Power Drive Unit (PDU), rotate flexible shafts to move the flap ball-screw actuators, extending or retracting the flaps. When the desired flap position is reached, measured by a flap position sensor on the PDU, the motors are de-energised and the brakes in the BDUs are applied. The flaps are mechanically interconnected for simultaneous movement of the inboard and outboard flap sections. A schematic diagram of the flap system is shown in Figure 2.

Schematic diagram of flap system

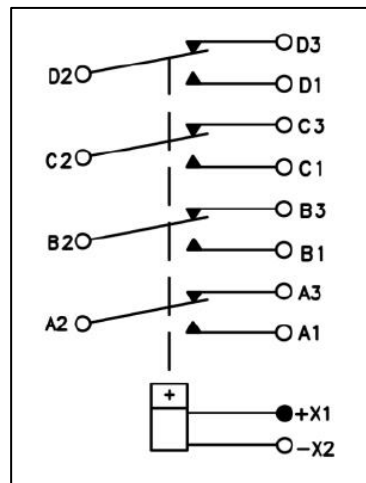
Figure 3

- Contacts A1, B1, C1 and D1 are normally OPEN.
- Contacts A2, B2, C2 and D2 are the input to be switched.
- Contacts A3, B3, C3 and D3 are normally CLOSED.
- Contacts +X1 and -X2 are for the operating coil.

Schematic of relay arrangement

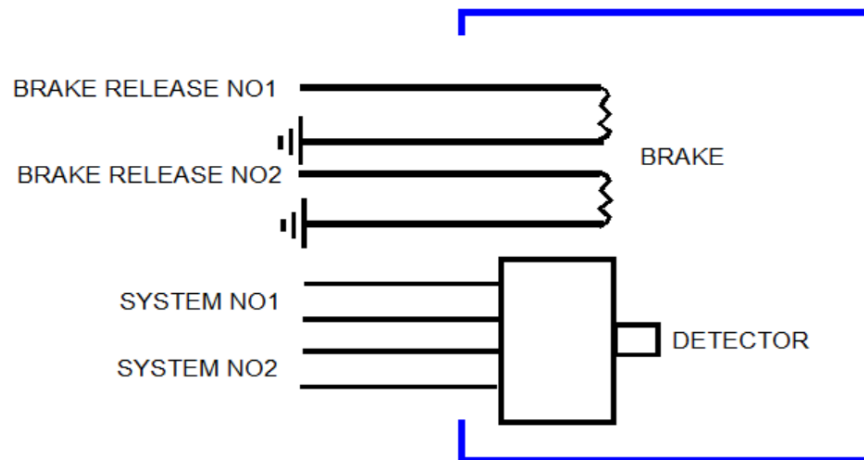
Figure 4

The aircraft has two BDUs. Each consists of a 28 V DC solenoid operated brake and a speed sensor detector unit (Figure 4). To provide redundancy each brake solenoid has two operating coils, one powered by each operating system, and each system powers an

operating solenoid in each of the two BDUs; these are connected in parallel. The brake solenoids are energised to release the brake and are de-energised to apply the brake.

Schematic of BDU Brake Solenoid arrangement

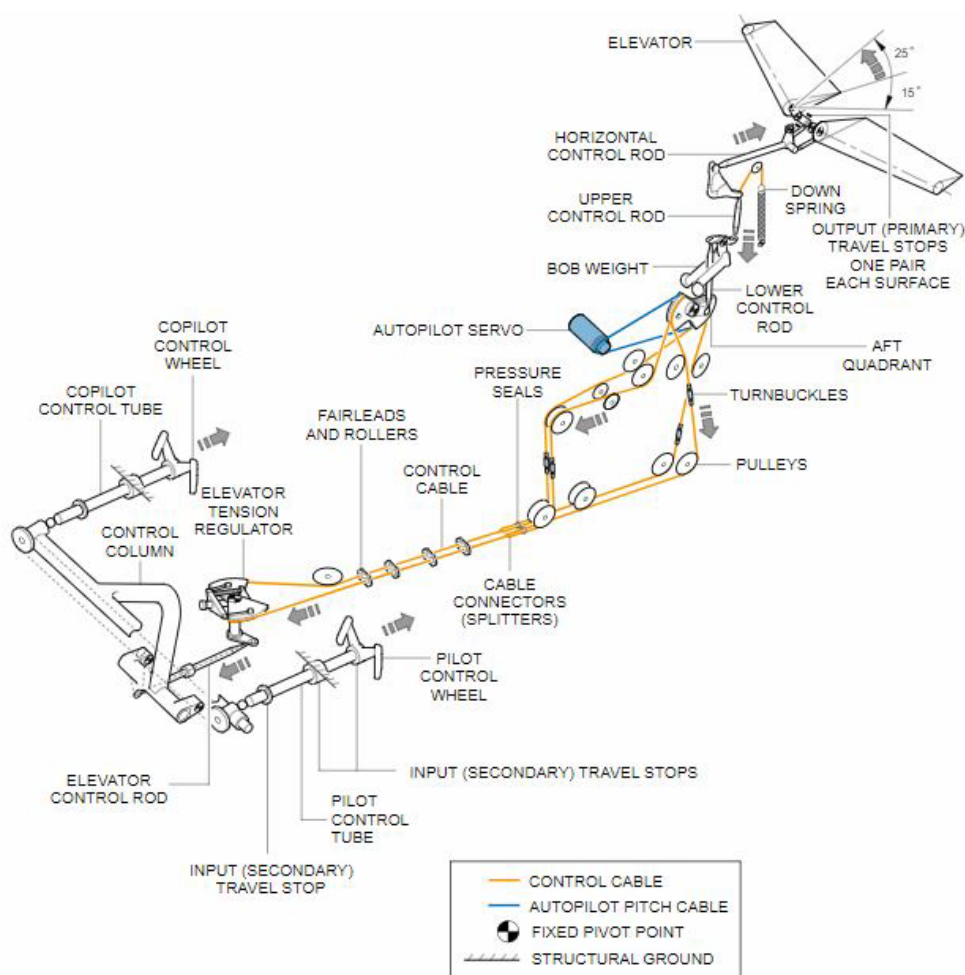
Figure 1

The aircraft's elevator control is a conventional, unpowered mechanical system comprising pilot and co-pilot control yokes connected via cables, pushrods, quadrants and levers to the elevator control surfaces (Figure 1).

PC-24 elevator control system
(courtesy of manufacturer)

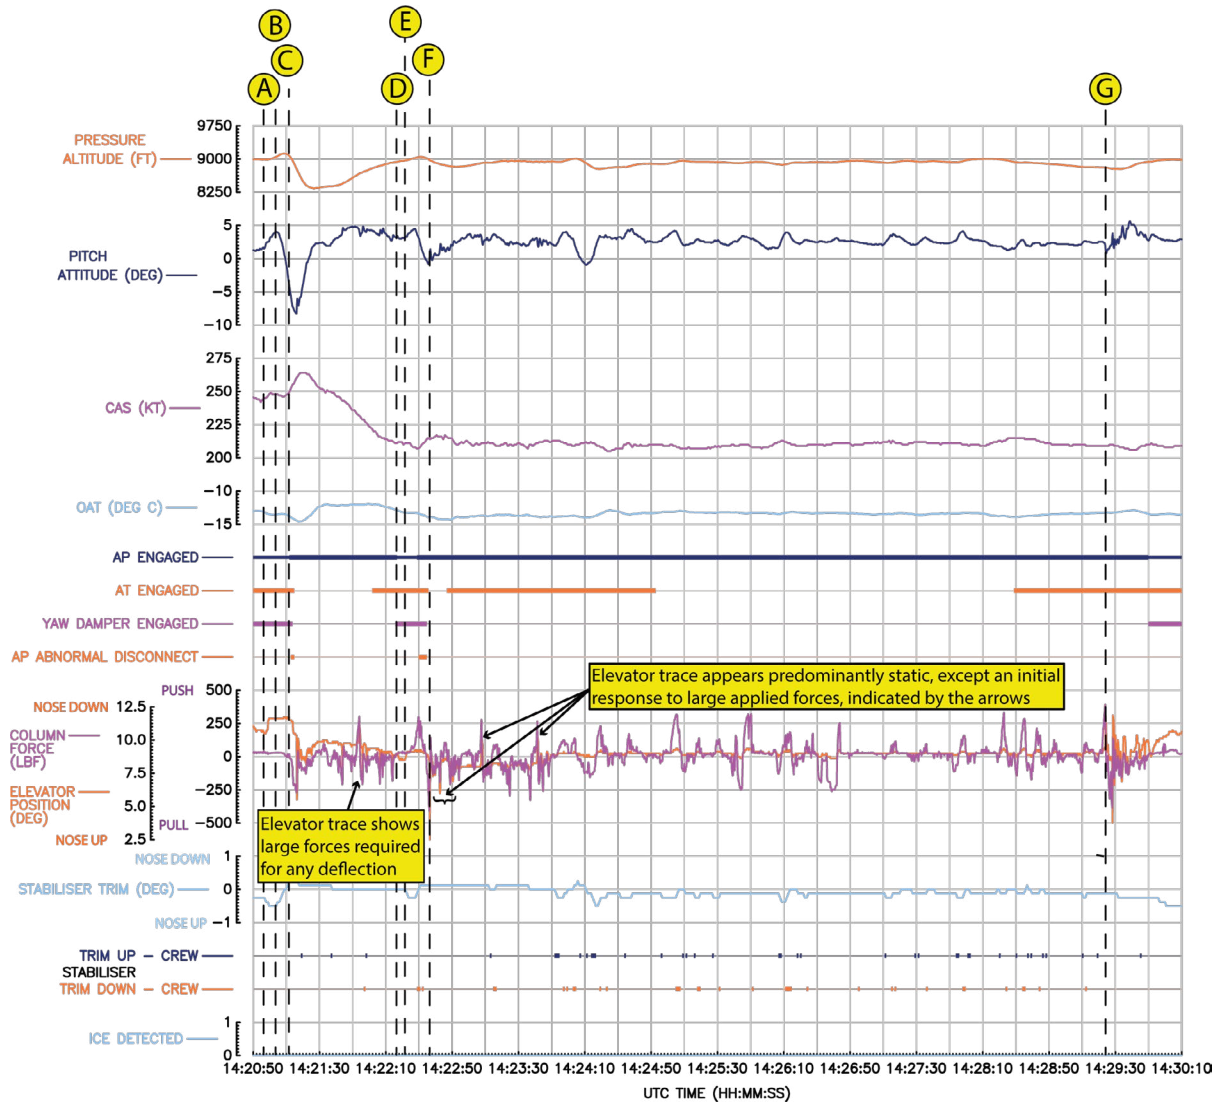
Figure 3

D-CMSL was fitted with both a CVR and an FDR. The aircraft remained in service for nine days following the event, prior to the AAIB being notified, during which the CVR was overwritten. The following significant points from the FDR data are highlighted in Figure 3:

FDR data for the cruise portion of the incident flight

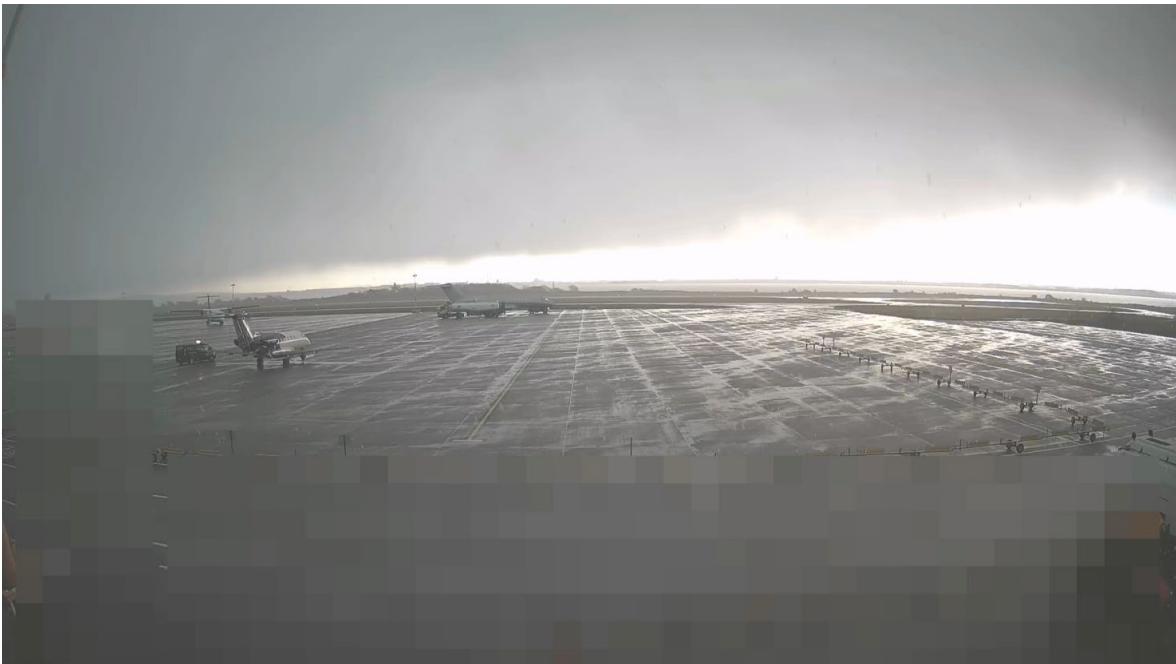
Figure 5

Closed-Circuit TV (CCTV) recordings from Liverpool showed the weather conditions, particularly the level of precipitation, in the hour prior to departure. It also showed how the pre-departure external checks were carried out by the crew. A screenshot from the recording (Figure 5) taken approximately one hour prior to departure shows rain and large areas of standing water on the apron.

Screenshot from the CCTV recording, an hour prior to departure of D-CMSL

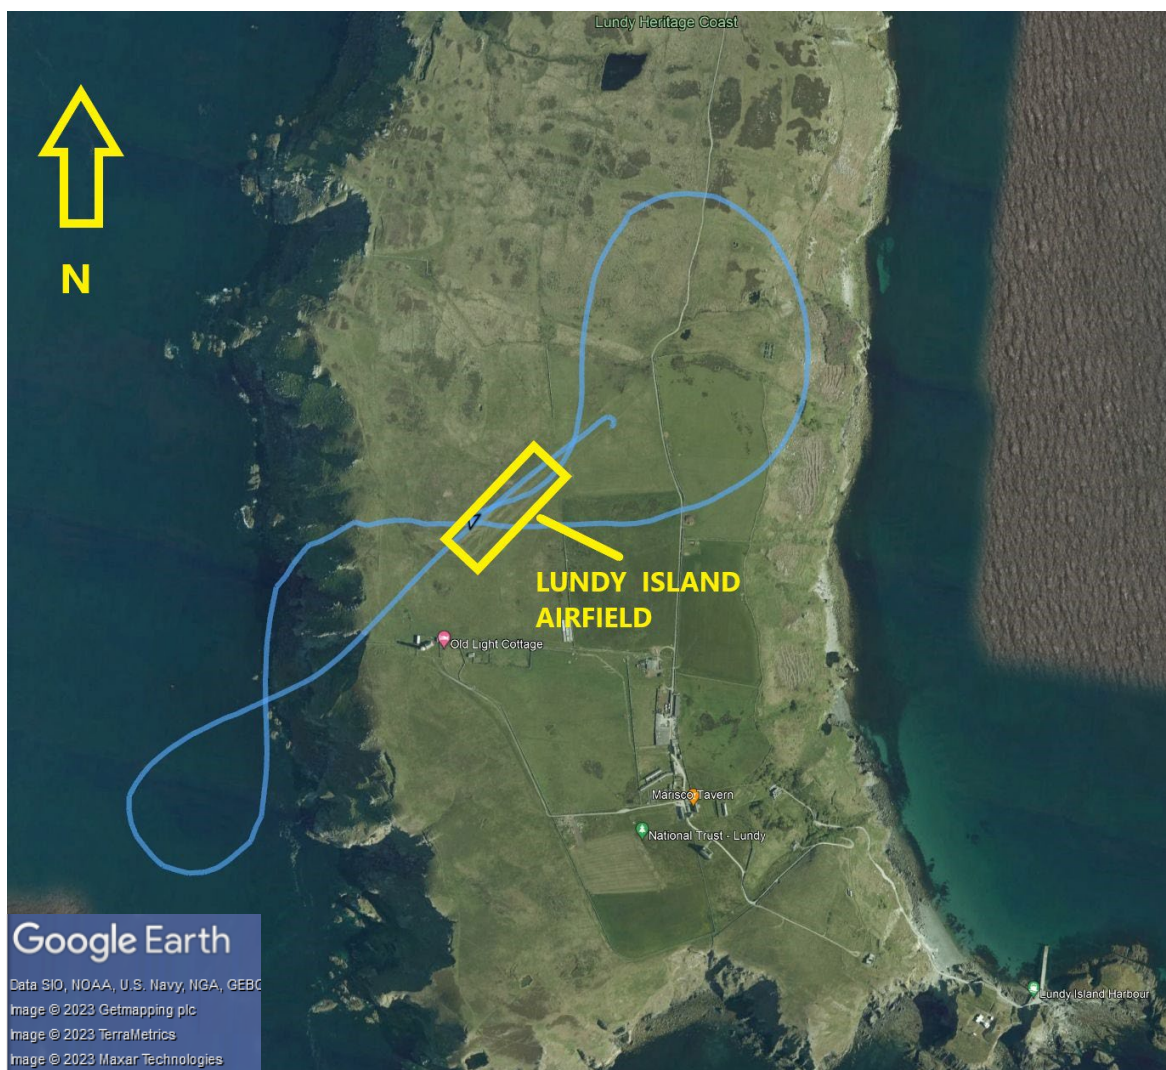
The aircraft turned through approximately 270° and flew north along the west coast of Lundy Island until abeam the airfield (Figure 2). The pilot then flew over the airfield and made a left turn to position for an approach to RWY 24. During these manoeuvres the pilot described control forces so high that he had to wedge the control bar under his arms to sustain the load. The pilot made a wide slow left turn to final approach for RWY 24. During the turn the aircraft came very close to the ground and the pilot added power to regain height. He described the final stages of the approach as follows:

Figure 2
Aircraft track

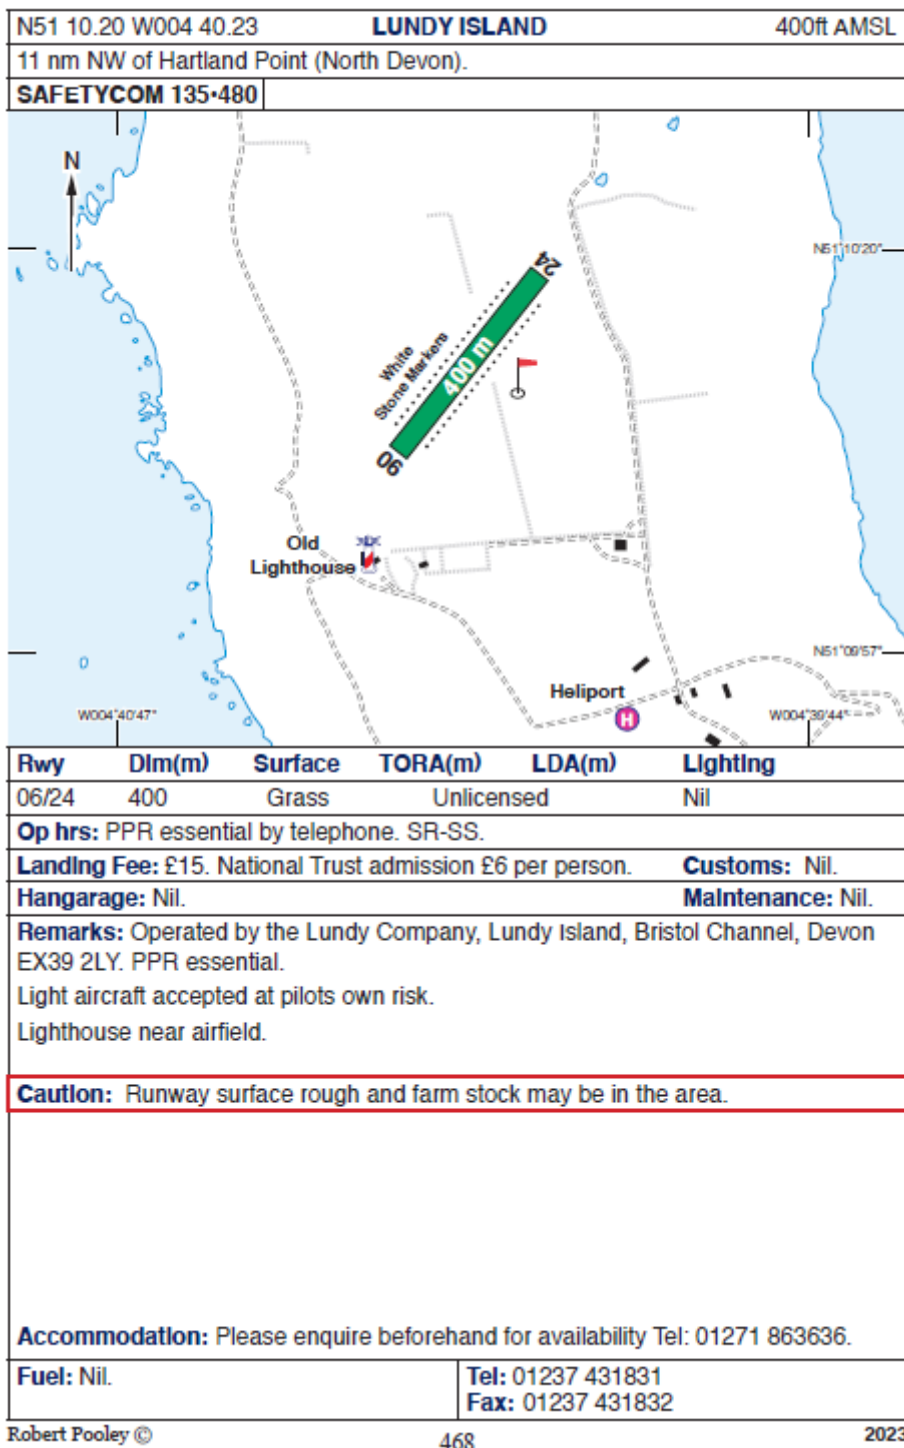
Figure 4

The accident occurred at Lundy Island Airfield. It has a grass runway 400 m long orientated 060/240°. Details are shown at Figure 4.

Lundy Island Airfield information
