Defence
Safety Authority

Service inquiry

Death of a RAF Service
person and serious injuries
during British Services
Mountaineering Expedition,
Pakistan July 2022

Service inquiry into the death of a Service person and the seriously injured casualties whilst participating in the British services mountaineering expedition in Pakistan in July 2022

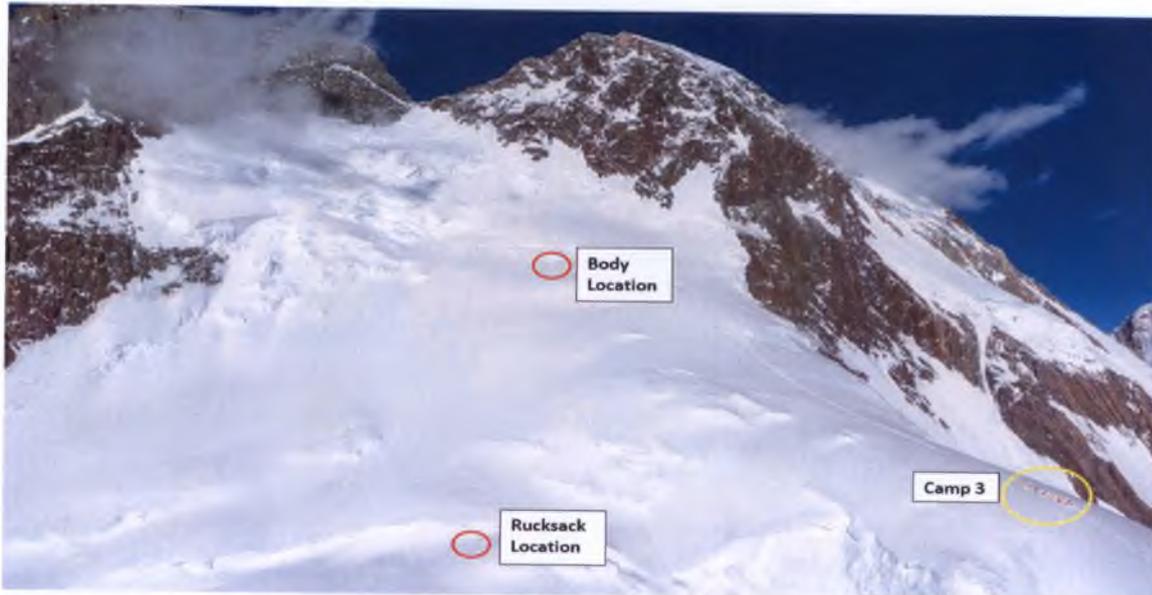
Figure 1.3.7 – Image from paragliding pilot.¹⁵

<p>1.3.20. Initial sighting of body. At 17:15, a report was received over the radio at Broad Peak Base Camp that two paragliding pilots had seen a rucksack (approximately 7000m) and a body (approximately 7400m) in a crevasse field (Figure 1.3.7).</p>	<p>Witness 08 Exhibit 20 Exhibit 21 Exhibit 43</p>

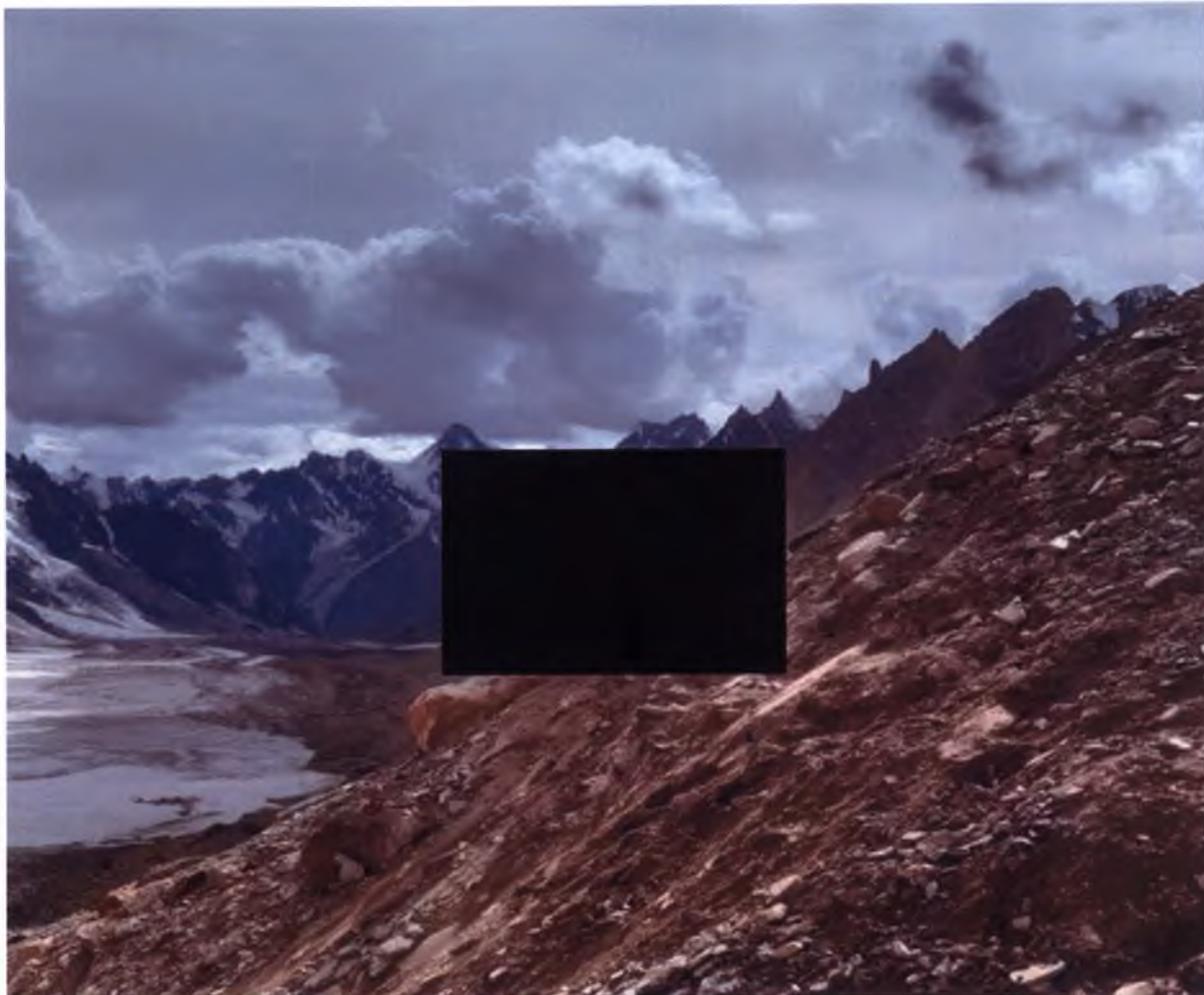
Figure 1.3.10 – Very Seriously Injured (VSI) Casualty Stretcher Evacuation.³¹

1.3.44. **VSI casualty (DT-6) stretcher carry.** At approximately 13:00, DT-9, 7 and 2, assisted by porters, used an improvised stretcher to move DT-6 (Figure 1.3.10) towards a suitable HLS. During the stretcher carry DT-2 received the note from DT-3, stating that a helicopter had been requested. During the stretcher carry, DT-8 was sent to Xhuspang Camp to pass further information on DT-6's condition. En-route, DT-8 met MT-9 and attempted to establish communications with the Main Team. This was unsuccessful due to the BGAN access being restricted, and MT-9 not possessing the required permissions to unlock it.²⁸ Over the next couple of hours, DT-1,3,14 and 15 arrived at Xhuspang Camp.

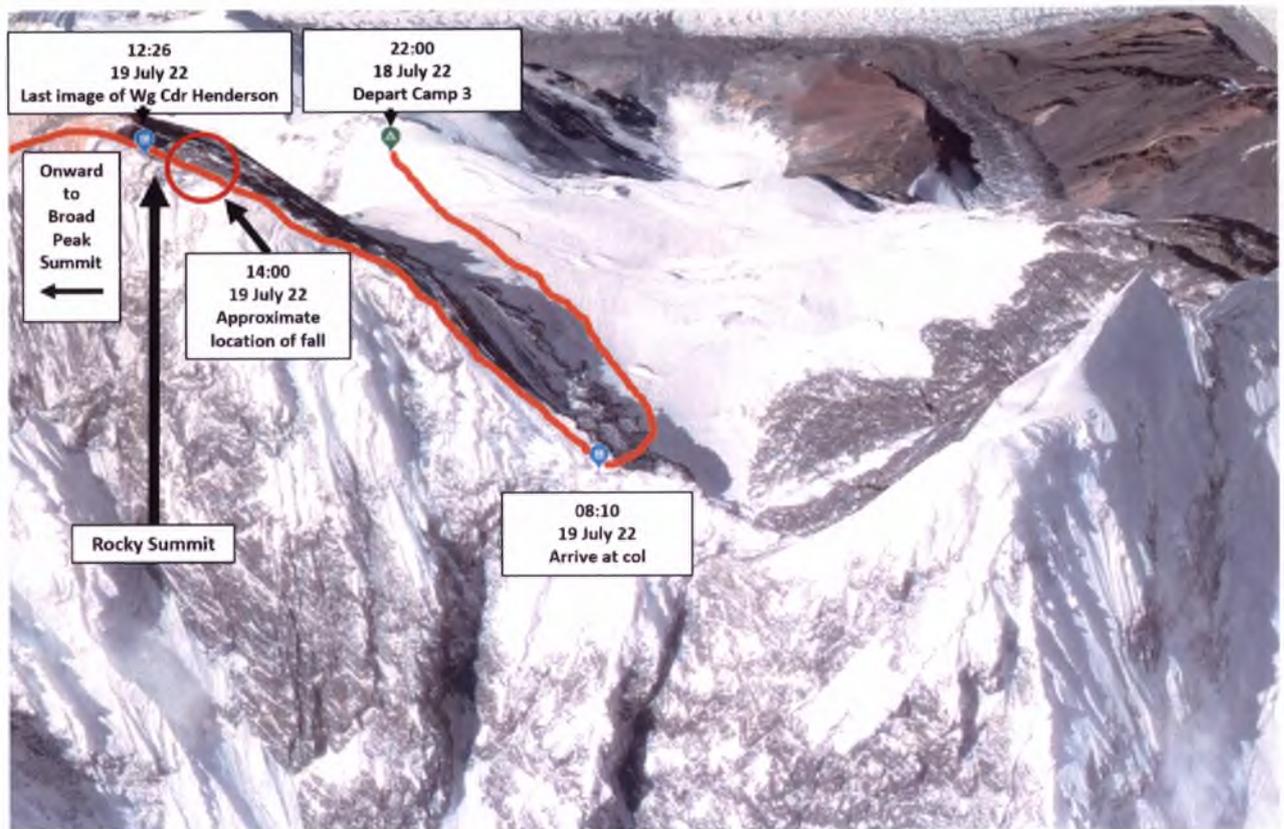
Figure 1.4.2 –Timeline image.

1.4.24. The panel was able to acquire GPS data from GoPro™ images/videos of the summit team's ascent from Camp 3 and Wg Cdr Henderson's last confirmed sighting. This assisted in producing a timeline image (Figure 1.4.2).

1.4.25. **Direction of travel.** To confirm Wg Cdr Henderson's direction of travel at the time of accident, the panel analysed video, photographic, GPS, and interview evidence. The analysis provided the panel with the GPS location of the last sighting of Wg Cdr Henderson at 12:26 at a point beyond the Rocky Summit area. This was compared against witness interviews placing Wg Cdr Henderson descending from Rocky Summit, towards the col at approximately 14:00.

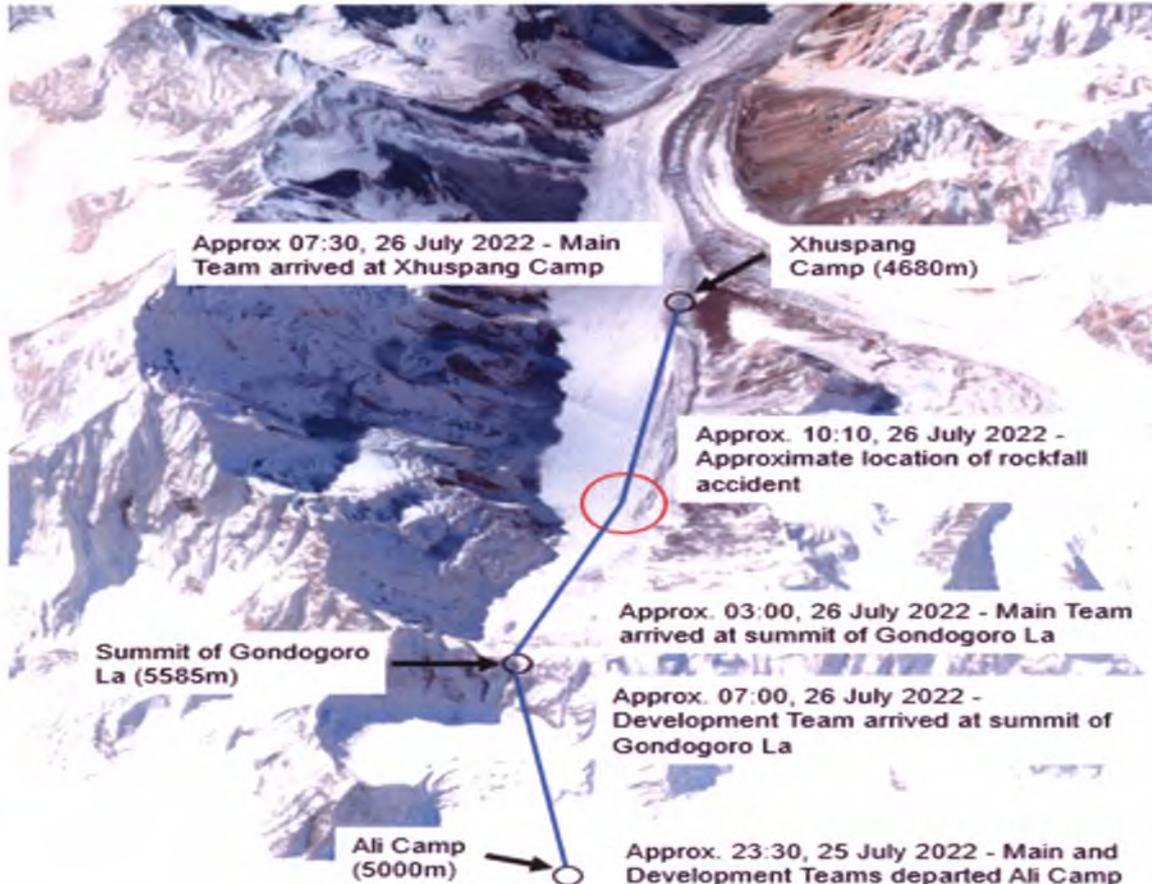
Figure 1.4.14 – Gondogoro La transit timeline.

1.4.198. At the time of the rockfall event at approximately 10:10 and 5200m, the Development Team were still descending. During this period, the likelihood of a rockfall increased due to the fact it was five hours after sunrise and the temperature had increased.

1.4.199. The panel determined that the Development Team were delayed in both their ascent and descent, compared to the Main Team, for several reasons.
