Accident

Aircraft Type and Registration:	EV-97 teamEurostar UK, G-IFLE	
No & Type of Engines:	1 Rotax 912-UL piston engine	
Year of Manufacture:	2004 (Serial no: 2113)	
Date & Time (UTC):	4 June 2023 at 1257 hrs	
Location:	Otherton Airfield, Staffordshire	
Type of Flight:	Private	
Persons on Board:	Crew – 1	Passengers – 1
Injuries:	Crew – 1 (Fatal)	Passengers – 1 (Fatal)
Nature of Damage:	Destroyed	
Commander's Licence:	National Private Pilot's Licence	
Commander's Age:	56 years	
Commander's Flying Experience:	134 hours (of which 134 were on type) Last 90 days – 3 hours Last 28 days – 2 hours	
Information Source:	AAIB Field Investigation

Synopsis

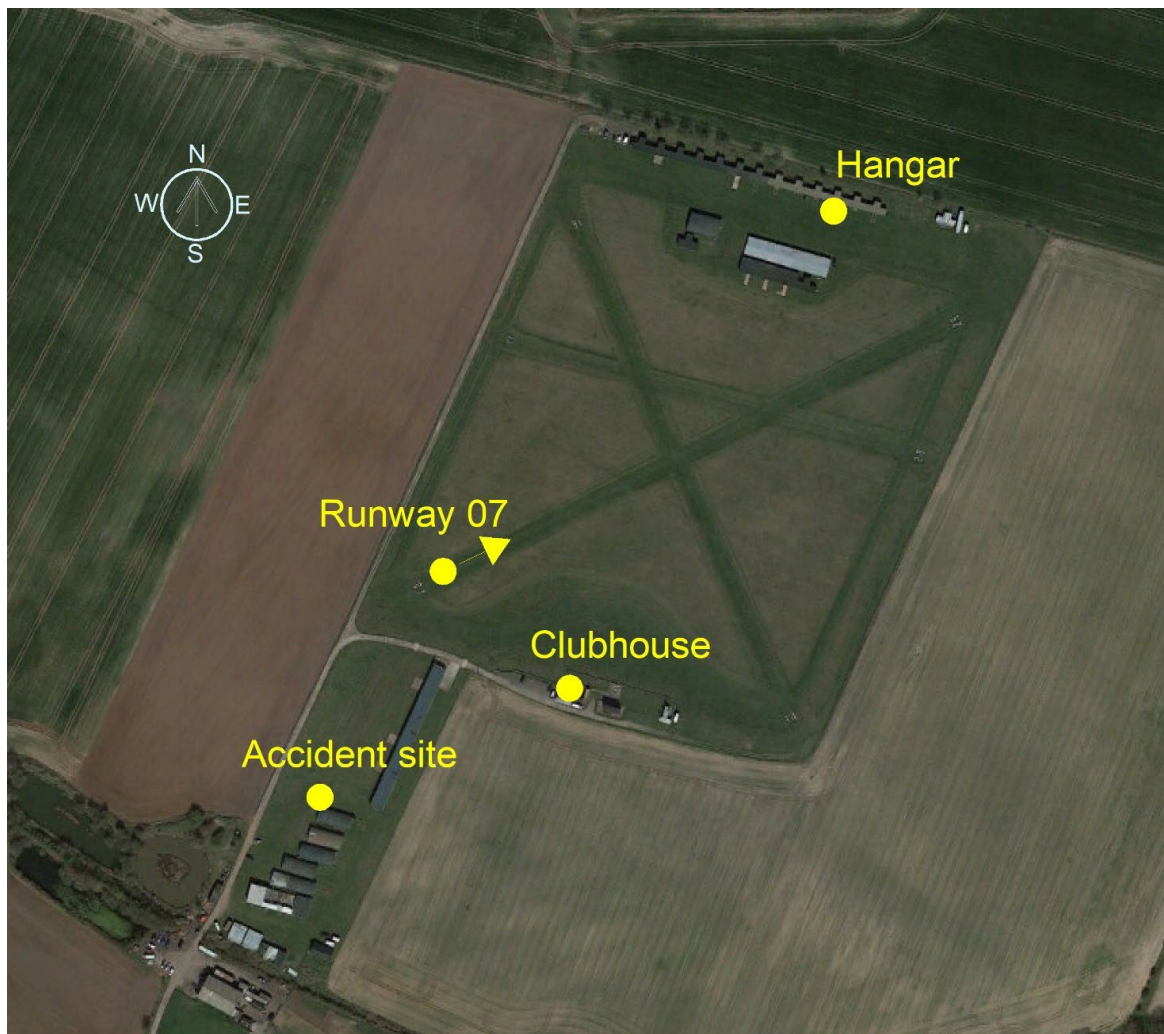
Figure 1

Otherton Airfield - location of G-IFLE's hangar, clubhouse and accident site
(© 2023 Google, Image © Maxar Technologies)

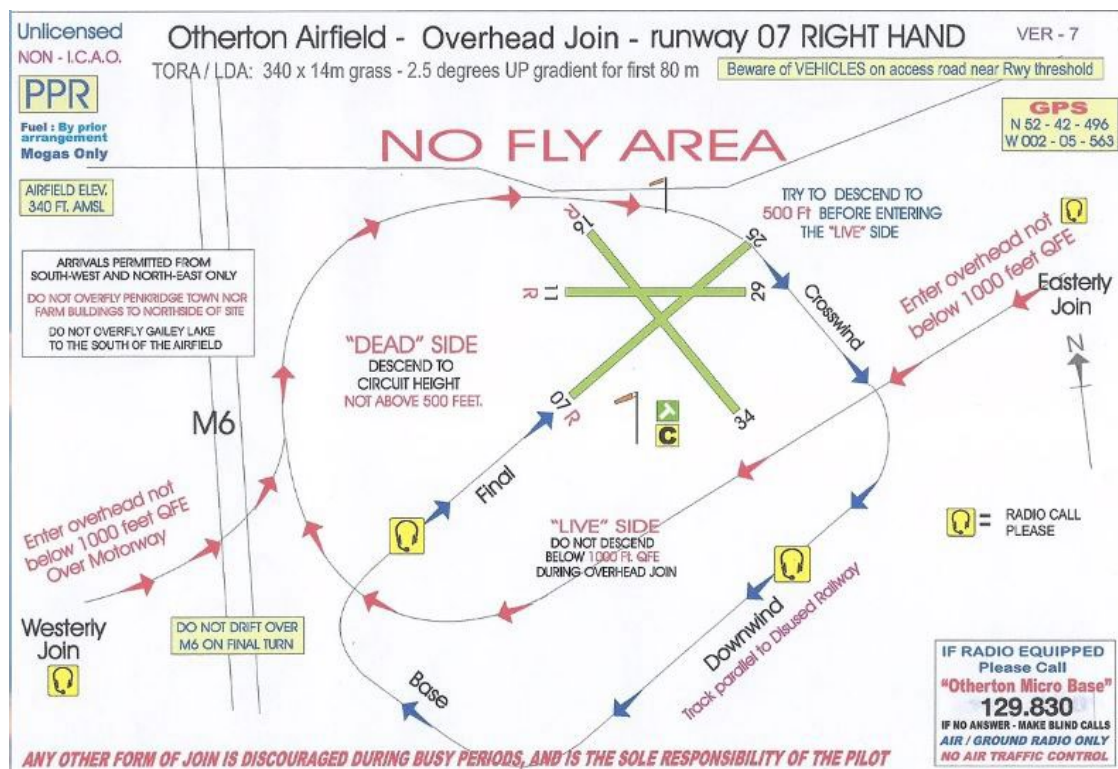
Otherton Airfield has three grass runways and the circuit height is 500 ft agl² (Figure 2). The airfield elevation is 340 ft amsl. An Air/Ground radio service is available and if it is unmanned, pilots are asked to make "Blind Calls".

Figure 2
Airfield information
(Used with permission)

Comparison of the ground track of the accident flight with a previous flight recording of G-IFLE landing on Runway 07 showed that the downwind leg of the previous flight had extended much closer to the M6 motorway (Figure 2) before the aircraft turned onto base leg.

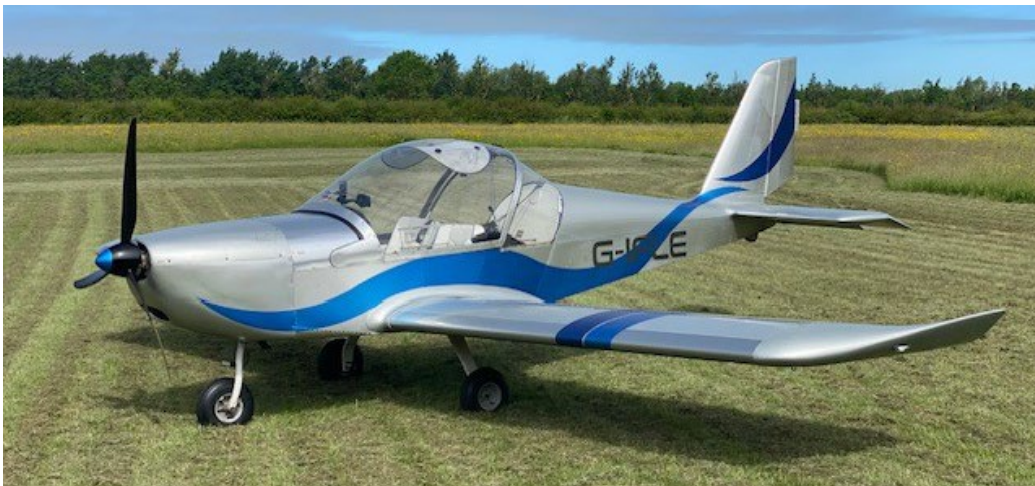
Figure 4

The EV-97, also known as the Eurostar, is a two-seat microlight aircraft (Figure 4). G-IFLE was an EV-97 teamEurostar UK, meaning that it was assembled in the UK by a CAA approved organisation. The aircraft was built in 2004 and its Permit to Fly was valid until 18 September 2023. The aircraft was kept in a hangar at the airfield.

Image of teamEurostar UK, G-IFLE
(Image used with permission)
