**Serious Incident**

| <b>Aircraft Type and Registration:</b> | ATR 72-212A 600, EI-GPN | |
| <b>Location:</b> | Belfast City Airport | |

**Synopsis**

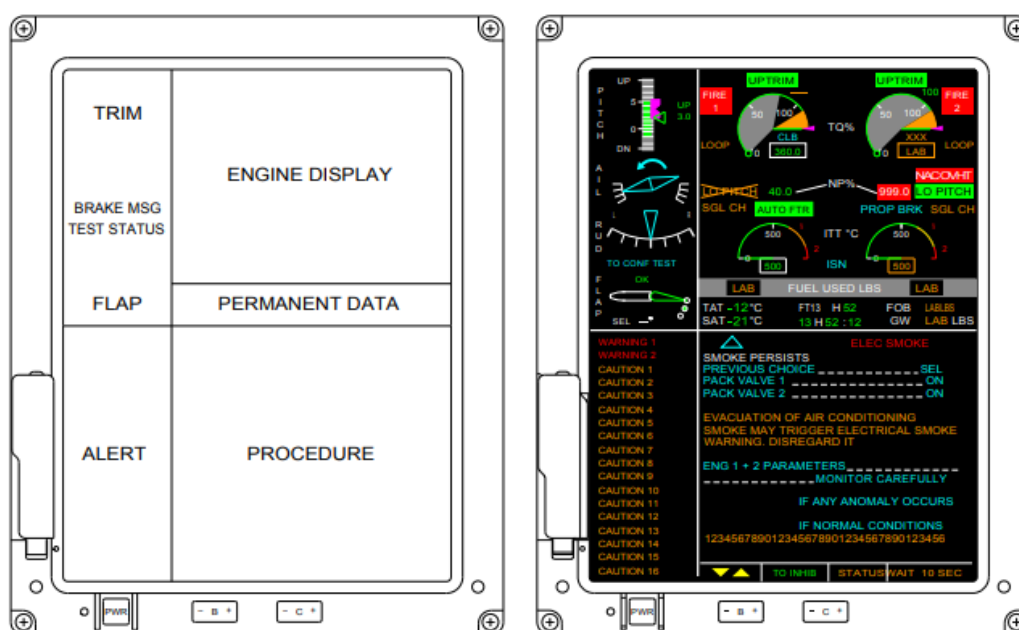
**Figure 4**

The commander asked the co-pilot to transmit a PAN call to ATC but VHF 1 along with transponder 1 had failed. By the time the co-pilot transmitted it on VHF2, ATC were simultaneously calling the aircraft, having lost SSR contact. The co-pilot reported he was unable to scroll through or select the EWD list of alerts<sup>7</sup>, commenting "CAN'T GET ANY OF THESE CHECKLISTS" (Figure 4). Both pilots subsequently reported the screen, including engine instruments, appeared "frozen"<sup>8</sup>. The commander asked the co-pilot to check the circuit breakers and tried unsuccessfully to re-engage the FD modes, AP, and YD.

Example Indications on EWD from Flight crew operating manual  
(not a representation of the indications presented during the incident)

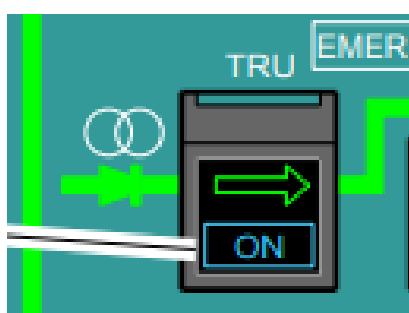
**Figure 5**

TRU pushbutton on overhead 'Main electrical power' panel

The commander reported that while considering how to resolve the failure, he still had the TRU in mind from earlier on. At 0856 hrs and around 1,900 ft amsl, he instructed the co-pilot to select TRU OFF. Immediately, the display units and normal pitch trim control returned; the landing gear and flaps deployed. The commander reported being right of the runway track with four white 'precision approach path indicator' (PAPI) lights<sup>10</sup> visible. The crew selected FLAP 30, performed the '*Before landing checklist*', and were cleared to land. The co-pilot stated "ONE THOUSAND ABOVE YOUR SPEED IS GOOD". The aircraft's rate of descent peaked at just over 1,000 ft/min and at 500 ft agl the commander announced he could see two red and two white PAPI lights. The aircraft landed at 0859 hrs.

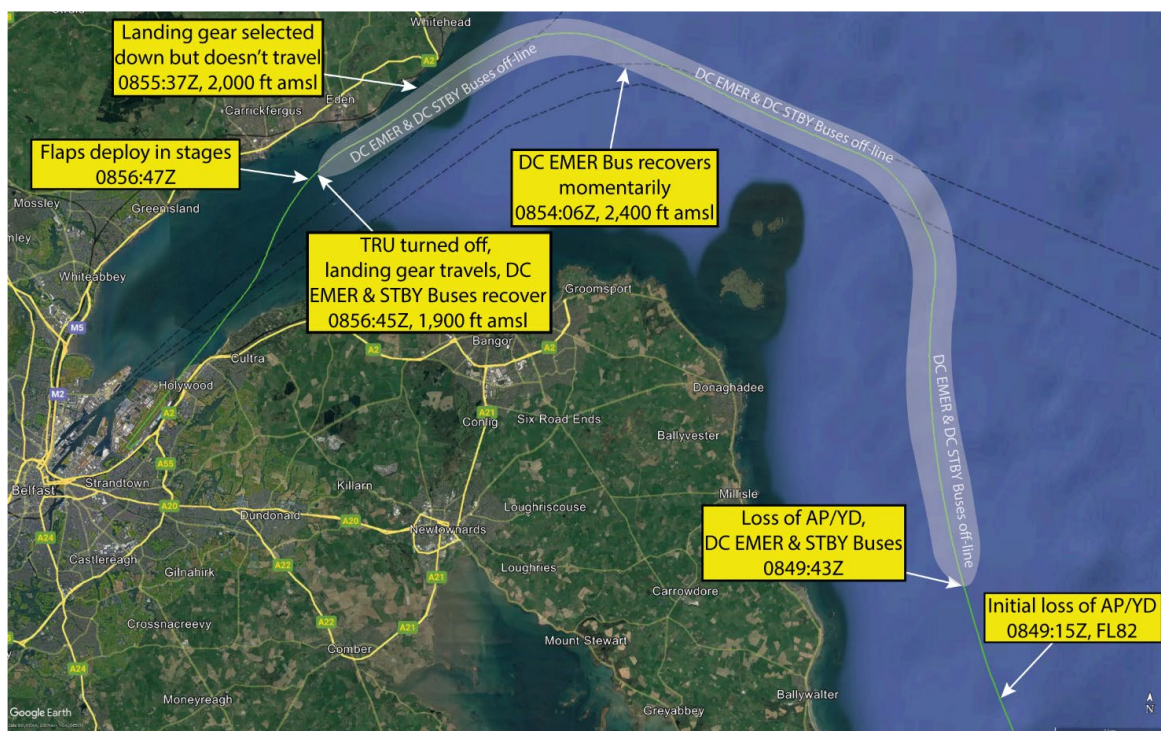
**Figure 7**

The FDR data showed that throughout this time, as the crew continued their approach towards Belfast (Figure 7), the functionality of several systems was lost. These included:

- The co-pilot's air data computer (ADC); this resulted in no airspeed, altitude, and vertical speed data displayed on the co-pilot's PFD<sup>13</sup>,
- the blue hydraulic system required for flap extension and the roll spoilers,
- the normal pitch trim system<sup>14</sup>,
- the normal landing gear extension system,
- some secondary engine instrumentation for the left engine,
- VHF radio number 1 and the transponder.

Approach towards Belfast from just prior to the loss of AP and YD, until after landing.

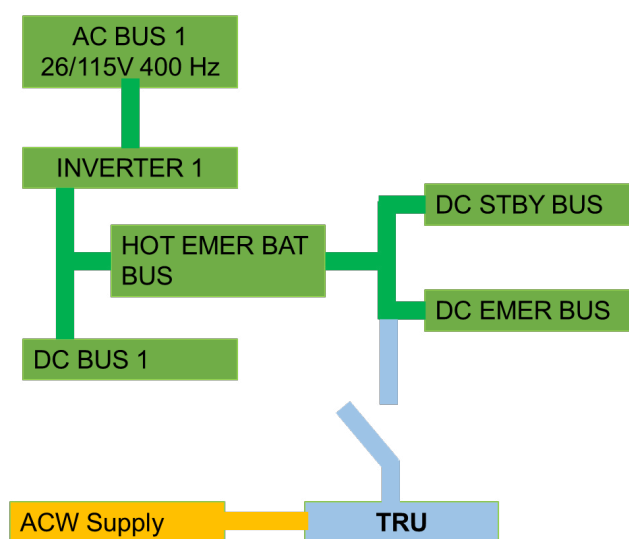
**Figure 13**

The AAIB attended a simulator session at the manufacturer's headquarters on 25 November 2022 to explore the technical and procedural aspects of the event, using the incident location and flight conditions. With no function to simulate the 95PA contactor failure, the incident conditions were recreated by failing the DC SBY BUS<sup>20</sup> then the DC EMER BUS, and inverter 1 (Figure 13). Consequently, the manufacturer estimated the technical aspects of the simulation were accurate but that anomalies were possible.

Simulator circuit configuration to recreate the loss of DC STBY BUS and DC EMER BUS
