Runaway of an engineering train at London Liverpool Street station, 2 October 2022

Summary of the incident

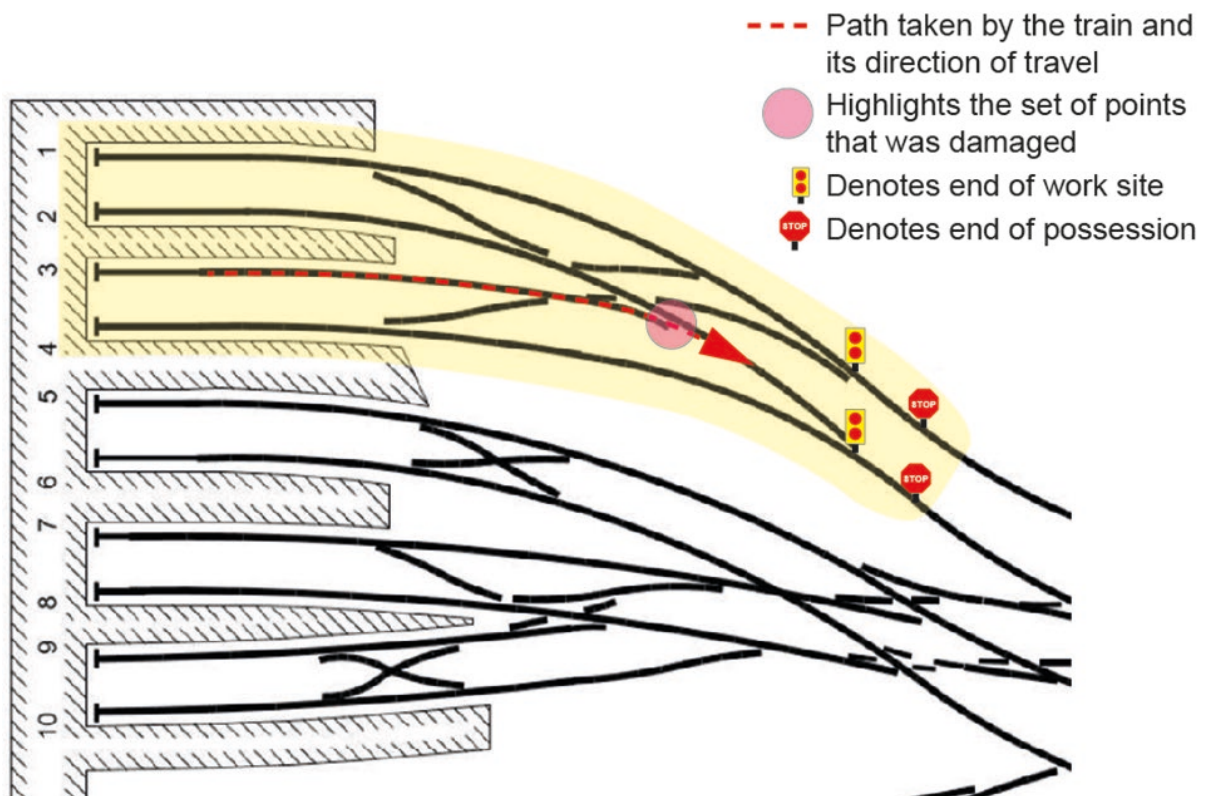
The train was to be used as part of work on the station's roof, that was planned to take place in a possession over the weekend. The possession, which was from 00:40 hrs on Saturday to 04:00 hrs on Monday, included the closure of platforms 1 to 4 and the railway lines leading into these platforms.

The extent of the railway lines under possession for the engineering work.
