# ***AAIB Bulletin***

***3/2024***

| AW189 | G-MCGT | 26-Jul-21 | 3 |

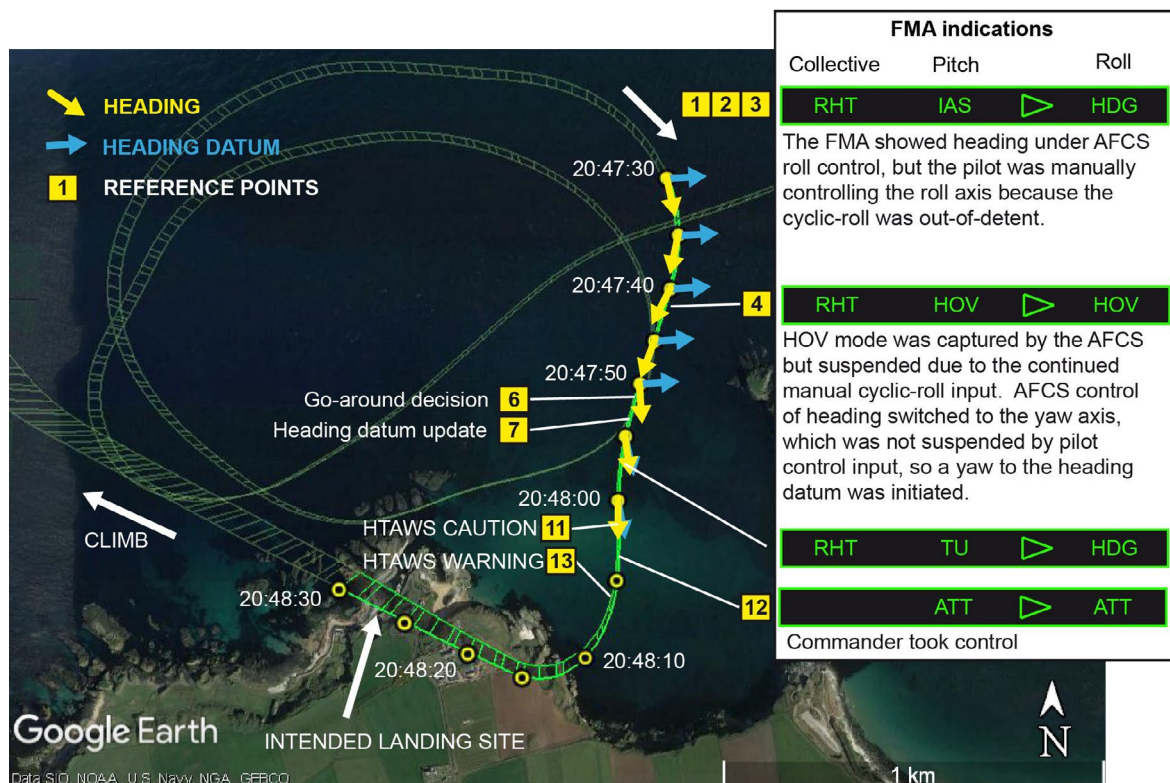
The later stage of the third approach is shown at Figure 11 (recorded data) and Figure 12 (flight path). The following significant events occurred during this stage of flight, some of which are annotated on Figure 11 and 12 using the numbers in brackets as the reference points:

Overhead view of third approach showing FMA indications  
(Reference points relate to Figure 11 and the report text)

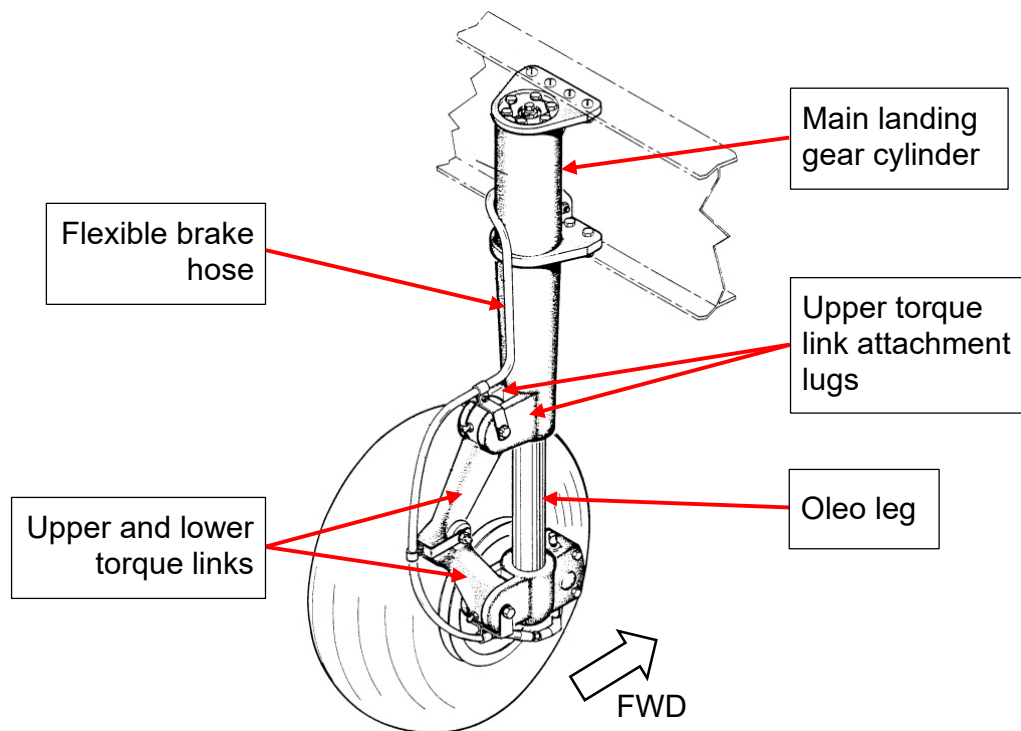
**Figure 2**

Left main landing gear leg assembly

- The left landing gear wheel, torque link and oleo strut assembly had detached from the landing gear cylinder but remained attached to the aircraft by the brake hose.
- The torque link attachment lugs had broken from the main landing gear cylinder and remained attached to the upper torque link (Figure 3).
- The base of the main landing gear cylinder had fractured into several smaller pieces near to the upper torque link attachment lugs (Figure 4).
- There was damage to the left flap and wing surface sustained from the oleo leg and wheel assembly during the accident sequence.
- The left wheel brake disc surface was corroded and did not show witness marks from the brake pad rubbing against the disc.

Both torque link attachment lug fracture surfaces showed an area of stable, progressive fatigue crack growth with faint striations<sup>2</sup> present. The fractures had initiated at the inner lower radii of each lug (Figure 5). The cracks reached a maximum depth of 2 mm on the inboard lug and 3 mm on the outboard lug before instantaneous fracture occurred. There was no evidence of pre-existing material or mechanical defects associated with the fatigue crack initiation.

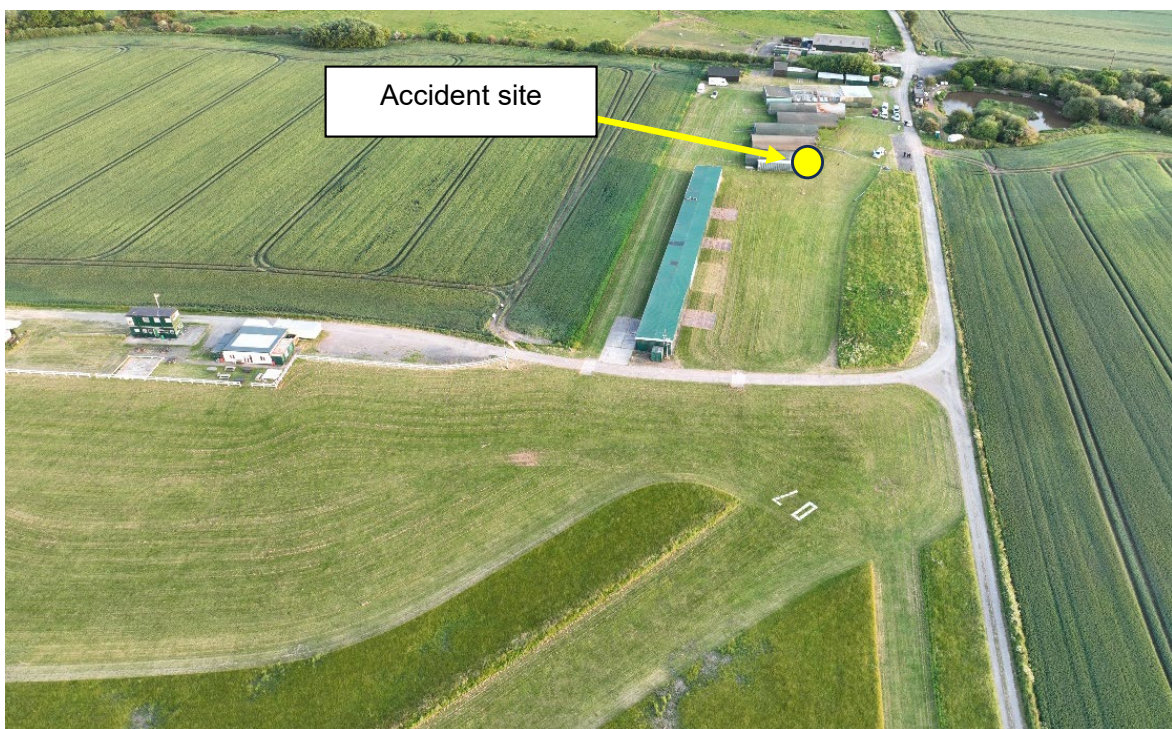
**Figure 3**

The accident site was approximately 140 m from the threshold of Runway 07 and adjacent to one of the hangars on the south side of the airfield (Figure 3).

Aerial view showing the location of the accident site relative to the Runway 07 threshold

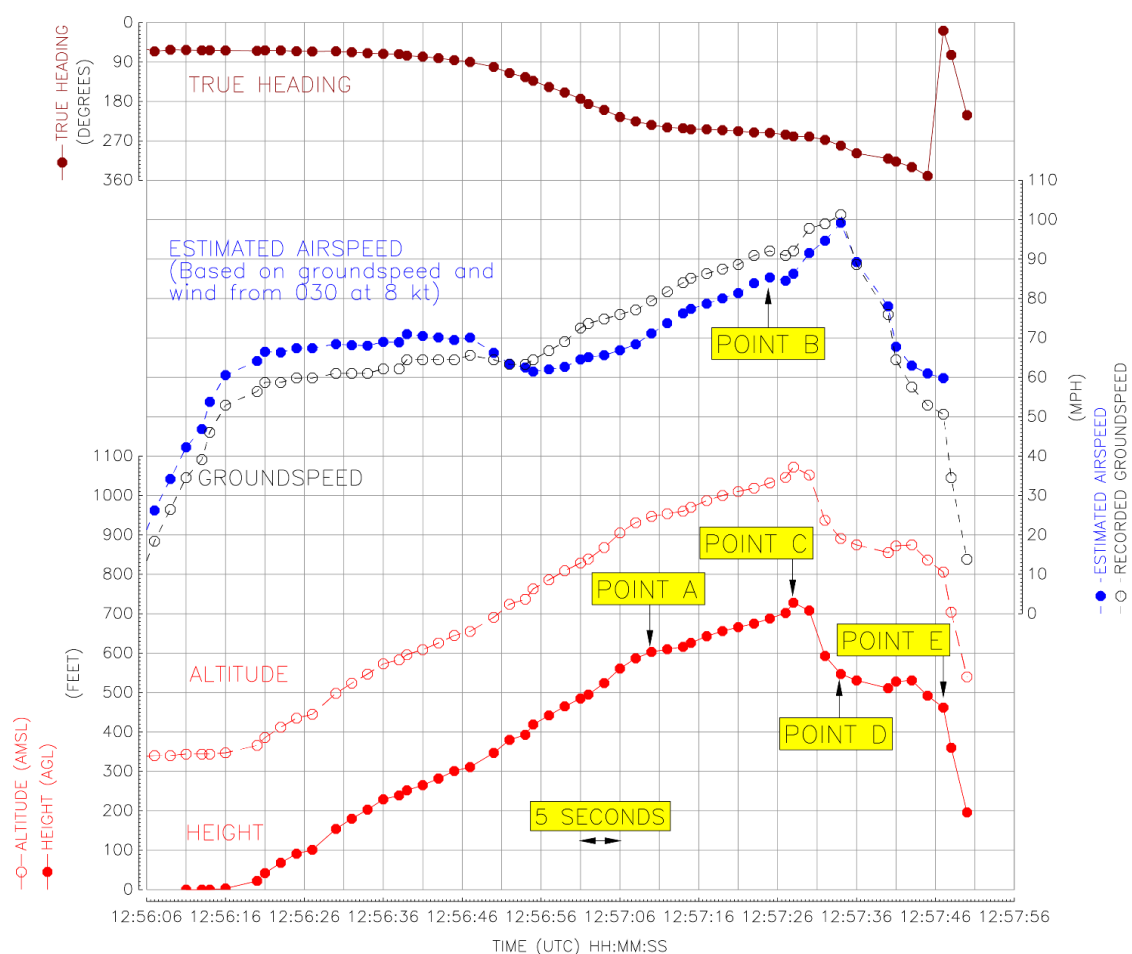
**Figure 5**  
Data plot of accident flight

- As the aircraft climbed through 260 ft agl (600 ft amsl) it started a right turn onto a downwind heading and at 600 ft agl (940 ft amsl) the rate of turn was reduced with the aircraft rolling out onto a track of about 240° (Figure 5 and Figure 6 Point A).
- The climb rate then reduced to about 340 ft/min and the airspeed gradually increased to an estimated 85 mph (Figure 5 and Figure 6 Point B).
- At a height of about 740 ft agl (1,080 ft amsl) (Figure 5 and Figure 6 Point C) the aircraft started to descend and its airspeed increased to an estimated 100 mph; the aircraft was laterally positioned about 550 m from the threshold of Runway 07 at this time. As the aircraft descended it turned to the right,

- As the aircraft descended to about 550 ft agl (880 ft amsl) (Figure 5 and Figure 6 Point D) its rate of descent reduced from about 1,800 ft/min to an average of 360 ft/min. As the aircraft gradually descended its airspeed also reduced.
- After about 10 seconds the estimated airspeed of the aircraft had reached about 60 mph at which point the data indicates that the rate of turn had also increased quickly with the estimated bank reaching more than 45°.
- At a lateral distance of about 200 m from the threshold of Runway 07, the aircraft then entered a rapid descent from a height of about 480 ft agl (Figure 5 and Figure 6 Point E). The first CCTV image of the aircraft as it descended was captured shortly after.

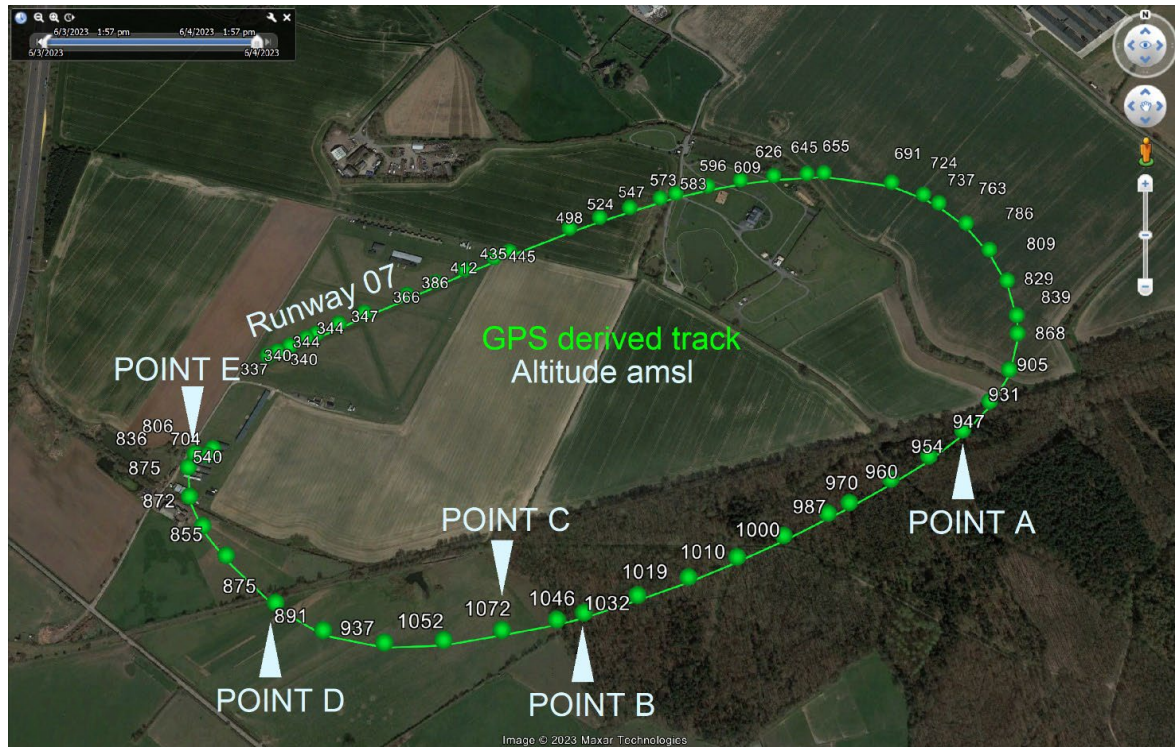
**Figure 6**

GPS derived track and altitude  
(© 2023 Google, Image © Maxar Technologies)

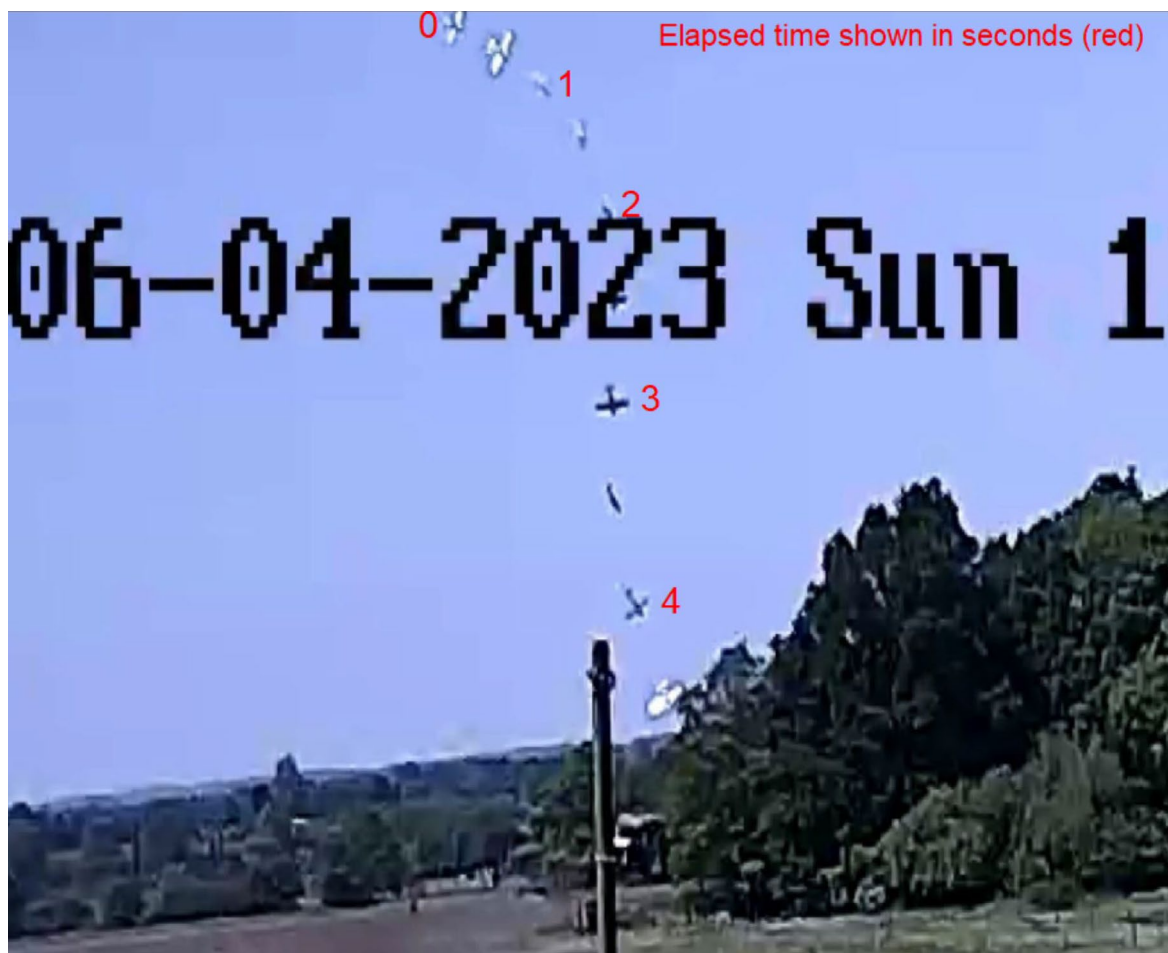
**Figure 7**

At the beginning of the CCTV footage the aircraft's pitch attitude was at about 35° nose-down and the bank angle was about 80° right wing down. The aircraft turned to the right as it descended, and its nose-down attitude increased to about 70°. The average descent rate was about 5,000 fpm (57 mph) with one complete rotation of the aircraft taking about 4.5 seconds. The aircraft remained in a steep nose-down attitude until it struck the ground, which was captured by CCTV at the airfield.

The time from the aircraft departing from controlled flight to crashing was approximately six seconds during which it made around 1.5 rotations. There was no evidence of the aircraft starting to recover from the spin.

Composite CCTV image of the descent

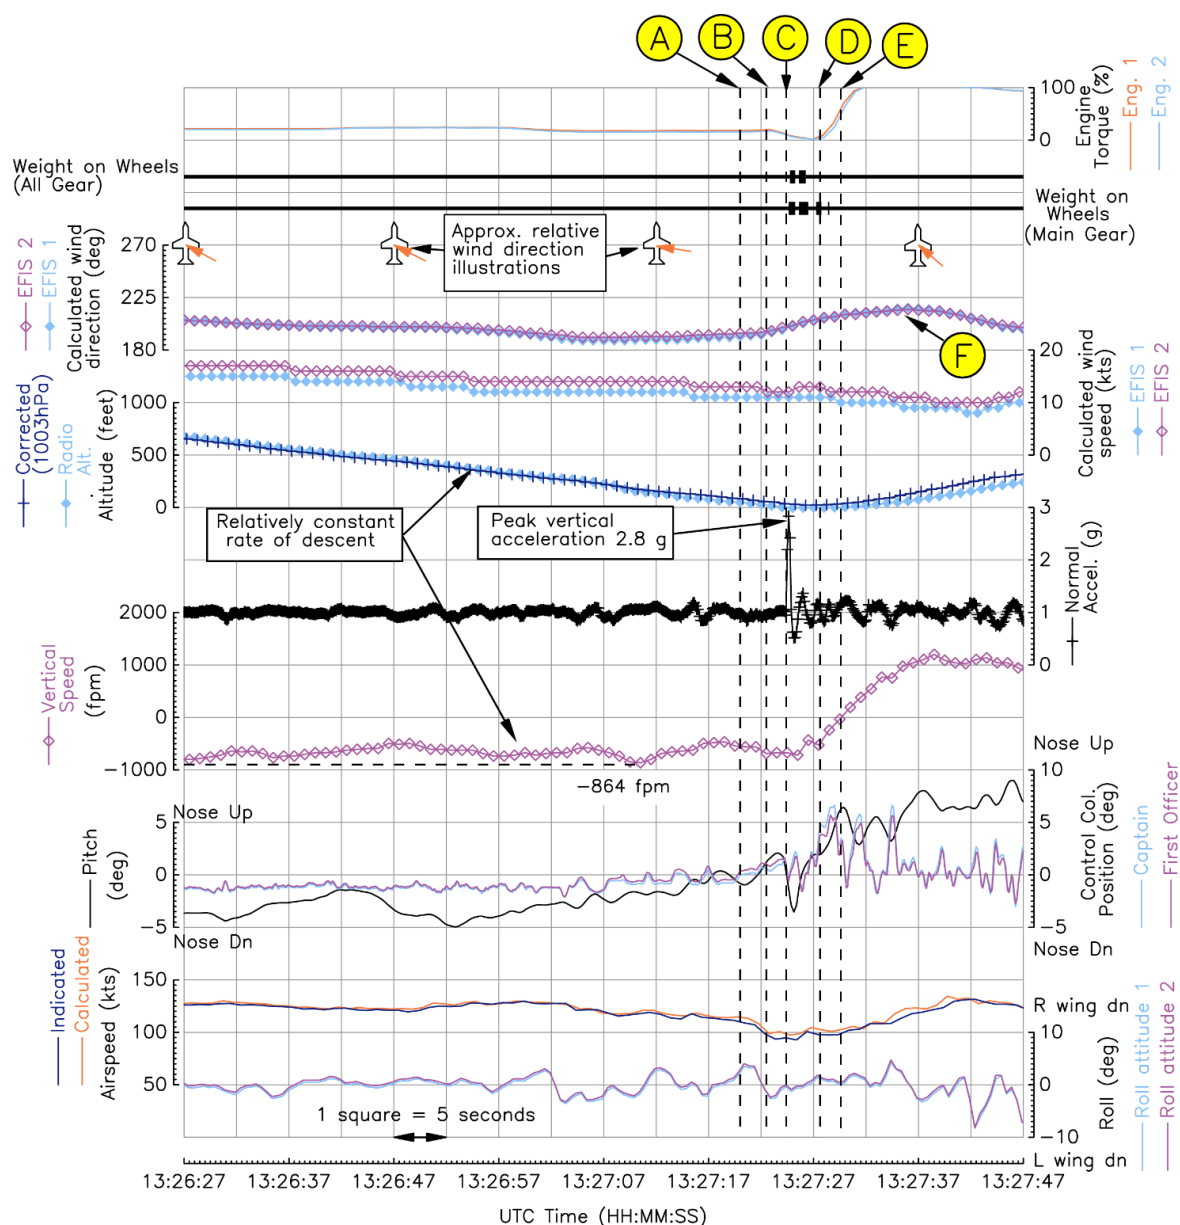
**Figure 1**

The recordings indicate that the aircraft was flying with a crosswind from the right, which changed direction between points B and F to give an increasing tailwind component. After point F, the recordings indicate that the wind returned to a crosswind from the aircraft's right. There was no significant change in the aircraft's heading during this time.

Pertinent parameters recorded by the FDR.

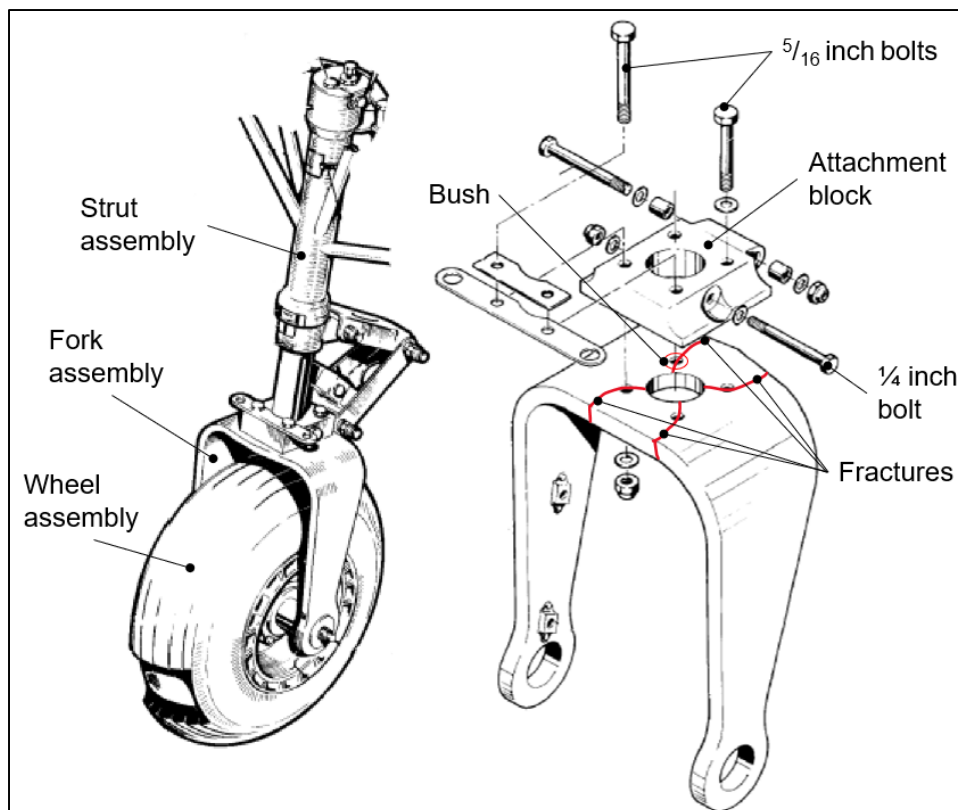
**Figure 2**  
PA-28 Nose landing gear

The nose landing gear of the PA-28 consists of a wheel, fork and strut assembly (Figure 2). The aluminium fork is attached to an attachment block by four  $\frac{5}{16}$  inch diameter steel bolts and the strut is retained to the attachment block by a single  $\frac{1}{4}$  inch diameter steel bolt.

The fork and strut assembly were inspected and it was determined that the fork assembly had fractured through all four of the attachment block bolt holes (Figure 2). Two pieces of the fork and all the bolts remained attached to the strut assembly and showed evidence of heavy abrasion from the runway surface. There was wear and paint loss on the upper surface of the fork where it was in contact with the attachment block.
