**SERIOUS INCIDENT**

<b>Aircraft Type and Registration:</b>	MBB-BK 117 C-2, G-MPSB	
<b>No &amp; Type of Engines:</b>	2 Arriel 1E2 turboshaft engines	
<b>Year of Manufacture:</b>	2005 (Serial no: 9068)	
<b>Date &amp; Time (UTC):</b>	12 March 2021 at 1150 hrs	
<b>Location:</b>	North Weald Airfield, Essex	
<b>Type of Flight:</b>	Private	
<b>Persons on Board:</b>	Crew - 2	Passengers - None
<b>Injuries:</b>	Crew - None	Passengers - N/A
<b>Nature of Damage:</b>	Distorted aft crosstube between skids	
<b>Commander's Licence:</b>	Airline Transport Pilot's Licence (Helicopters)	
<b>Commander's Age:</b>	52 years	
<b>Commander's Flying Experience:</b>	7,170 hours (of which 2,196 were on type) Last 90 days - 28 hours Last 28 days - 14 hours	
<b>Information Source:</b>	AAIB Field Investigation

**Synopsis**

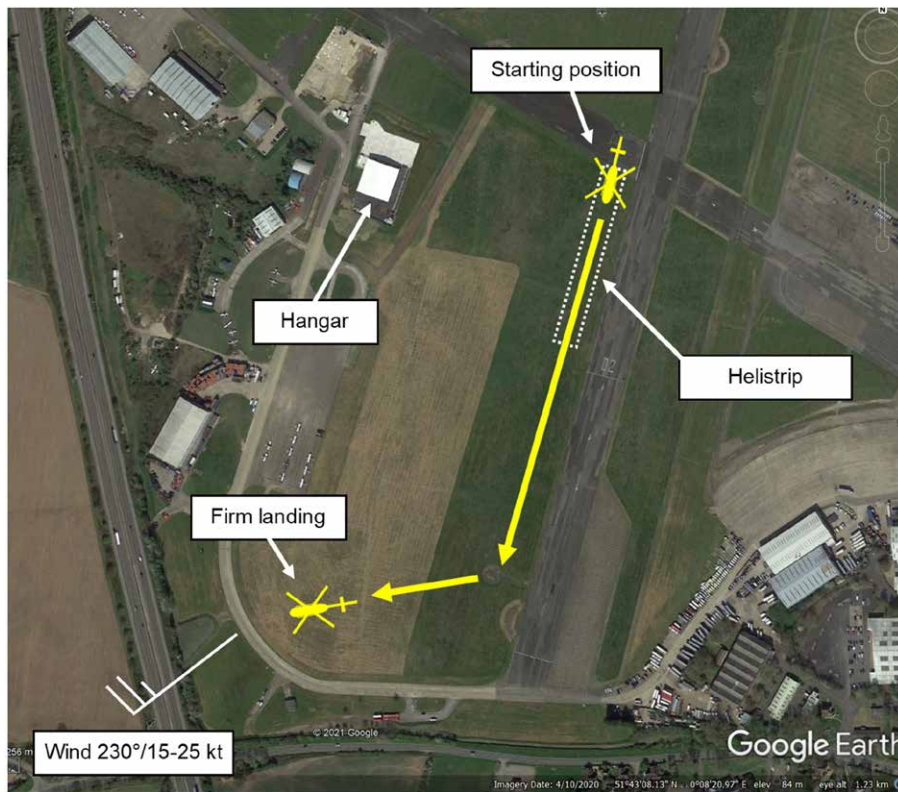
**Figure 1**

Approximate track of G-MPSB from Cat A takeoff to firm landing (satellite imagery courtesy of Google Earth ©2021 Google)

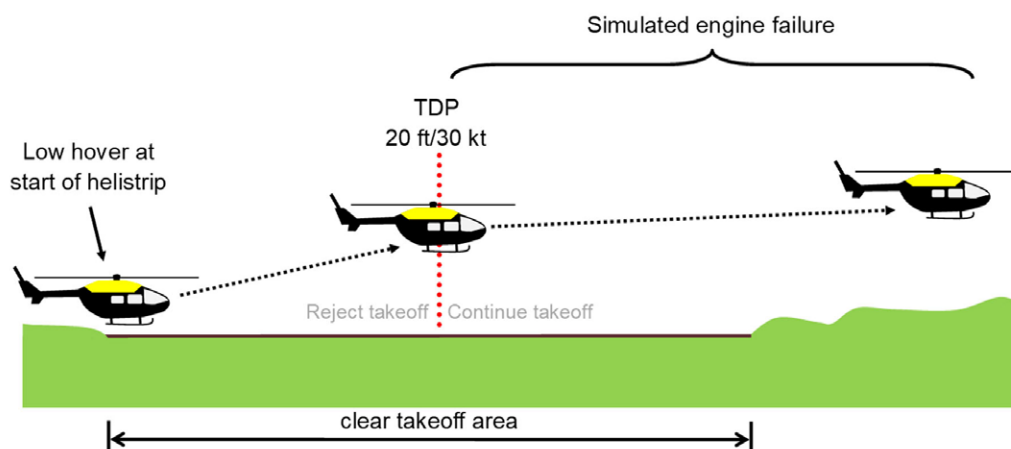
**Figure 2**

Overview of Cat A Clear Heliport takeoff profile with simulated engine failure after TDP

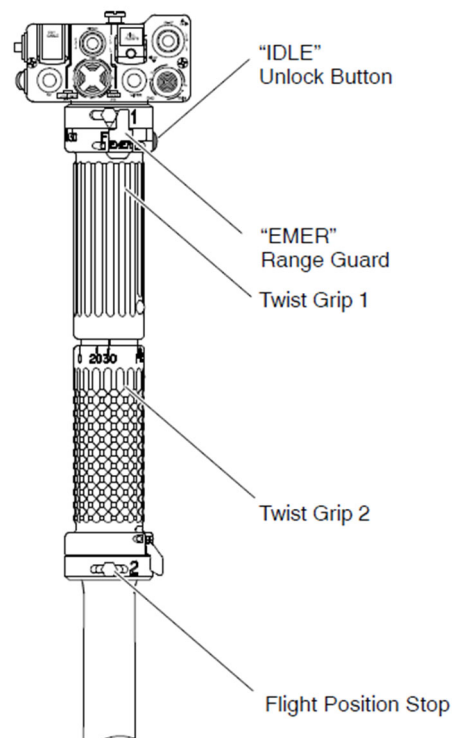
**Figure 4**

BK 117 C-2 collective pitch lever showing twist grip positions

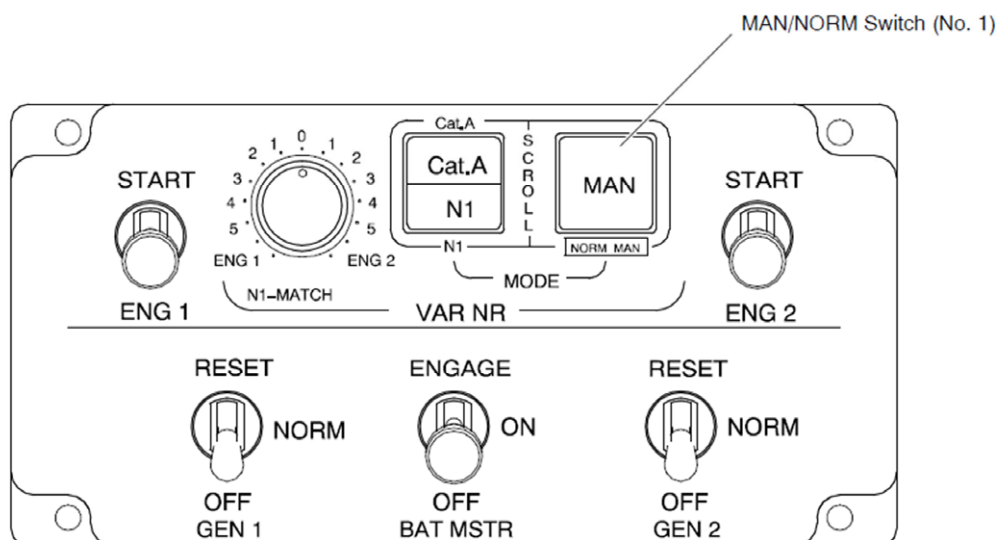
**Figure 6**

VARTOMS control panel

If the VARTOMS identifies that there is an engine torque split of greater than 15% the system will automatically switch to manual mode and the MAN button will illuminate yellow. If a VARTOMS failure is detected a caution will be illuminated on the CAD.

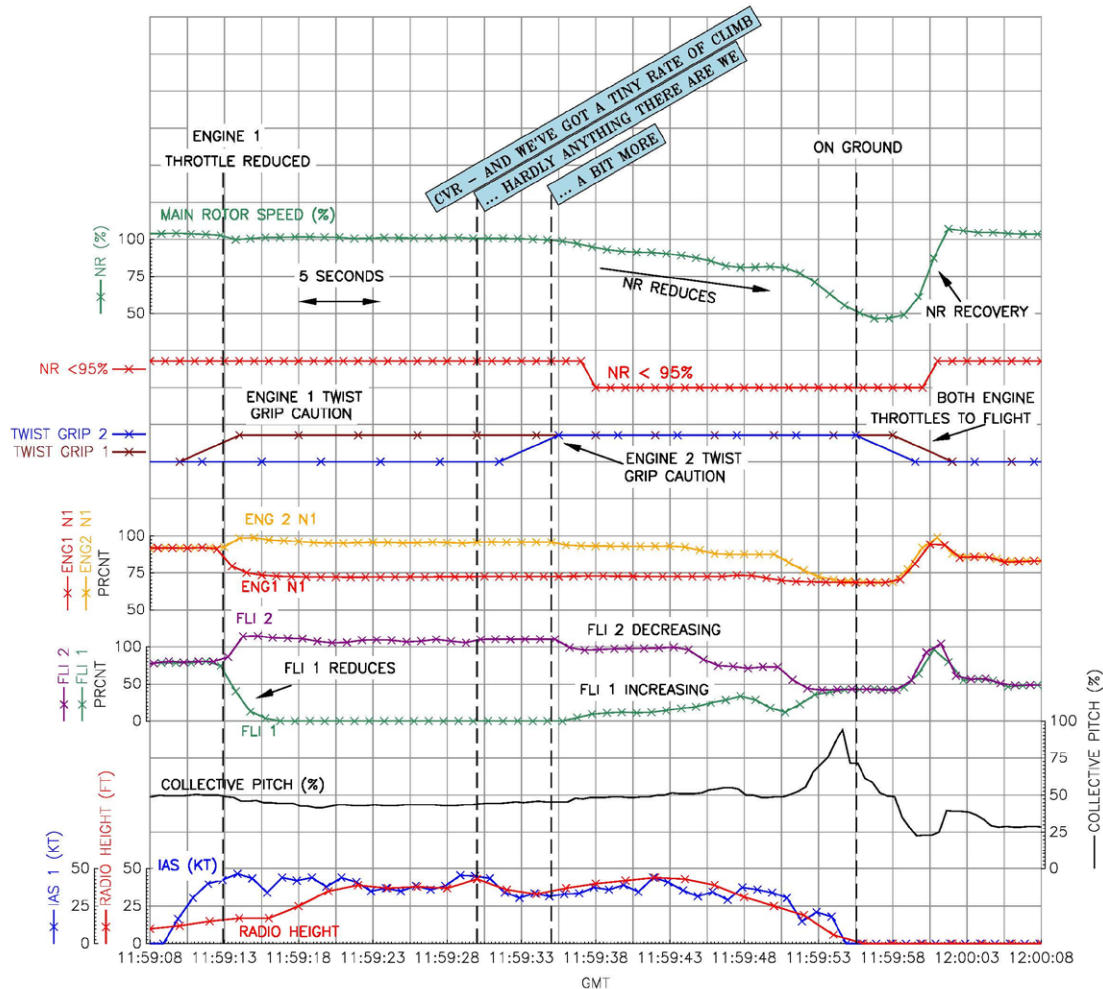
**Figure 8**

At 1159:13 hrs, while climbing through 16 ft agl at an IAS of 43 kt, Engine No 1 FLI began to reduce, signifying the point at which the Engine No 1 throttle was reduced. This was confirmed by the CAU TWIST GRIP parameter (Figure 8). The position of the Engine No 1 throttle was not recorded but within 3 seconds, Engine No 1 torque had reduced to less than 3%.

G-MPSB FDR parameters  
NOTE FLI is recorded as percentage on the FDR
