Rail Accident Investigation Branch

Rail Accident Report

Derailment of a tram at Bulwell, Nottingham 12 June 2023

Report 02/2024
March 2024

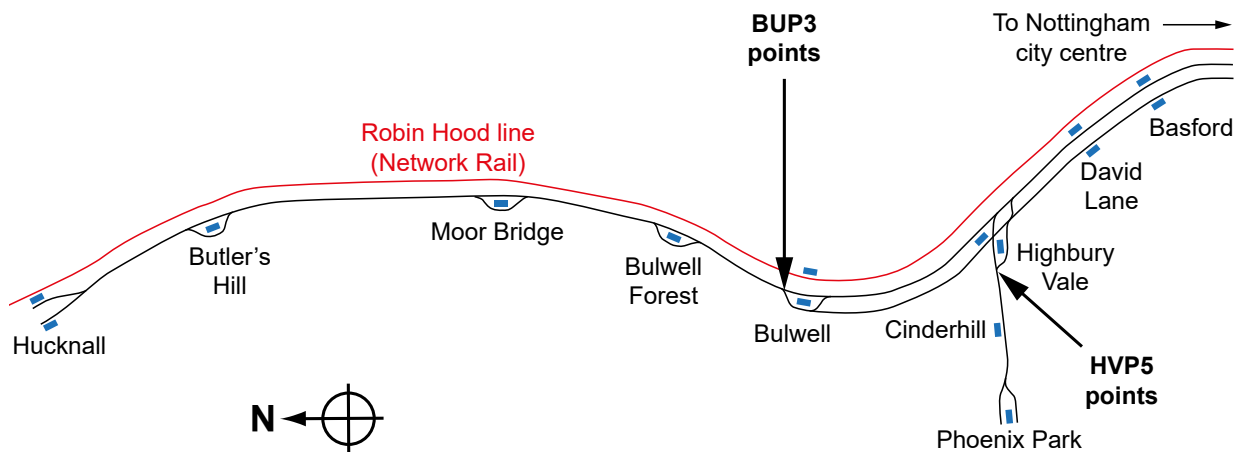
Figure 3: Schematic of the tramway between Hucknall (left) and Bulwell (right).

- 6 To the north of Bulwell, the tramway runs on a single track, used by trams in both directions, with passing places at each intermediate tram stop (figure 3). The tramway at Bulwell tram stop and further to the south runs on two tracks, one for each direction of travel. The accident occurred at BUP3 points, immediately to the north of Bulwell tram stop, where the single track from the north splits into the two tracks used by the rest of the network. Directly north of BUP3 points, the track passes under Highbury Road overbridge.
- 7 Bulwell tram stop has an island platform accessed by walkways from a car park to the west. Northbound trams stop to the west of the platform, with southbound trams being directed by BUP3 points to stop to the east of the platform.

- 98 In a similar cause to the derailment at Bulwell, the facing points (HVP5 points, figure 3) had stuck in the incorrect position, and neither the trainee driver nor the driver instructor observed the FPI which was indicating that the points were set incorrectly.
