Annual Safety Review 2023

CIAA Foreword

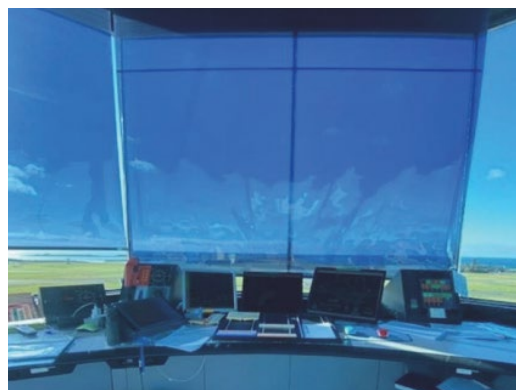
View of Runway 03 approach with similar glare and sunblind position as the incident (Photograph from the ATS unit's investigation report on the incident)

- The ATSU has published a reminder to controllers to monitor all stages of an aircraft's final approach to recognise when an aircraft might be incorrectly or dangerously positioned. It intends to provide TRM training for all members of the ATS section and to replace the VCR sun blinds if a better solution can be found.

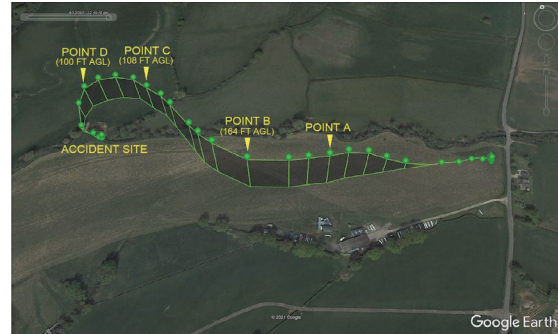
The accident occurred during a simulated failed winch launch. The glider was initially flown away from the airfield at a low height and, whilst turning back to land, stalled and collided with trees on the edge of the airfield. Both occupants were seriously injured. With assistance from the British Gliding Association (BGA), the gliding club has taken several safety actions to improve elements of the club's operation.

Recorded GPS flightpath of aircraft

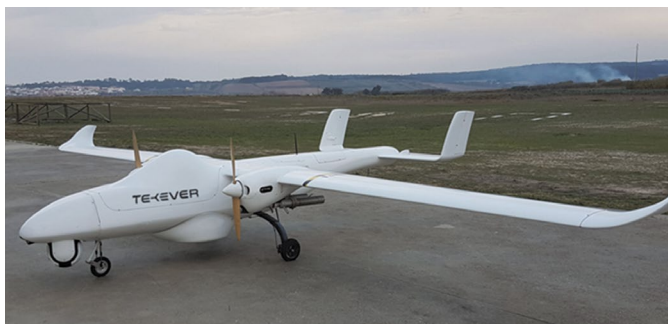
Tekever AR5 Evolution

The unmanned aircraft encountered a loss of the communications link due to a fault in the Satcom antenna, such that it was not under the direct control of the remote pilot for a period of several minutes. In accordance with contingency procedures, the aircraft entered a holding pattern and the communications link was subsequently re-established. The remainder of the flight proceeded without incident.

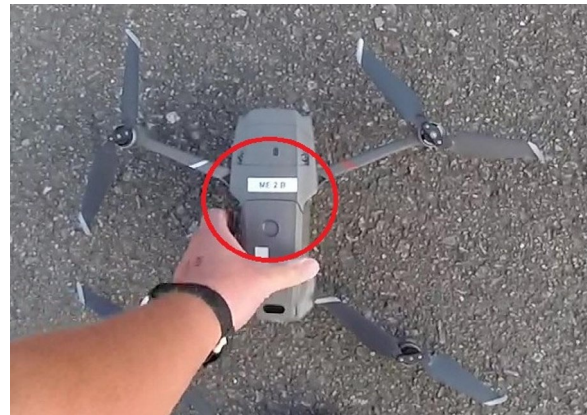
The UAS was being used in a police operation over an abandoned building near a public car park and train station. During hover over the building the aircraft's motors stopped and the aircraft fell vertically with no prior warning to the remote pilot. The aircraft struck the roof of the building and the battery separated. Recorded data indicated that the battery probably disconnected in flight. This could have been caused by the battery not having been fully latched prior to takeoff, or the latching mechanism or battery being worn from repeated use resulting in an in flight disconnection.

Image from the pilot's bodycam prior to takeoff

- The operator has shared the learning from this accident with all its UAS pilots and reminded them of their responsibility to turn on their body worn camera before they carry out the UAS pre-flight checks so that the checks are captured, and of their responsibility to take time on the UAS checks that are completed at a local air base to ensure the aircraft is fit for use.
- They also planned to reinforce the briefing of observers, and to carry out routine checks of the batteries.
