Accident

Aircraft Type and Registration:	AW109SP, G-RAYN	
No & Type of Engines:	2 Pratt & Whitney Canada PW207C turboshaft engines	
Year of Manufacture:	2019 (Serial no: 22401)	
Date & Time (UTC):	1 November 2022 at 1726 hrs	
Location:	Nantclwyd Lodge, near Llanellidan, Denbighshire	
Type of Flight:	Non-commercial operation	
Persons on Board:	Crew - 1	Passengers - 5
Injuries:	Crew - None	Passengers - 1 (Serious) 4 (Minor)
Nature of Damage:	Helicopter destroyed	
Commander's Licence:	Commercial Pilot's Licence (Helicopters)	
Commander's Age:	47 years	
Commander's Flying Experience:	3,815 hours (of which 1,565 were on type) Last 90 days - 81 hours Last 28 days - 24 hours	
Information Source:	AAIB Field Investigation

Synopsis

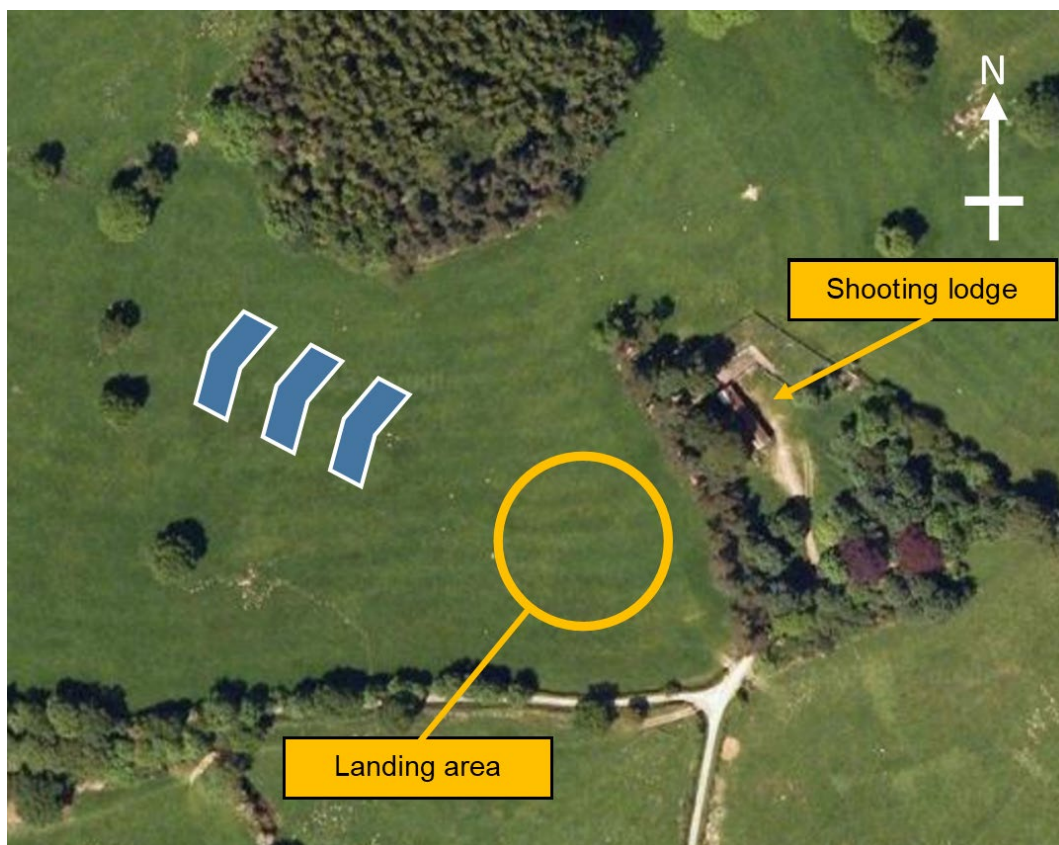
Figure 1

Having flown G-RAYN from Biggin Hill, the pilot landed at the helicopter owner's private landing site (Lisvane) north of Cardiff at 0830 hrs and embarked the five passengers and their luggage. The flight from Cardiff to North Wales was uneventful and the helicopter landed near Llanelidan at 0920 hrs. The field landing site was listed in the operator's company landing site directory (CLSD) with the reference code LEA2. The designated landing location was a flat area of grass adjacent to a stand of trees and a shooting lodge (Figure 1). To the northwest of the landing area the ground sloped down and away toward several isolated trees, as indicated by the chevrons in Figure 1.

LEA2 field landing site near Llanelidan
(©2023 Bluesky, Infoterra Ltd & COWI A/S, CNES / Airbus, Getmapping plc,
Maxar Technologies)

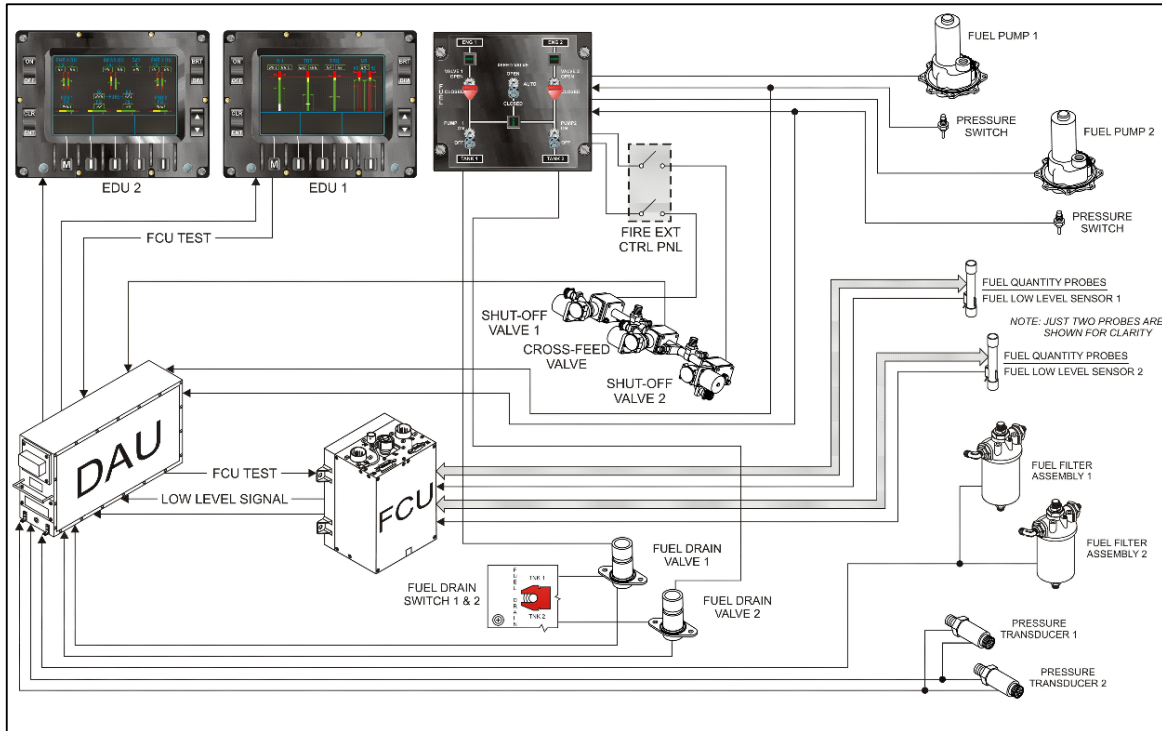
Figure 4

The fuel indicating system (Figure 4) consists of the fuel monitoring and indicating systems to provide fuel system malfunctions and system indications. The fuel indicating system gives a continuous indication of the quantity of fuel contained in the fuel tanks and the pressure in the fuel system. Five variable-capacitance fuel probes are installed inside the tanks (two probes in the left bottom tank, two in the right bottom tank, one probe in the top tank). The tanks sense the difference in the dielectric constant of fuel and air. A change in the fuel level in the tank causes a change in the probe capacitance. Two independent electrical lines supply the Fuel Control Unit (FCU) with 28 V DC electrical power. When the quantity of fuel in the tank changes, the probes send an electrical signal to the FCU, which processes it and then sends proportional output currents to the Data Acquisition Unit (DAU). The latter sends the fuel quantity signals to the No 2 Electronic Display Unit (EDU) where the fuel quantity is continuously displayed. Another function of the FCU is to continuously monitor the system for faults. The FCU has two independent channels (left and right) and faults are monitored at channel level: when the analogue output signal of either FCU channel is less than 1.93 mA, the affected fuel quantity readout displays a white box with three red dashes.

Fuel indication system schematic

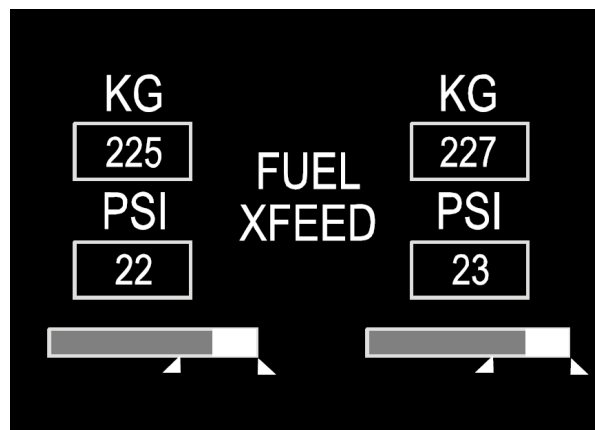
Figure 5

Fuel quantity is displayed to pilots as separate totals for the left and right tanks rather than being presented as a single combined fuel total (Figure 5). Pilots are required to mentally sum the figures to calculate the total amount of fuel on board.

EDU fuel display

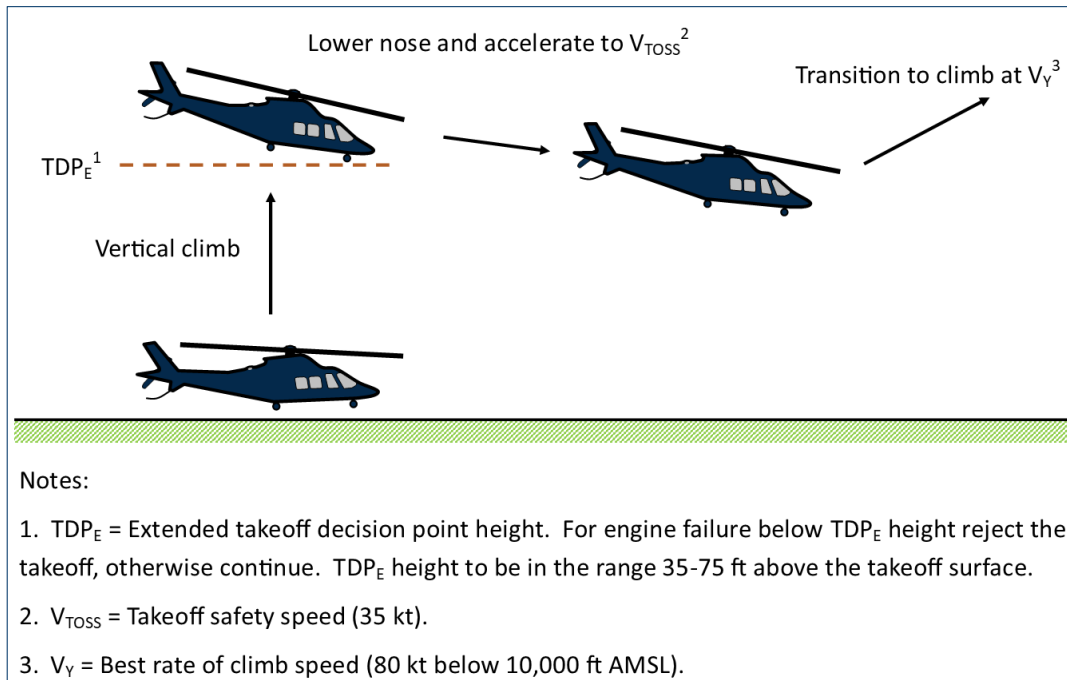
Figure 12

takeoff profile (Figure 12) which was compliant with PC1 operations and described in the RFM²⁷. This was in line with the OMB direction²⁸ that *'the Commander shall endeavour to operate the helicopter in [PC1] whenever possible thereby maximising the safety margin for the passengers at all times.'* Due to the presence of trees behind the helicopter, the pilot elected to fly a vertical rather than 'back-up' procedure which would have required an initial rearward climbing flightpath (Figure 14).

Overview of Category A ground level vertical departure profile

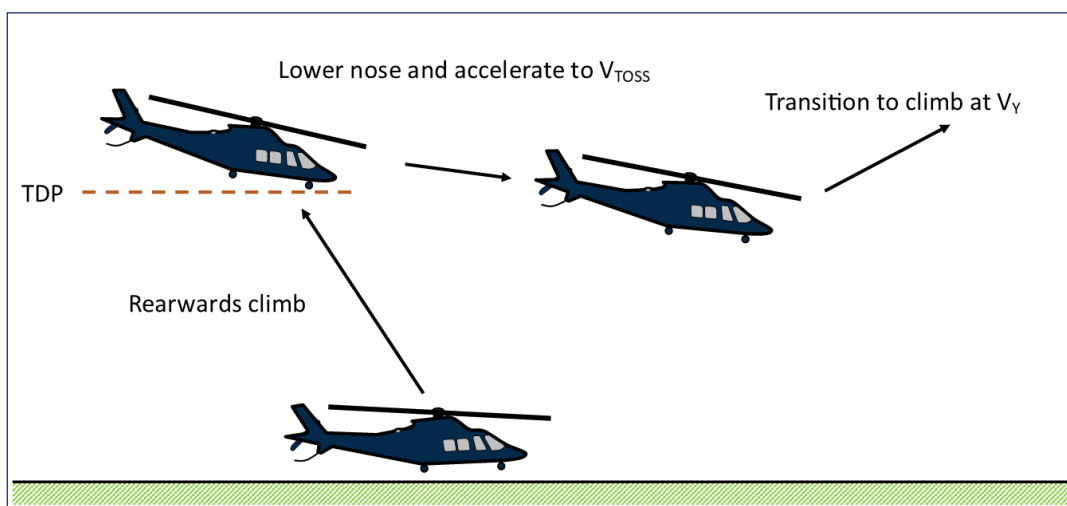
Figure 13

Overview of Category A ground level back-up takeoff procedure

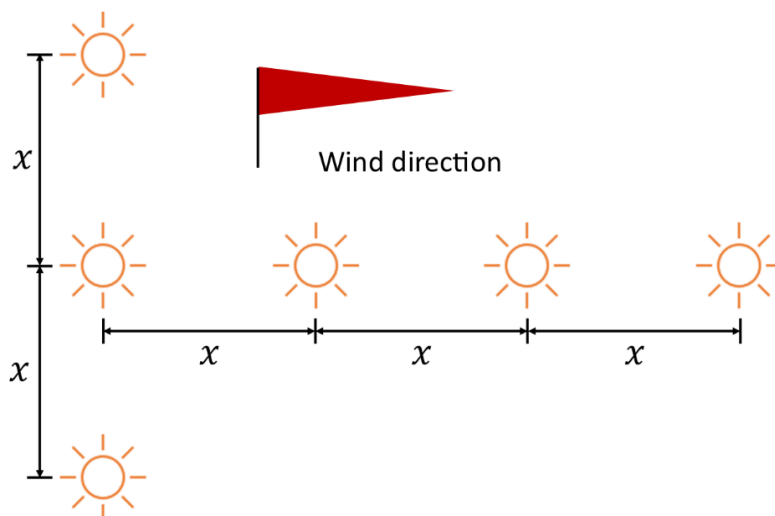
Figure 16

For pre-planned night operations at an HLS without an established lighting system, the operator had engaged a third-party contractor to deploy suitable lighting. The preferred solution was a set of portable lights laid out in the NATO-T lighting configuration as shown below in Figure 16. Deployable lighting had not been requested to support the accident flight.

Omni-directional white lights, with dimension x being approximately 10 m.

Ideally visible from 4 nm away and orientated for helicopter to approach into wind.

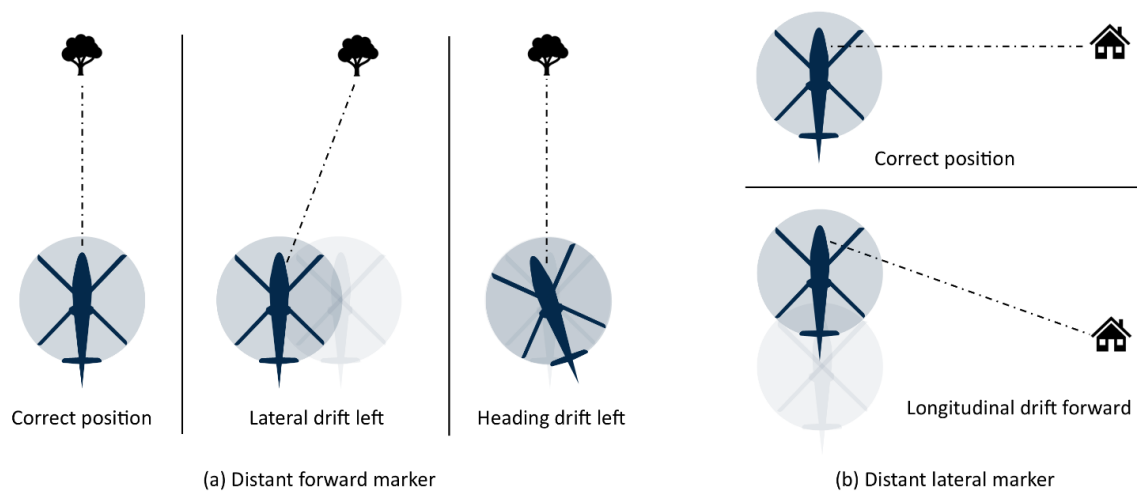
Figure 18

Helicopter pilots use visual references, referred to as 'markers,' to maintain a stable position over the ground. By picking suitably visible objects when the helicopter is established in the desired location, pilots can detect, and correct, any drift away from the target position by reference to the alignment of their markers with other objects or the cockpit structure. Normally, a distant forward marker would be used to assess heading and lateral drift, while a distant lateral marker is used to detect longitudinal drift (Figure 18). Pilots would also generally choose a close-in lateral marker for height assessment and fine position keeping.

Distant forward and lateral markers

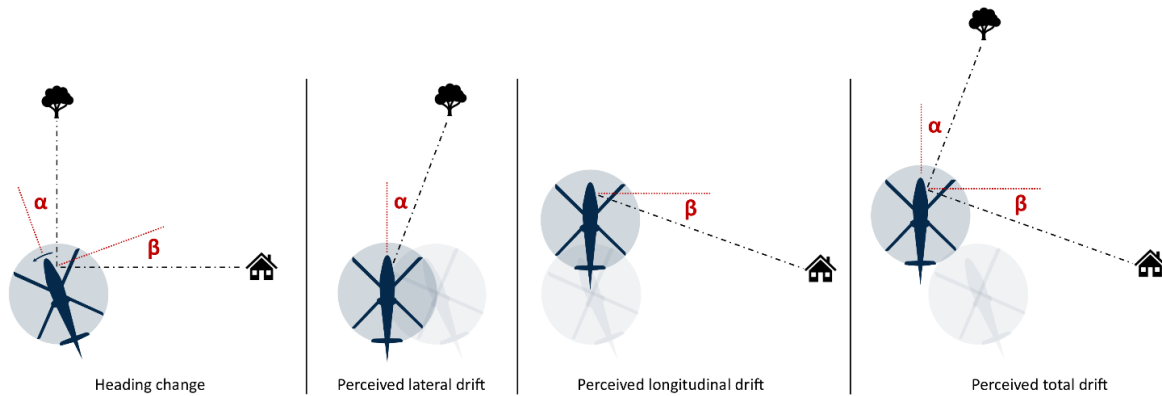
Figure 19

Heading changes affect the angular orientation of markers relative to the helicopter's longitudinal and lateral axes (Figure 19). In a degraded visual environment without two usable distant markers, it is more challenging to correctly determine if the change in marker orientation results from positional rather than heading drift.

Heading change perceived as positional drift

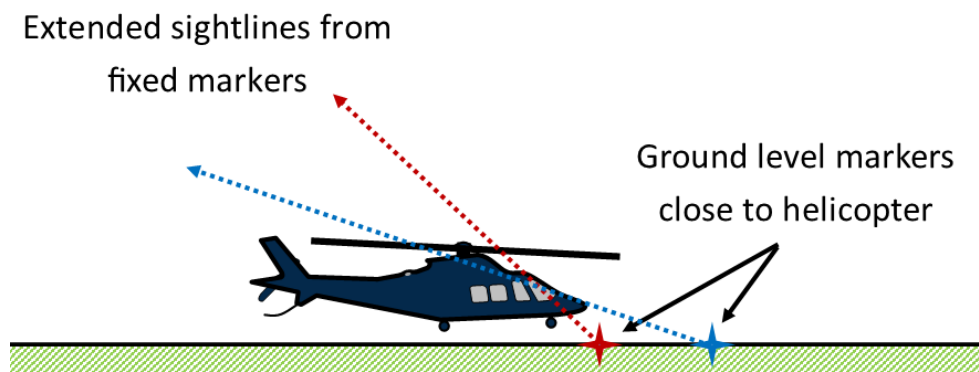
Figure 20

Visually acquiring suitable markers at night is challenging unless they are lit, there is sufficient cultural or environmental lighting (eg moonlight on a clear night) for objects to be easily seen with the naked eye or the pilot is using a night vision device. In conditions of limited visibility, such as when relying on illumination from a helicopter's external lights, pilots are more likely to pick a single identifiable ground feature close to the cockpit to use as their primary hover reference. The downward sightline from the pilot's eyes to the feature means that, if it is maintained in the same relative position when lifting, the helicopter will naturally move up and rearwards as the pilot maintains that fixed sightline (Figure 20). Without an adequate distant lateral marker any consequential rearward movement is more difficult to detect visually. The investigation heard that, at night on an unlit site, a searchlight beam directed to a close-in reference 30-60° either side of the helicopter's nose offers greater opportunity to detect rearward drift than one directed straight ahead.

Extended sightline from close-in ground level markers
