# Train damaged by collision with an object at Highdyke, Lincolnshire, 19 December 2023

## Summary of the accident

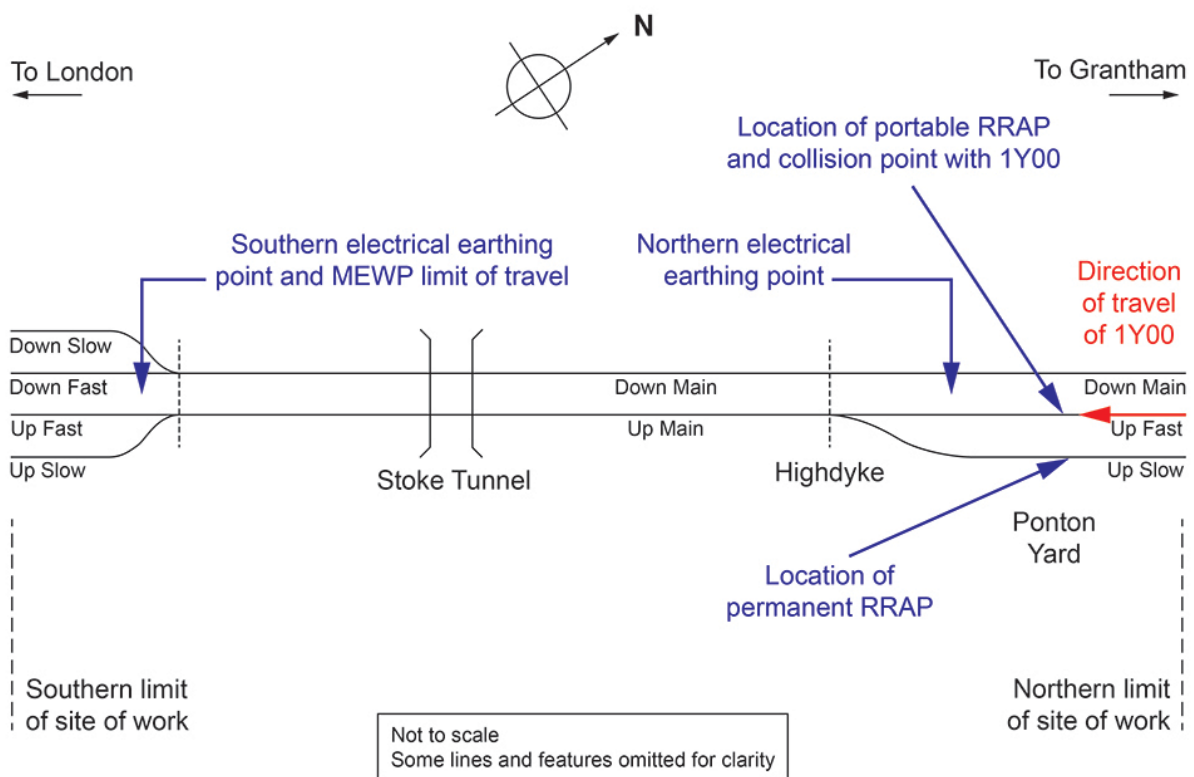
The OHLE inspection and maintenance activity was one of six sites of work within one of the work sites. This site of work had all lines blocked to service trains from south of Stoke (99 miles 550 yards), to near Grantham South Junction (102 miles 110 yards) from 01:05 hrs to 05:35 hrs.

**Line map of the site of work.**

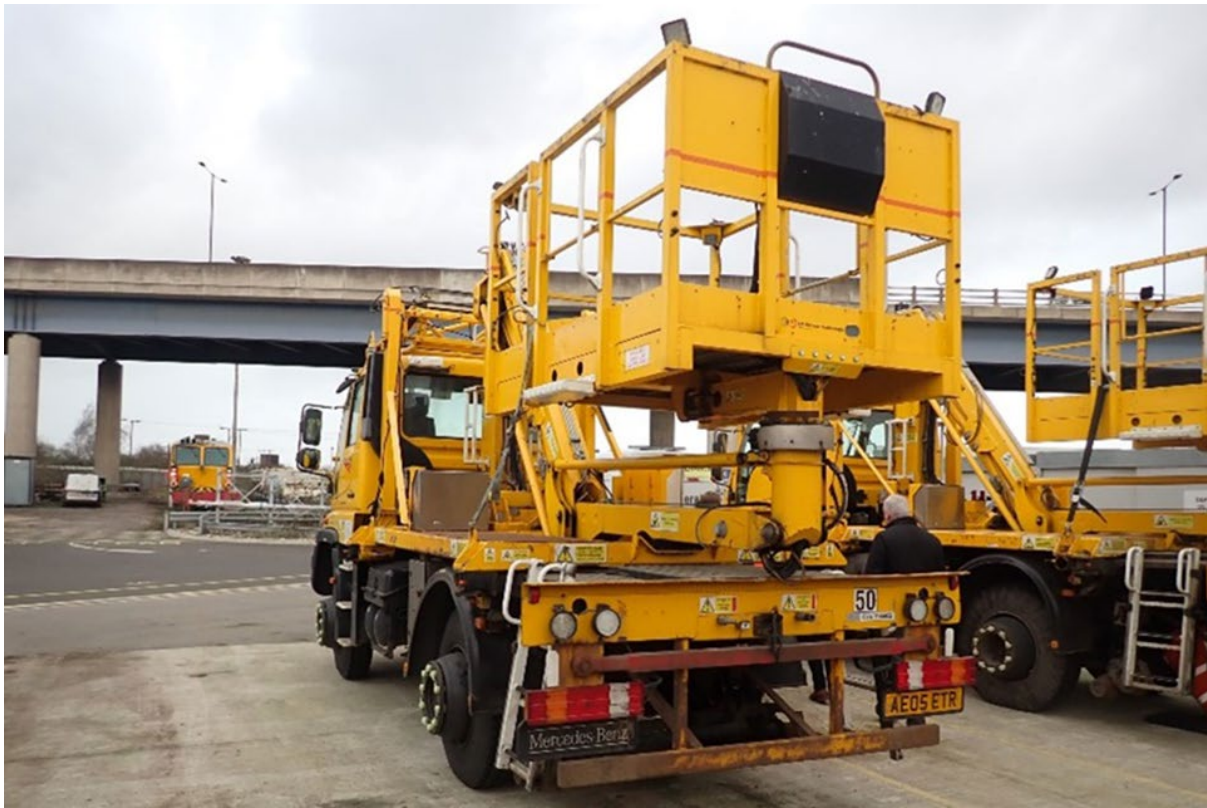
The inspection and maintenance required a mobile elevated work platform (MEWP) road-rail vehicle so that the OHLE could be examined closely. The MEWP was to access the track at Ponton Yard which is within the northern part of the site of work (101 miles 75 yards).

**A Network Rail road-rail vehicle with a mobile elevated work platform and basket as used on the East Coast Main Line for overhead line equipment inspections.**
