# ACCIDENT REPORT

REPORT NO 2/2024

## Loss of control of the powerboat *Awesome* near Little Thatch Island, British Virgin Islands on 2 October 2022, resulting in two fatalities

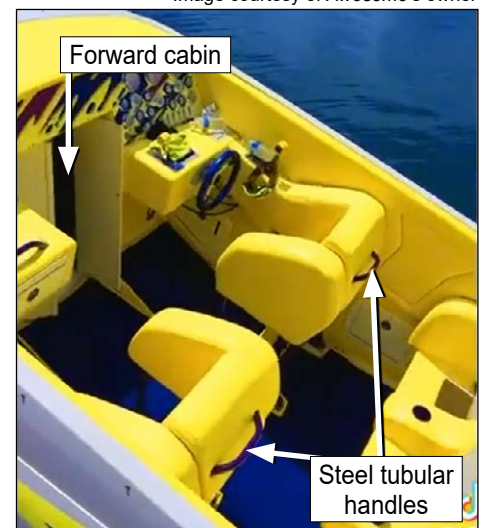
**Figure 6:** *Awesome*'s general seating arrangement

*Awesome* had seating capacity for five people. Two seats were located forward in the cockpit area, one on the port side and the other on the starboard side, which was also the driver's position. A further three seats were fitted in the aft of the cockpit, across the width of the boat (**Figure 6**).
