AAIB Bulletin

5/2024

Serious Incident

Aircraft Type and Registration:	Beech 400A, N709EL
No & Type of Engines:	2 Pratt & Whitney Canada JT15D turbofan engines
Year of Manufacture:	1992 (Serial no: RK-52)
Date & Time (UTC):	7 October 2022 at 1100 hrs
Location:	Newquay Airport, Cornwall
Type of Flight:	Private
Persons on Board:	Crew – 2 Passengers – 1
Injuries:	Crew – None Passengers – None
Nature of Damage:	Damage to mainwheel tyres
Commander's Licence:	Airline Transport Pilot's Licence
Commander's Age:	40 years
Commander's Flying Experience:	5,263 hours (of which 2,692 were on type) Last 90 days – 150 hours (of which 30 on type) Last 28 days – 47 hours (of which 4 on type)
Information Source:	AAIB Field Investigation

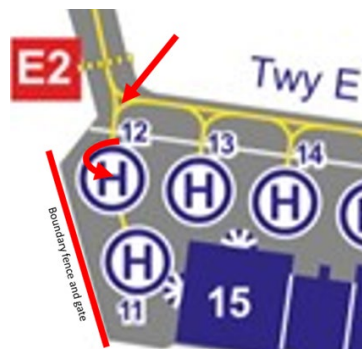
Figure 2
Parking stand positions

The only unoccupied parking stand on the apron was Stand 12 which is the closest stand to the airfield perimeter (Figure 2). Stand 11 is disused. As the helicopter ground taxied toward Stand 12 the commander was PF. He stated that he followed the yellow line off Taxiway Echo into the parking stand and then followed the outer yellow circular line (Figure 3) to the right to allow him to turn left and park facing to the east, in the same direction as the helicopter on the adjacent Stand 13.

The commander believed that following the outer line would give the helicopter clearance from obstacles. However, as the helicopter turned left toward the centre of Stand 12 the main rotor blades struck a lamp post that was located on the street just outside the airfield perimeter. The path followed by the helicopter is illustrated in a sketch provided by the commander (Figure 3).
