Rail Accident Investigation Branch

Rail Accident Report

Uncontrolled evacuation of a partially platformed train at Clapham Common London Underground station, 5 May 2023

Report 03/2024
May 2024

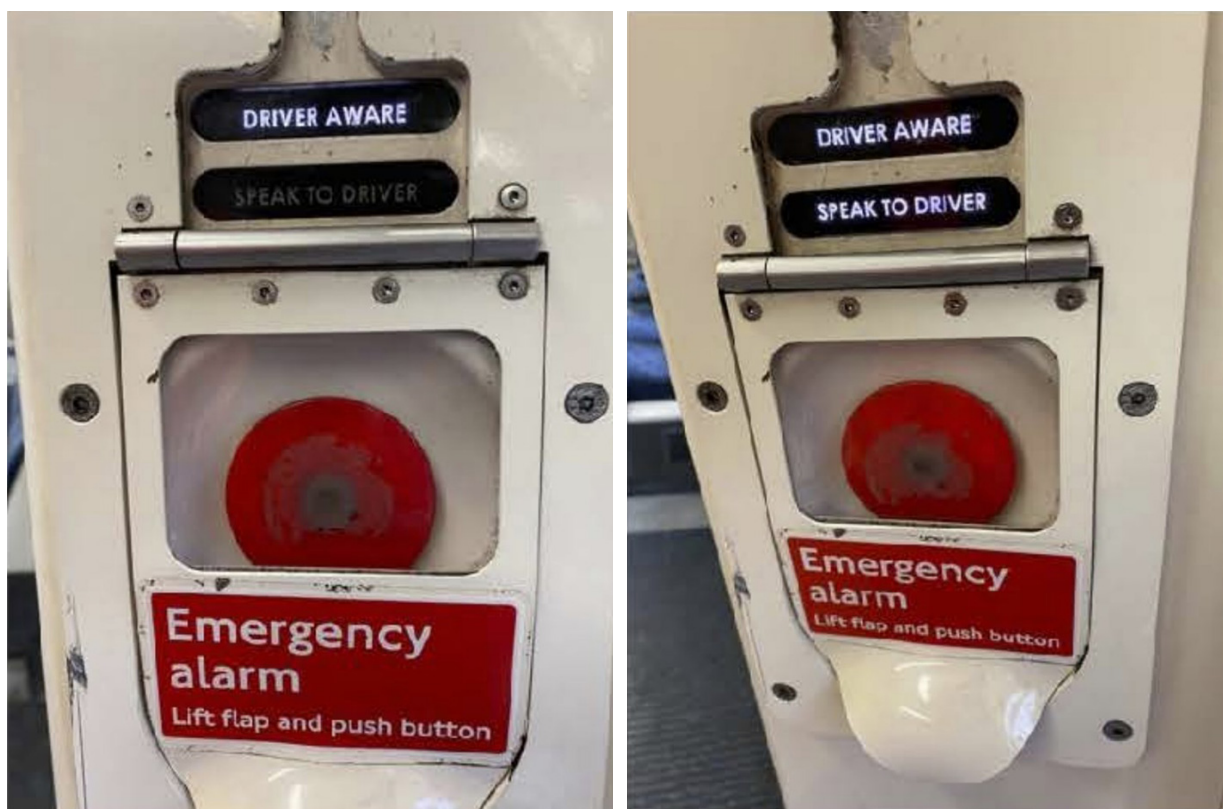
Figure 8: PEA system alarm on 1995 stock. Once activated the 'Driver Aware' sign will light up (left-hand side image). When the train operator answers the PEA the 'Speak to Driver' sign illuminates (right-hand side image) allowing the passenger to communicate with the train operator. Courtesy of LUL.

24 1995 stock trains are also fitted with a public address system which allows the train operator to make announcements to the whole train. Public address announcements are not recorded. After the incident, LUL tested the PEA and public address systems on train 065 and all were found to be in correct working order.

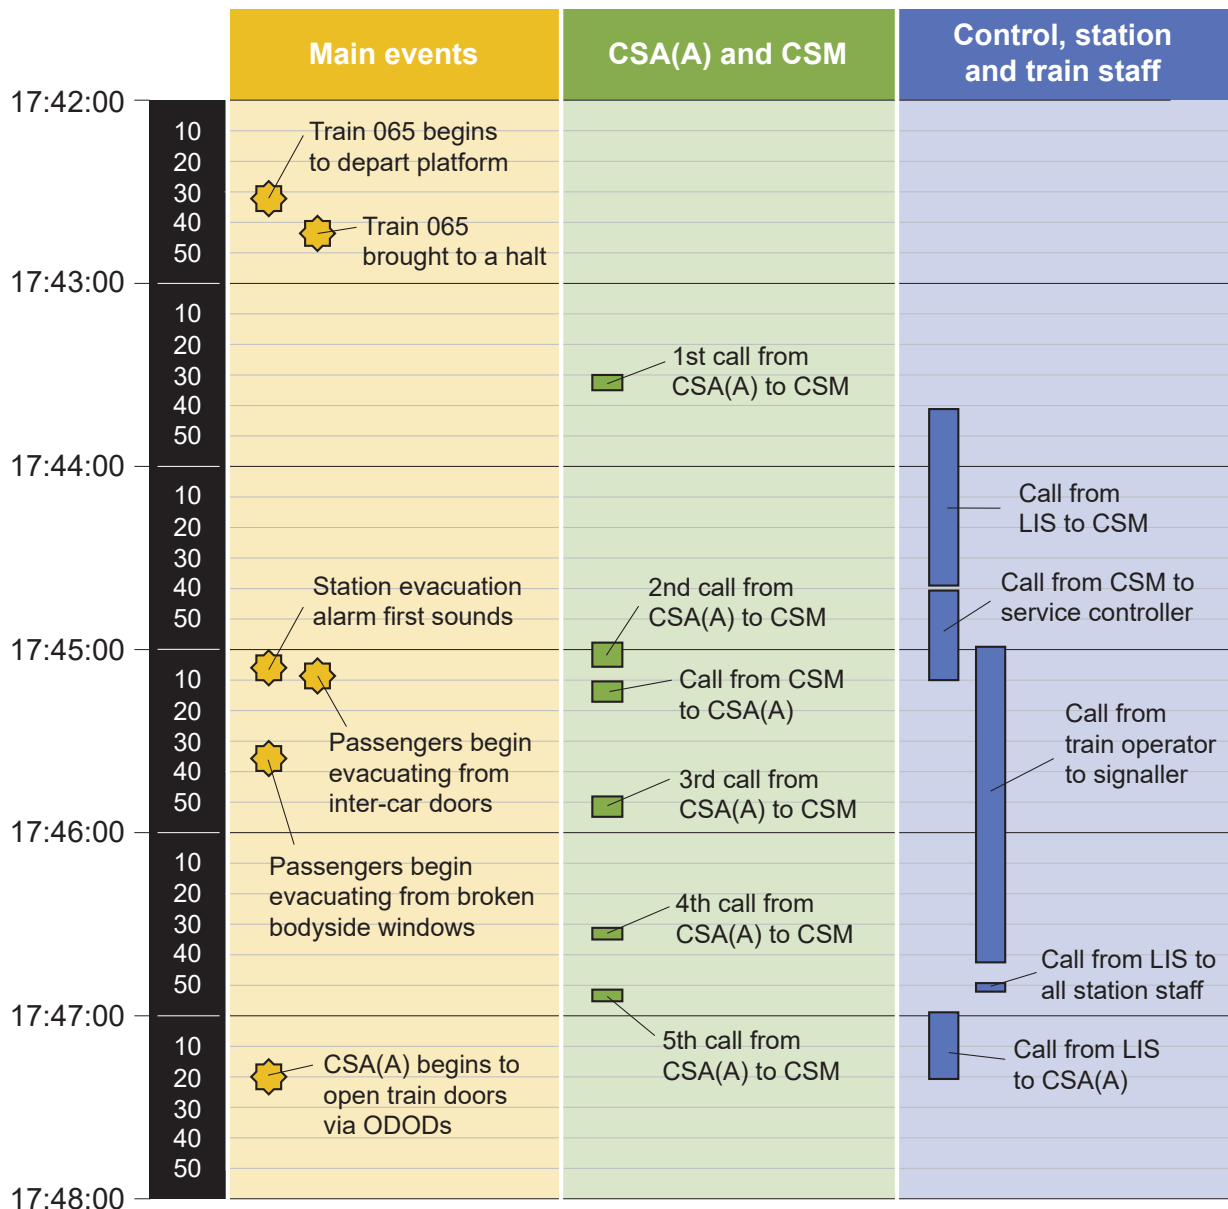
Figure 12: Timeline of communications between operational staff. The yellow section outlines some of the main events during the incident (not directly associated with communication). The green section outlines the communication between the CSM and CSA(A). The blue section outlines the communication between control staff and other operation staff (including train operator, CSM and CSA(A)).
