Serious Incident

Aircraft Type and Registration:	ATR 72-202, G-NPTF	
No & Type of Engines:	2 Pratt & Whitney Canada PW121 turboprop engines	
Year of Manufacture:	1990 (Serial no: 192)	
Date & Time (UTC):	17 January 2023 at 0425 hrs	
Location:	East Midlands Airport	
Type of Flight:	Commercial Air Transport (Cargo)	
Persons on Board:	Crew - 2	Passengers - None
Injuries:	Crew - None	Passengers - N/A
Nature of Damage:	None	
Commander's Licence:	Airline Transport Pilot's Licence	
Commander's Age:	37 years	
Commander's Flying Experience:	5,264 hours (of which 583 were on type) Last 90 days - 74 hours Last 28 days - 28 hours	
Information Source:	AAIB Field Investigation

Synopsis

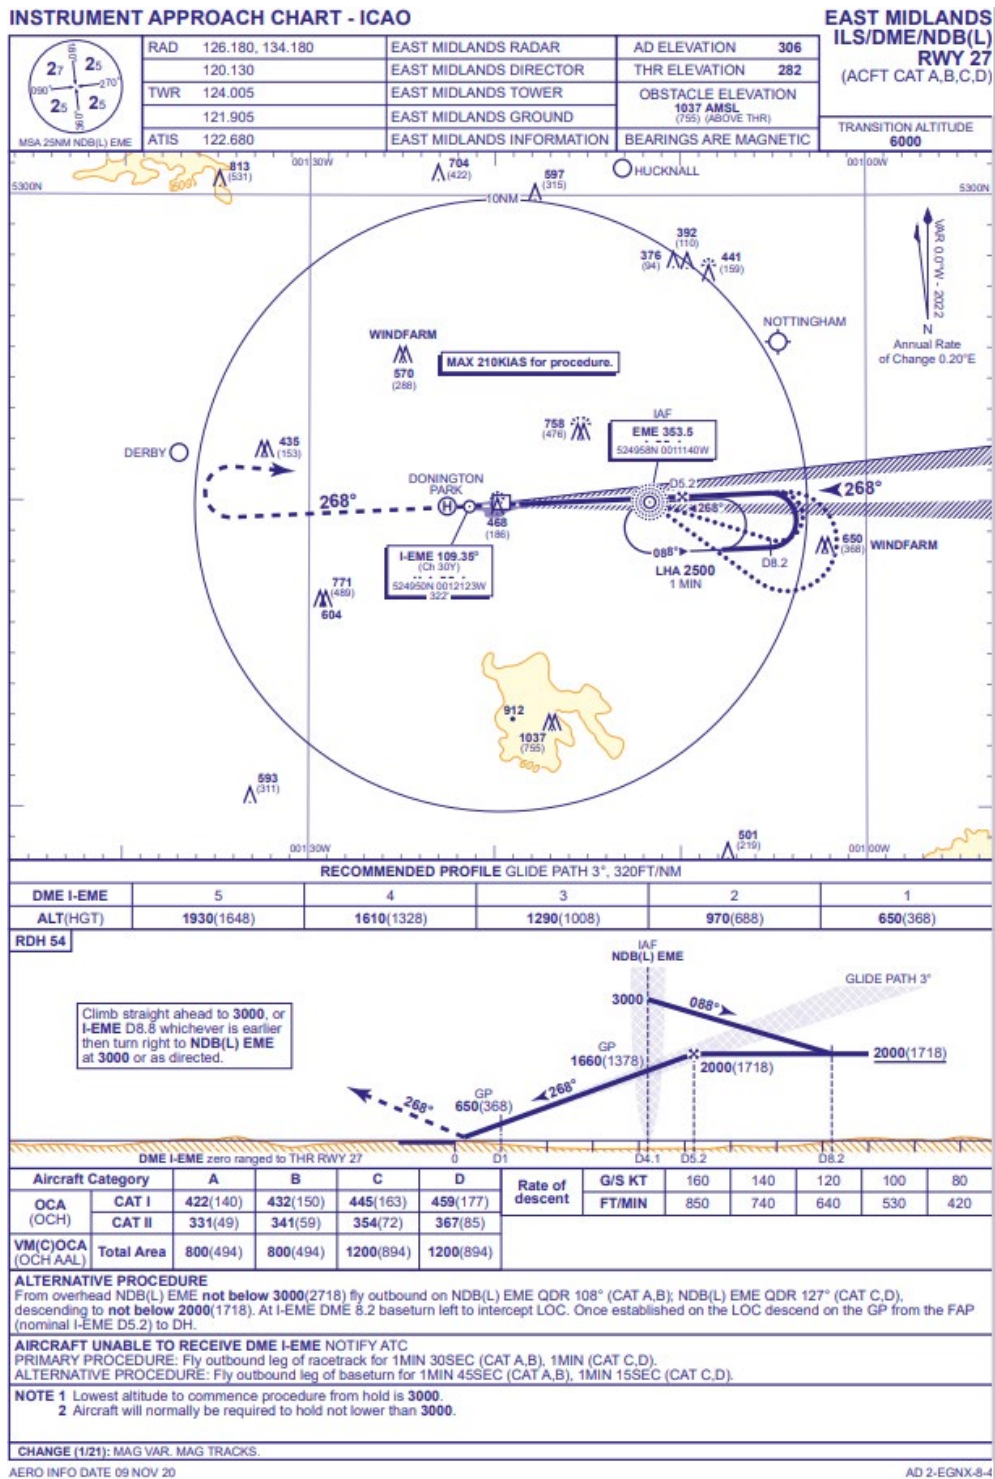
Figure 1
EMA approach and go-around procedure

During the climb, both pilots recalled hearing sounds that they believed were electrical relays cycling. The Autopilot Display Unit (ADU) was also flashing, and the crew were unable to reselect the AP. In the climb, the crew realised that the flap setting had remained at 30 and they retracted the flaps; flaps limiting speed was not exceeded. They carried out the published go-around procedure, levelled at 3,000 ft amsl and turned right toward the EME NDB (Figure 1).

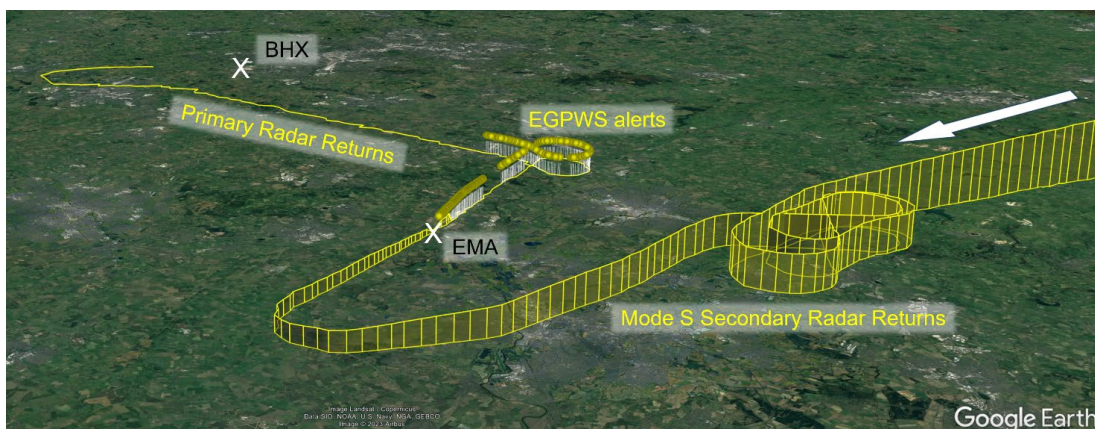
Figure 3
Radar ground track

The recorded radar track data for the approach to EMA and diversion to BHX are shown in Figure 3. The radar returns for the approach to EMA included pressure altitude from the aircraft's Mode S transponder. However, from 0418:51 hrs, with the aircraft within a nautical mile of the runway at about 400 ft aal, the transponder transmissions stopped, and the aircraft continued to be tracked only by primary radar for the remainder of the flight.

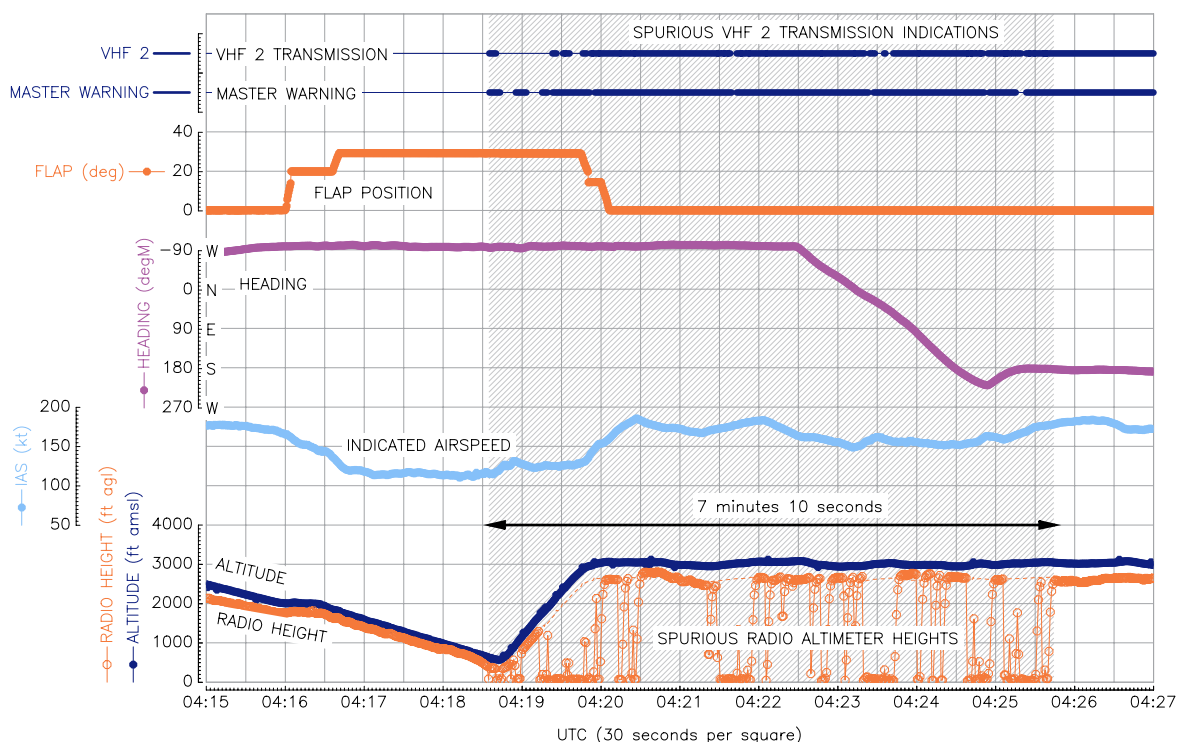
Figure 4
FDR data

Data from the aircraft's FDR show that just after 0418 hrs the master warning alert was triggered together with spurious VHF 2 transmission indications and radio altimeter heights (Figure 4). The spurious heights were intermittent over a period of seven minutes and ten seconds and were sufficiently low to trigger 31 EGPWS alerts (2x "PULL UP", 6x "TERRAIN, TERRAIN", 6x "TOO LOW TERRAIN", 12x "TOO LOW GEAR" and 5x "BANK ANGLE, BANK ANGLE") – see Figure 3 for the location of the aircraft during these EGPWS alerts. Note that some of the alerts coincided with others so not all were heard on the CVR.

The spurious VHF 2 transmission indications continued for the remainder of the flight as did the master warning alert.

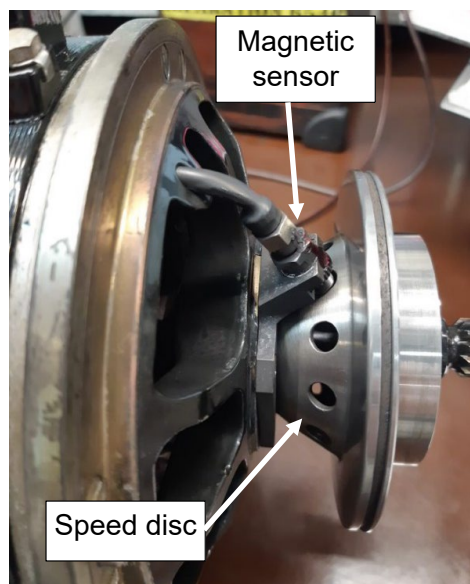
Figure 7
Speed sensor assembly

NH is measured by a magnetic speed sensor within the starter-generator. The speed sensor assembly consists of a conical metal speed disc with equally spaced holes around its face, that is attached to the unit's rotating shaft, and a magnetic sensing unit positioned above the disc (Figure 7). As the disc rotates, the holes pass the sensor. The change in air gap detected as the holes pass creates an output voltage from the magnetic sensor which is translated into the NH measurement.
