Rail Accident Investigation Branch

Rail Accident Report

Runaway wagon at Kineton, Warwickshire 25 May 2023

Report 04/2024
May 2024

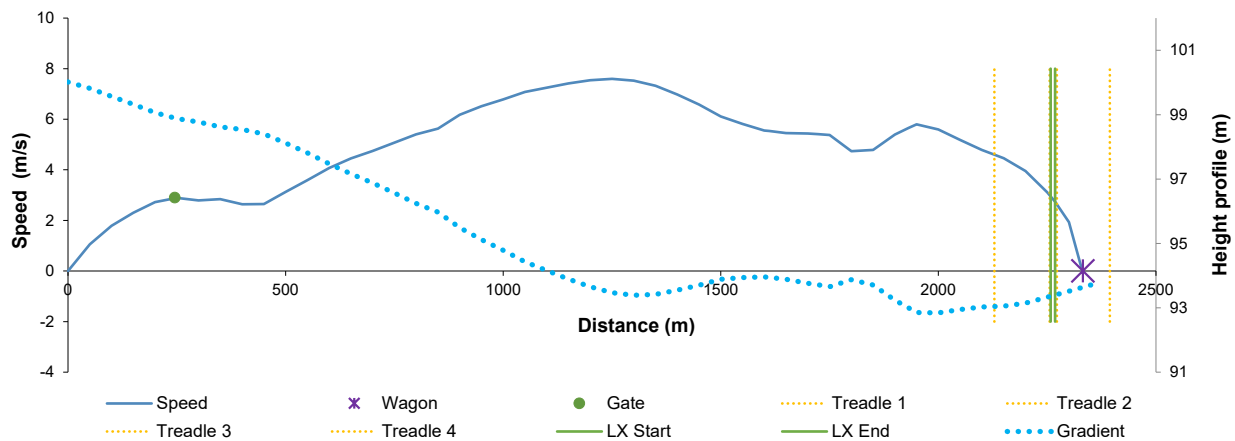
- 13 The track gradient falls from the Fenny Compton side of the exchange sidings towards the south-west end of the sidings. Once outside the sidings, the gradient continues to fall, before passing over a small incline and eventually starting to rise steadily approximately 250 metres on approach to level crossing 6 (figure 4).

Figure 4: Gradient profile of the track traversed by the wagon during the runaway.

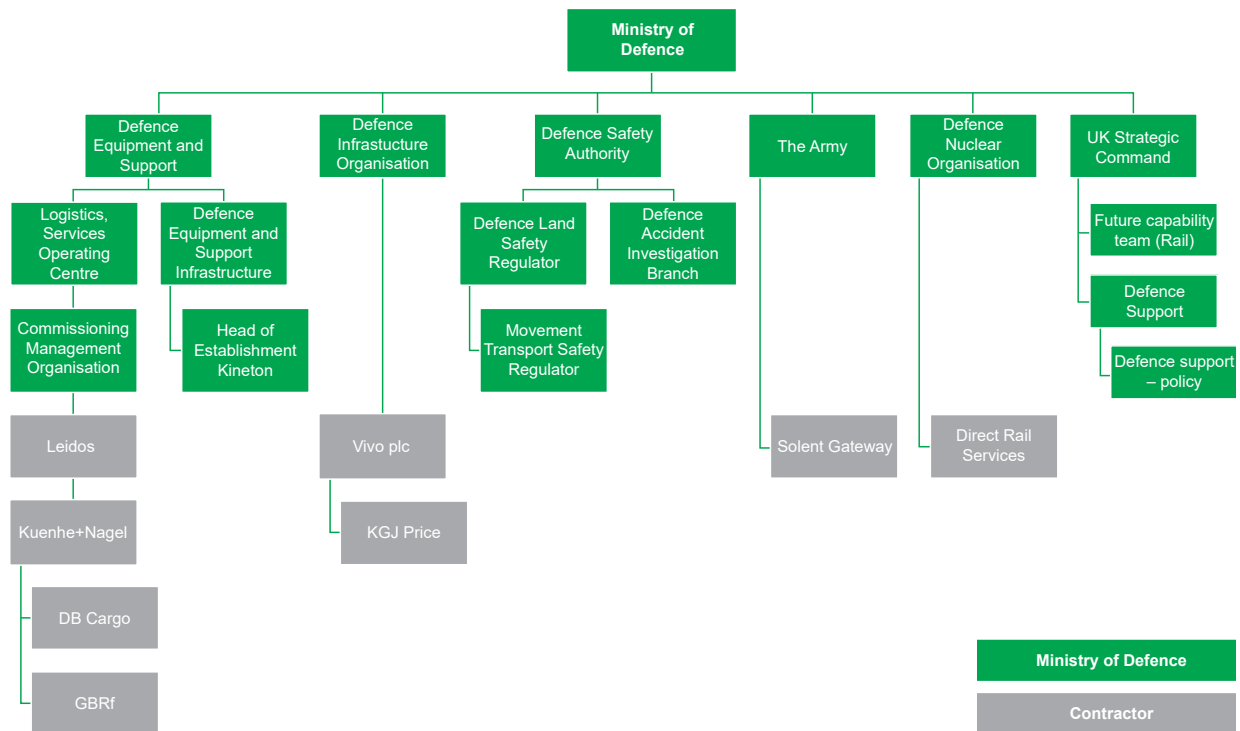
Figure 5: Organisation chart showing the relationships between different departments and companies involved in delivering defence rail. The chart shows that several contracts are managed across different MOD departments. Not all of the MOD departments listed have equivalent status within MOD.

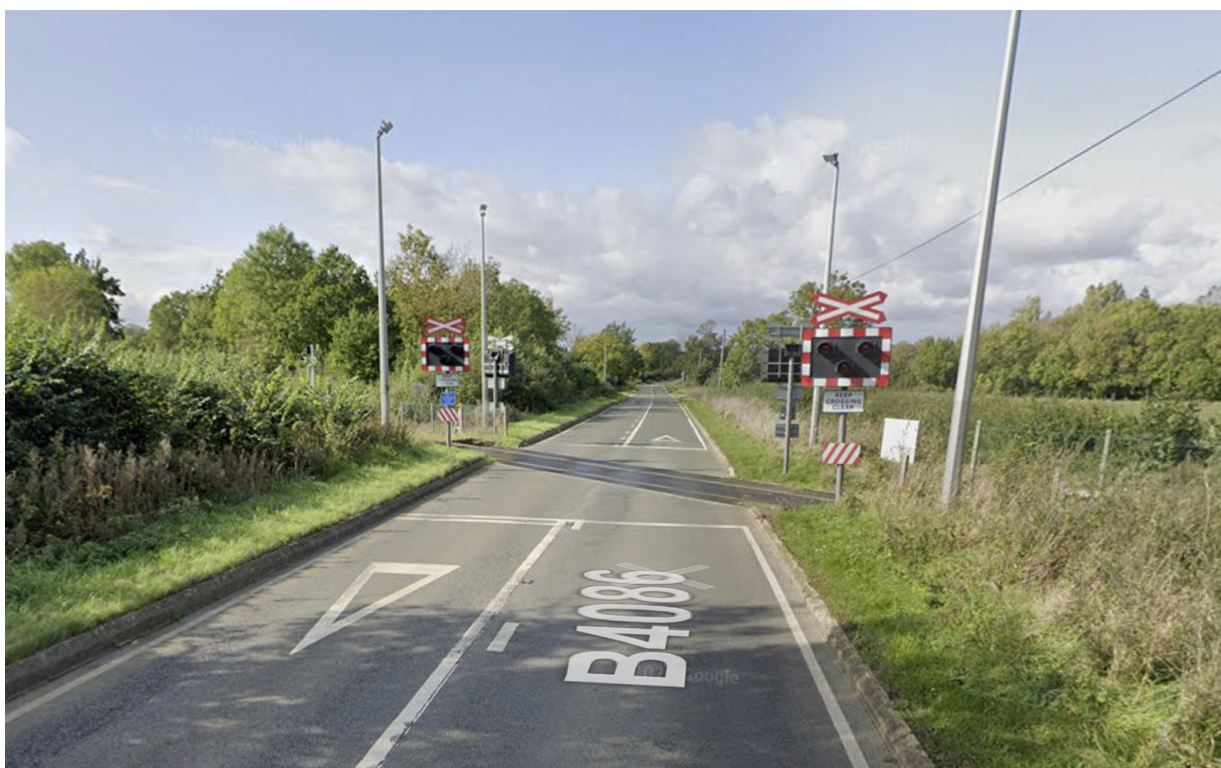
- 26 Level crossing 6 is an AOCL type of crossing, which protects road traffic with wig-wag traffic signals (figure 6). Depending on the time of day, floodlights and an audible warning may also be used to warn road users of the approaching train.³

Figure 6: Level crossing 6 approached from the east. The wagon moved over the crossing from right to left (courtesy of Google Street View).
