Report on the investigation of the
grounding of the roll-on/roll-off passenger ferry

Alfred

at Swona Island, Pentland Firth, Scotland

on 5 July 2022

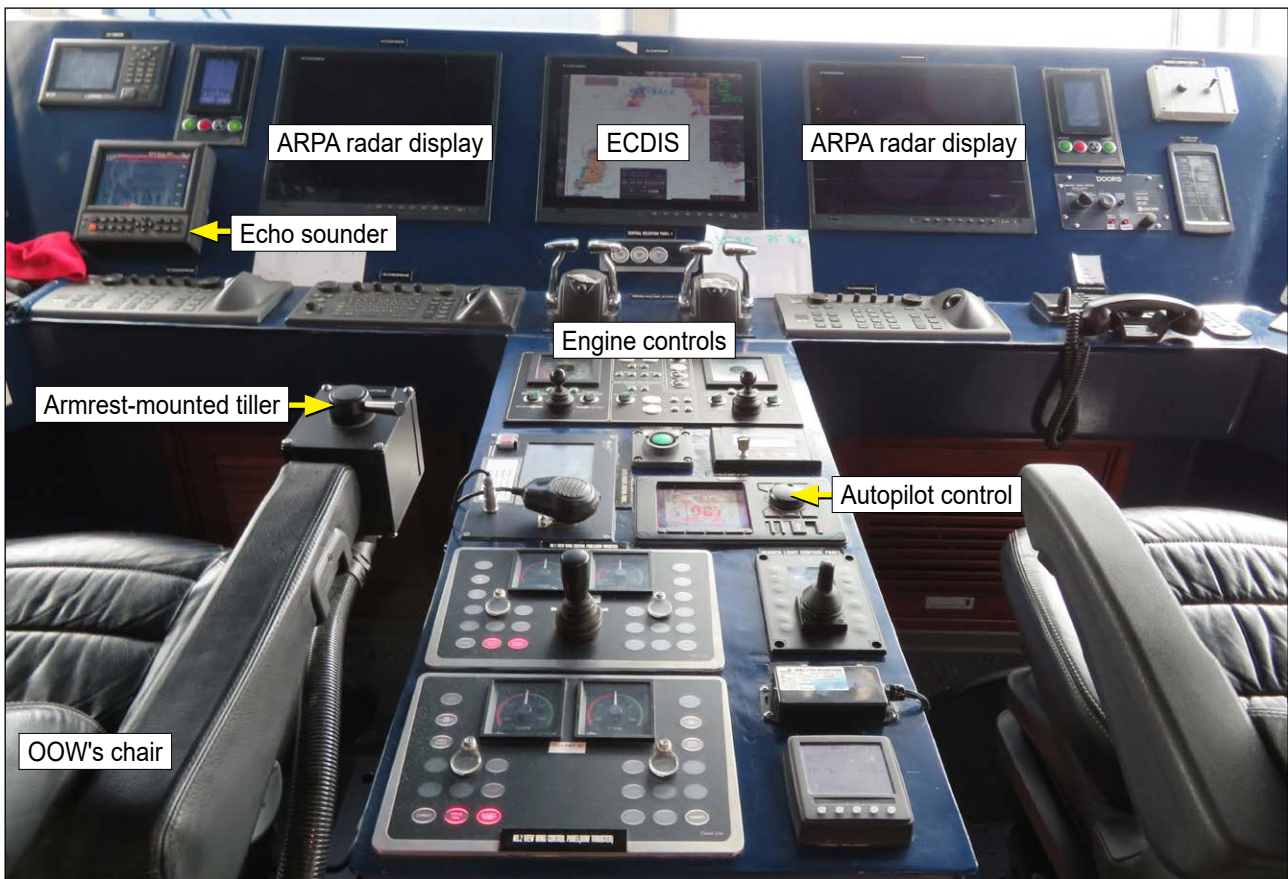
Figure 2: Central OOW console, showing the layout of steering controls and navigational equipment

At 1356, the master changed from autopilot to manual steering as *Alfred* passed the southern end of Swona Island and through the tidal race. He then used the armrest-mounted tiller (see **Figure 2**) to con the vessel and navigate *Alfred* along the east coast of Swona Island, remaining about 250m from shore. Shortly afterwards, *Alfred* entered the Orkney Islands Council Harbour Authority's area of responsibility.

Alfred's propulsion consisted of four diesel engines, two in each hull, each driving a fixed pitch propeller. The engines were controlled from the bridge. The vessel also had four rudders controlled by either autopilot, an armrest-mounted tiller located on the right-hand side of the OOW's seat (see **Figure 2**) or bridge wing control modules. *Alfred* had a turning diameter of approximately 280m and a stopping distance of about 400m.

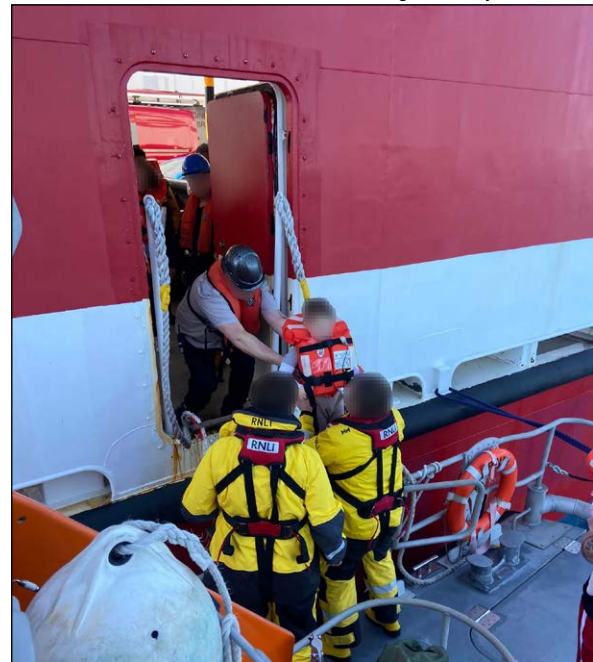
Figure 5: Passengers transferring from *Alfred* to the Longhope all-weather lifeboat

At 1440, the Longhope ALB came alongside *Alfred's* starboard pilot door and the crew of both vessels started to transfer 42 passengers from the ferry to the lifeboat via the starboard pilot ladder (**Figure 5**). The Thurso ALB arrived at the scene shortly afterwards and held off while waiting to be called alongside by *Alfred's* master.
