Accident

Aircraft Type and Registration:	Schleicher ASW 24, G-CHBB	
No & Type of Engines:	None	
Year of Manufacture:	1991 (Serial no: 24132)	
Date & Time (UTC):	16 August 2023 at 1125 hrs	
Location:	Dunstable Airfield, Bedfordshire	
Type of Flight:	Private	
Persons on Board:	Crew - 1	Passengers - None
Injuries:	Crew - 1 (Fatal)	Passengers - N/A
Nature of Damage:	Unknown	
Commander's Licence:	Sailplane Pilot's Licence and BGA Certificate	
Commander's Age:	47 years	
Commander's Flying Experience:	131 hours (26 of which were on type) Last 90 days - 11 hours Last 28 days - 0 hours	
Information Source:	AAIB Field Investigation

Synopsis

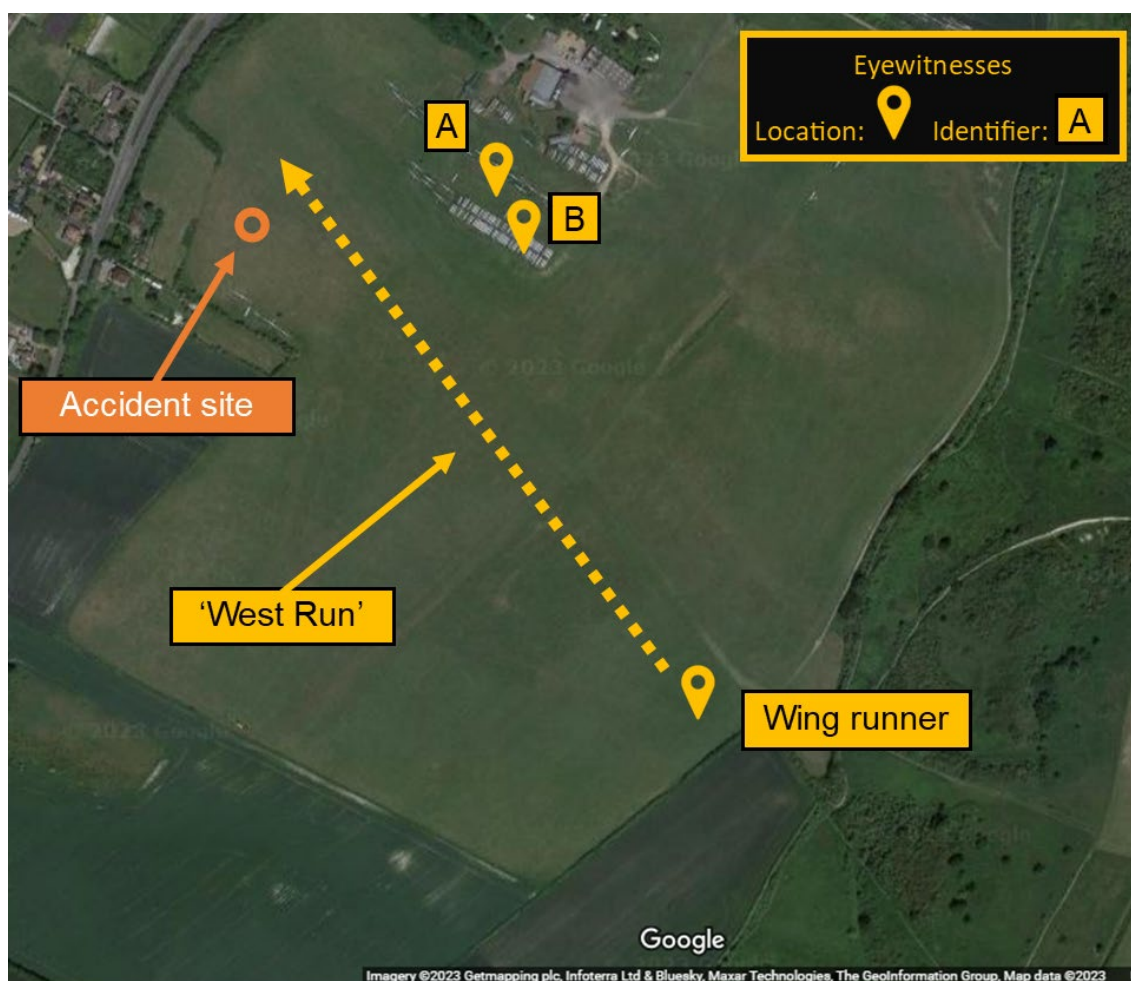
Figure 1

Overview of Dunstable Airfield, including accident site and eyewitness locations

The nature of the glider’s flightpath after it lifted off caused Eyewitness A, who was stood on the airfield near the row of glider trailers (Figure 1), to become concerned about the general vertical stability of the tow. He reported that, at an early stage in the aerotow, while the tug was still on the ground the glider was flying “unusually high.” The glider pilot initially corrected by descending to an estimated 0.5-1.0 m above the ground but this correction was followed by a second vertical oscillation. After the tug got airborne the glider appeared to settle into a more stable position, climbing with the tug. When it was passing through a height of approximately 6 m the glider appeared to pitch forward slightly. This pitch forward was preceded by a noise that the witness thought could have been the sound of the glider’s towing hook back releasing¹ due to the oscillations. This witness reported then being “surprised to see the glider pitch up to re-establish the original climb angle, at [which] point the tug was clearly accelerating away” from the glider. He watched the glider climb to approximately 25 m where it levelled to a “normal gliding attitude” before entering a steep left turn. He estimated that the glider completed approximately 90-120° of turn before its nose dropped into an “almost vertical” attitude from which it did not recover. The witness ran to the accident site to find the pilot “still strapped in but unconscious.”

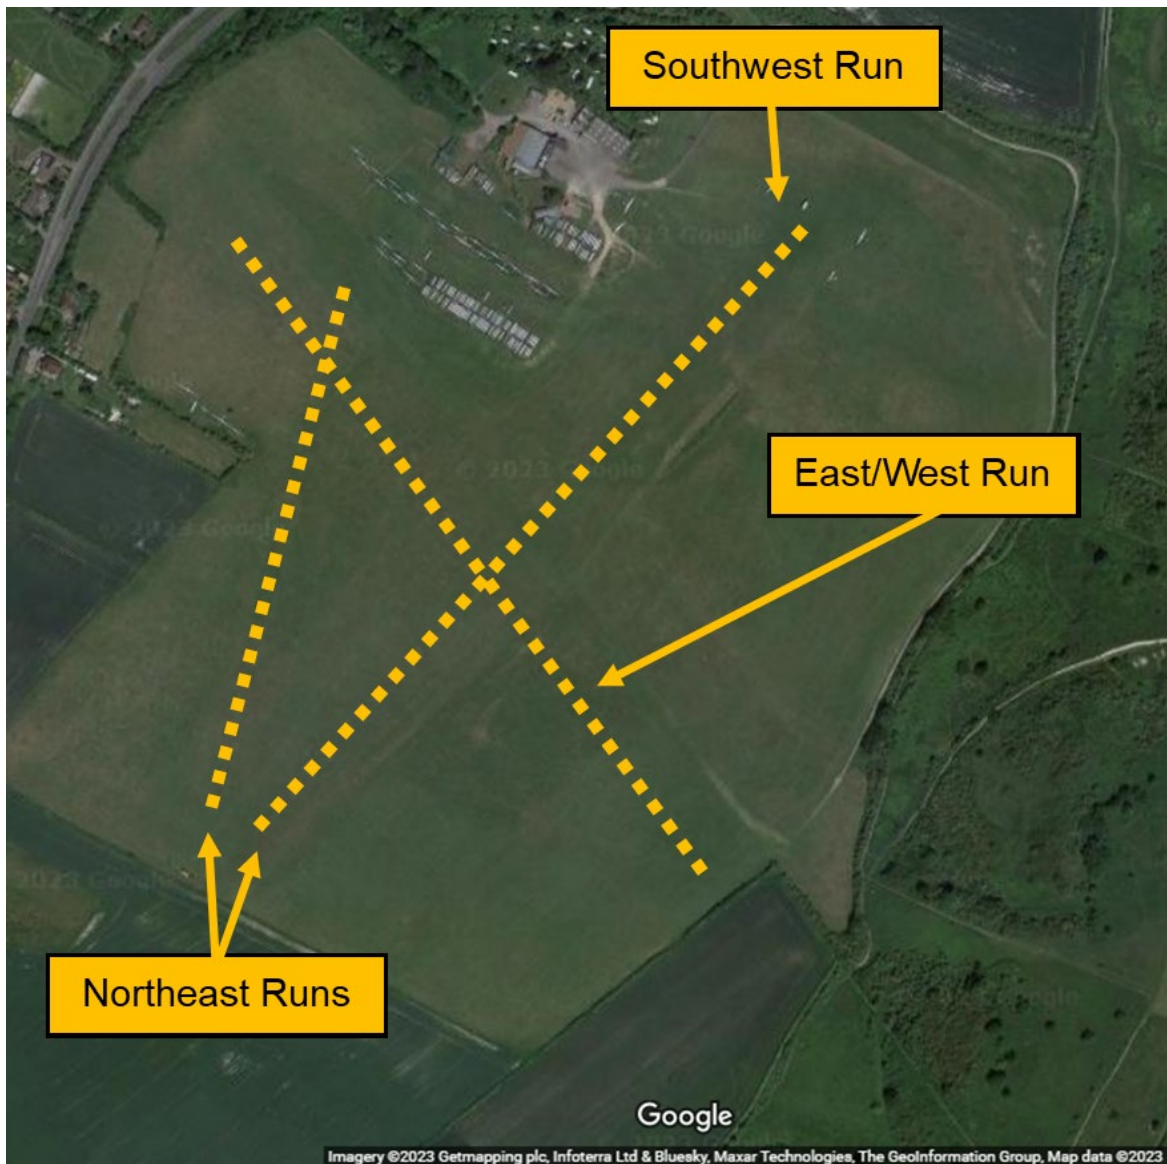
Figure 5

The airfield occupies an undulating site on lower ground to the west of Dunstable Downs. The resident gliding club oversees flying from the airfield including winch, aerotow and self-launch operations. There are several launching tracks (runs) available depending on the wind conditions on the day (Figure 5). On 16 August 2023, the wind was relatively light and blowing from a northerly direction, so the Northeast Run was operational for winch launching. There were a significant number of pilots participating in a club cross-country event and requiring aerotow launches, therefore a grid-style launch queue was established on the West Run to deconflict from the winch launching activities. As a further measure, the winch cables were retracted and no winch launching took place during the period when the aerotow run was active.

Launch runs at Dunstable Airfield

Comparing a notional 2:43 glide angle with the terrain elevation profile of the West Run (Figure 3), from the earliest point of disconnection it could theoretically have been possible for the pilot to glide past the B489 and land in the open fields beyond. While theoretically possible, this may not have been apparent to the accident pilot at the time and it was not known if he was aware of the successful field landing carried out by the KA 6E pilot in July 2022. From below 100 ft agl the pilot would have been largely unsighted on the low ground and intervening hazards between the airfield boundary and the fields to the northwest (Figure 5), making it more challenging to judge the distance to a safe landing area.

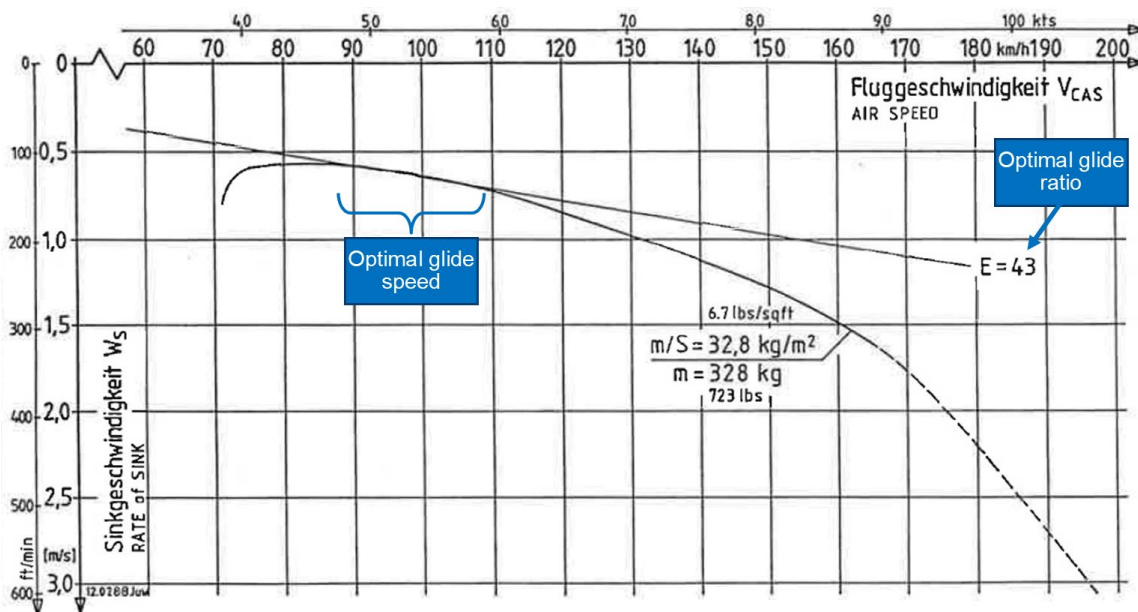
Figure 10

The performance chart at Section 5.3 of the glider's FM (Figure 10) indicated that, in a clean configuration and wings level flight, airspeeds in the range 47-59 kt would generate a maximum achievable glide ratio of 1:43, equating to an approximate descent gradient of 2.32%. Either side of that speed range gliding performance would be reduced.

ASW 24 FM performance chart (courtesy of manufacturer)
