Rail Accident Investigation Branch

Rail Accident Report

Runaway wagon at Kineton, Warwickshire 25 May 2023

Report 04/2024
May 2024

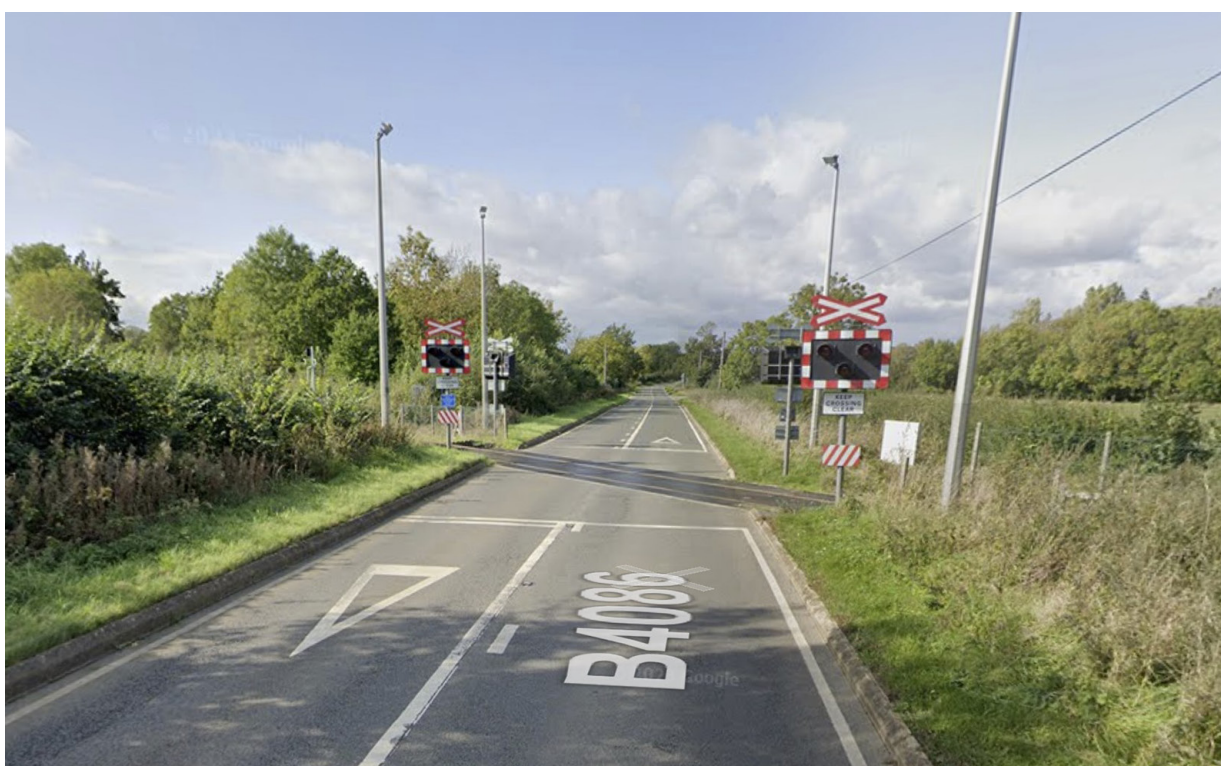
- 26 Level crossing 6 is an AOCL type of crossing, which protects road traffic with wig-wag traffic signals (figure 6). Depending on the time of day, floodlights and an audible warning may also be used to warn road users of the approaching train.³

Figure 6: Level crossing 6 approached from the east. The wagon moved over the crossing from right to left (courtesy of Google Street View).

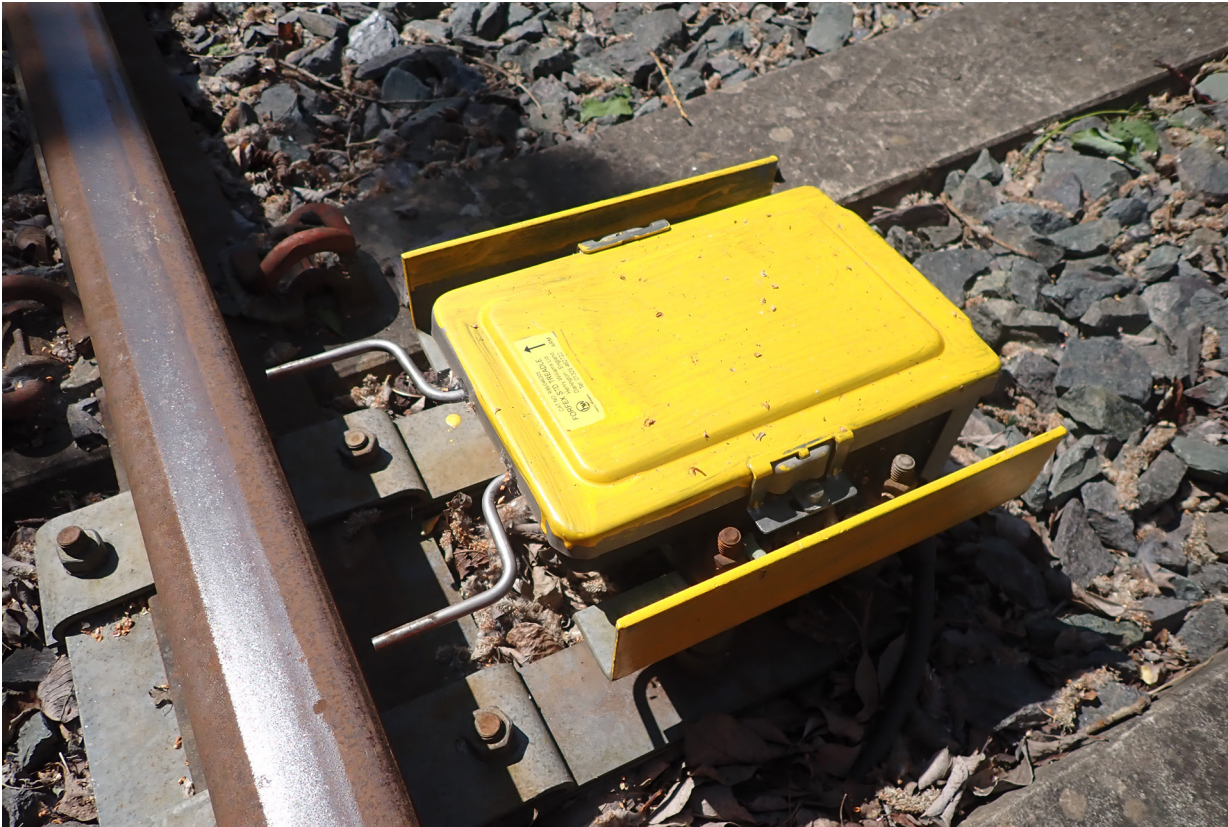
- 27 The wig-wag signals are triggered by a rail vehicle's wheel engaging a strike-in treadle as it approaches the crossing (figure 7). The level crossing system proves, through electrical relays, that the wig-wags are operating correctly and then displays a white light to indicate this to train drivers, allowing them to take the decision that it is safe to pass over the crossing.
- 28 There is a whistle board located adjacent to the strike-in treadle. This is an instruction to train drivers to sound their horn which may give road traffic additional warning that a train is approaching. However, in the event of a wagon runaway this additional protection is not available.

Figure 7: Level crossing 6 strike-in treadle when approached from the exchange sidings.
