Annual Safety Review 2023

Air Accidents Investigation Branch
Farnborough House
Berkshire Copse Road
Aldershot
Hampshire
GU11 2HH.

CIAA Foreword

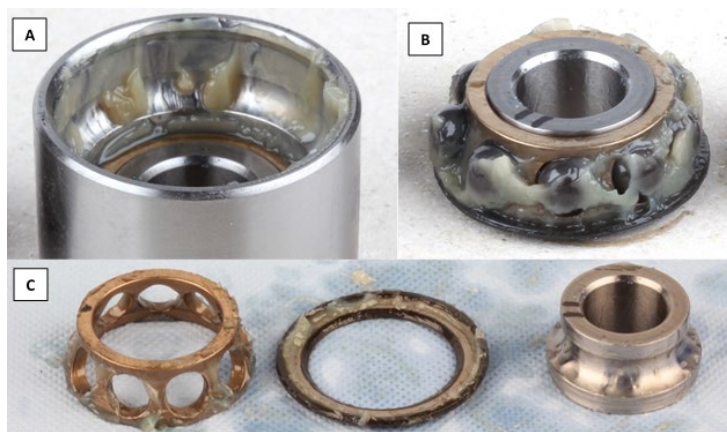
Bearing in new condition - (A) Housing and outer race, (B) inner race, cage and balls assembled, (C) cage, seal and inner race disassembled

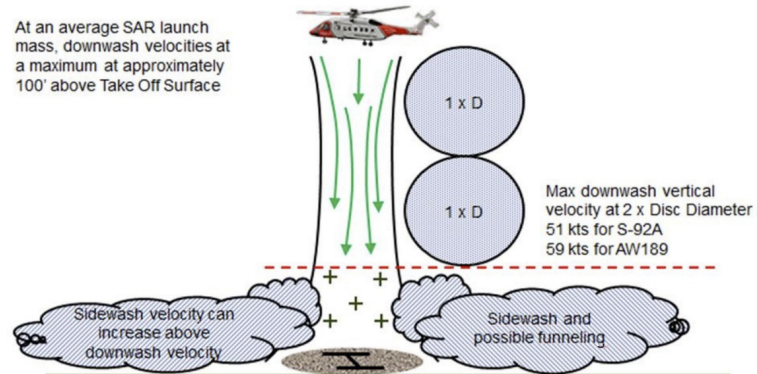
Diagram of maximum downwash from operator's OM

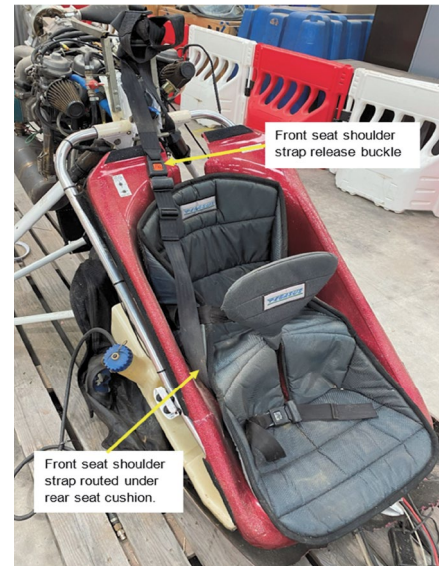
It is likely that the pilot started the engine with the hand throttle open and did not free the base bar, reduce the rpm or stop the engine before the aircraft became airborne. The pilot might have survived if he had been wearing his shoulder (diagonal) harness and his helmet had been designed to protect him from rotational head injuries.

Front seat diagonal shoulder strap positioned as found at the accident site

The finding from Royal Air Force Centre for Aviation Medicine (RAFCAM) and the experience of the AAIB that there is a greater risk of serious and fatal injury when a shoulder strap is not worn during an accident, is contrary to the CAA's position that a properly worn lap strap, in combination with a safety helmet, provides adequate protection.

Safety Recommendation 2023-038

It is recommended that the UK Civil Aviation Authority review the suitability of the Configuration Specific Provision in British Civil Airworthiness Requirements, Section S 1307 (a) Miscellaneous equipment which states, 'except that only a lap strap need be provided for front seat occupants of a weight-shift controlled aircraft'.

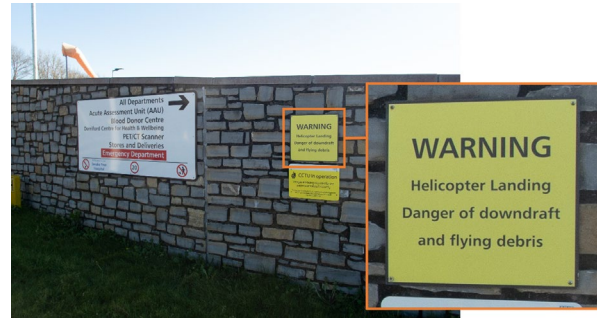
The helicopter, G-MCGY, was engaged on a Search and Rescue mission to extract a casualty near Tintagel, Cornwall and fly them to hospital for emergency treatment. The helicopter flew to Derriford Hospital (DH), Plymouth which has a Helicopter Landing Site (HLS) located in a secured area within one of its public car parks. During the approach and landing, several members of the public in the car park were subjected to high levels of downwash from the landing helicopter. One person suffered fatal injuries, and another was seriously injured.

Warning sign on the perimeter of the HLS

Following this accident, Safety Actions are being taken by the helicopter operator, Derriford Hospital and NHS England Estates to control and mitigate the risk.

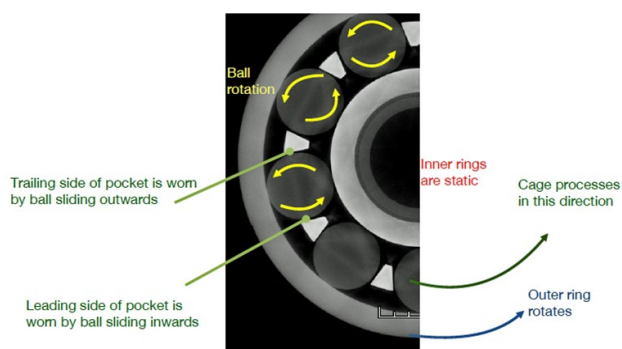
Rotation of balls and cage within the bearing

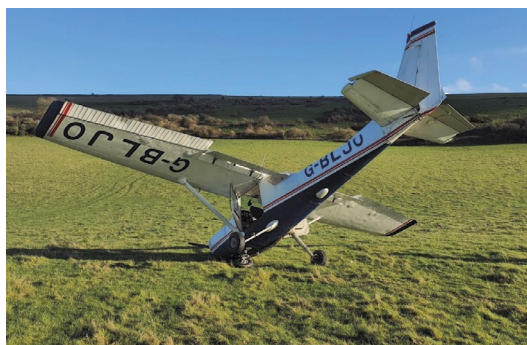
G-BLJO Accident site

While on late downwind the engine started coughing and losing power. The pilot carried out some checks, but the engine subsequently lost all power. He picked a field and glided to it but touched down nosewheel first causing the nose landing gear leg to collapse. The pilot had recently practised forced landings with an instructor and this likely contributed to the safe outcome. An aircraft examination did not reveal any faults, and the conditions were conducive to serious carburettor icing at any power, but the cause of the loss of power could not be determined.

The maintenance organisation's engine and fuel system examinations did not reveal any faults, although the engine core had yet to be examined. The conditions were conducive to carburettor icing at any power, so this was a possible cause, but no conclusive cause could be determined.

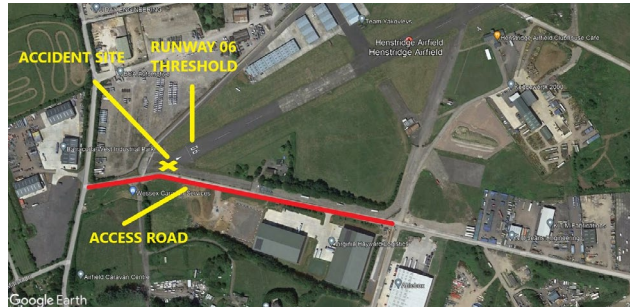
Henstridge Airfield and accident site

Late in the final approach to Henstridge Airfield, which is unlicensed, the aircraft struck a heavy goods vehicle on a road which crossed the undershoot. The aircraft then struck the ground inverted, short of the runway. The pilot sustained only minor injuries, but the passenger was seriously injured.

The aircraft was on a standard 3° approach path when it struck the lorry.

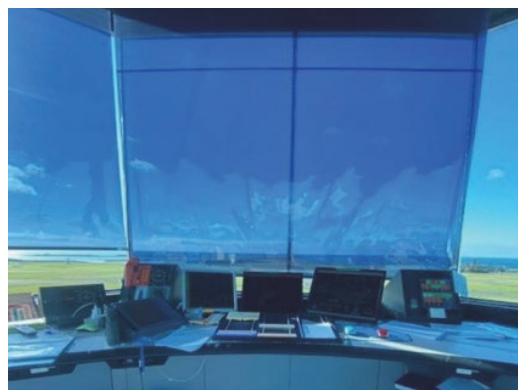
View of Runway 03 approach with similar glare and sunblind position as the incident (Photograph from the ATS unit's investigation report on the incident)

- The ATSU has published a reminder to controllers to monitor all stages of an aircraft's final approach to recognise when an aircraft might be incorrectly or dangerously positioned. It intends to provide TRM training for all members of the ATS section and to replace the VCR sun blinds if a better solution can be found.

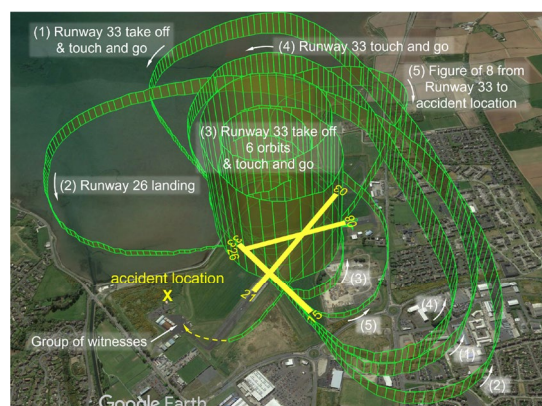
On the evening of 19 July 2022, two pilots were flying circuits around Newtownards Airport in G-ENVV an Aeroprakt Vixxen. After approximately 20 mins of circuits they flew a low pass parallel to Runway 03 followed by a steep right turn passing over several people on the ground. Recorded data showed the aircraft passed over the people with 70° angle of bank at 72 ft above the ground. During this turn the aircraft was seen to descend and hit the ground.

Flight path of accident flight

The investigation could not determine exactly why the aircraft descended in the turn but no defects could be found with the aircraft or engine. There was evidence that the aircraft's electronic displays lost power before the accident and this could have caused a distraction. However, it was being flown in a manner that exposed the aircraft, the occupants and the people on the ground to a high risk of an accident.

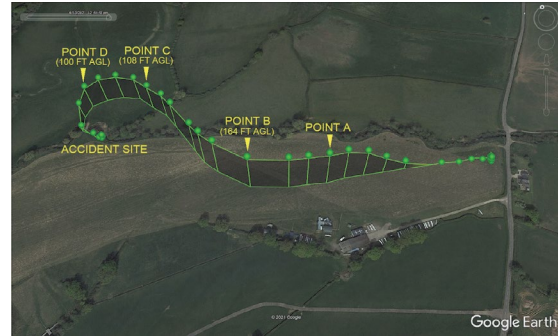
The accident occurred during a simulated failed winch launch. The glider was initially flown away from the airfield at a low height and, whilst turning back to land, stalled and collided with trees on the edge of the airfield. Both occupants were seriously injured. With assistance from the British Gliding Association (BGA), the gliding club has taken several safety actions to improve elements of the club's operation.

Recorded GPS flightpath of aircraft

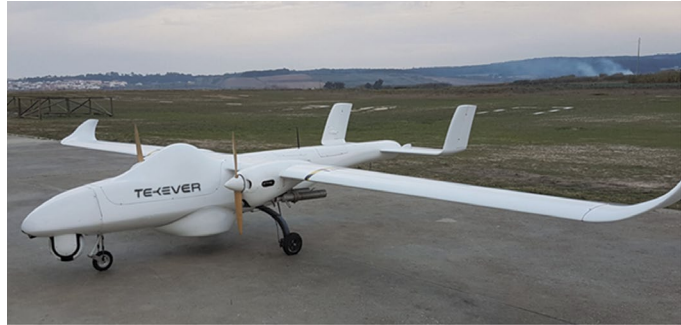
Tekever AR5 Evolution

The unmanned aircraft encountered a loss of the communications link due to a fault in the Satcom antenna, such that it was not under the direct control of the remote pilot for a period of several minutes. In accordance with contingency procedures, the aircraft entered a holding pattern and the communications link was subsequently re-established. The remainder of the flight proceeded without incident.

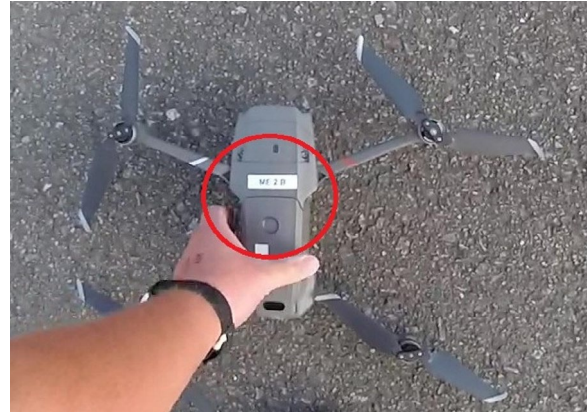
The UAS was being used in a police operation over an abandoned building near a public car park and train station. During hover over the building the aircraft's motors stopped and the aircraft fell vertically with no prior warning to the remote pilot. The aircraft struck the roof of the building and the battery separated. Recorded data indicated that the battery probably disconnected in flight. This could have been caused by the battery not having been fully latched prior to takeoff, or the latching mechanism or battery being worn from repeated use resulting in an in flight disconnection.

Image from the pilot's bodycam prior to takeoff

- The operator has shared the learning from this accident with all its UAS pilots and reminded them of their responsibility to turn on their body worn camera before they carry out the UAS pre-flight checks so that the checks are captured, and of their responsibility to take time on the UAS checks that are completed at a local air base to ensure the aircraft is fit for use.
- They also planned to reinforce the briefing of observers, and to carry out routine checks of the batteries.
