Rail Accident Investigation Branch

Rail Accident Report

Runaway wagon at Kineton, Warwickshire 25 May 2023

Report 04/2024
May 2024

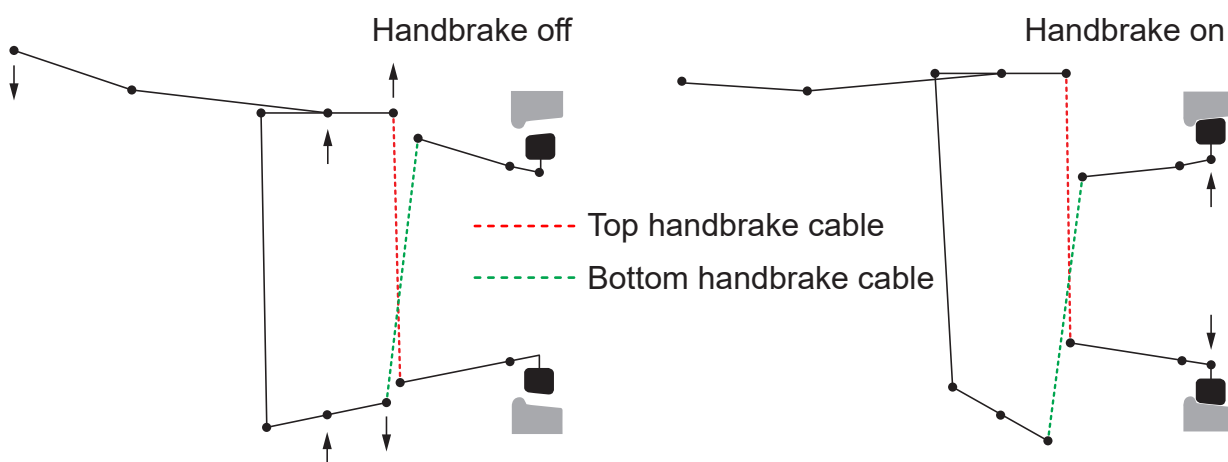
84 Effective handbrake operation was reliant on a single handbrake cable that if broken meant the system provided no brake force while indicating that the handbrake was on.

85 The FAA wagon's handbrake is applied by turning a control wheel on the outside of the wagon. This control wheel transmits a turning force down to a threaded bar which runs longitudinally down the centre of the wagon. The handbrake indicator on the side of the wagon takes a feed from this threaded bar and indicates only the position to which the control wheel has been turned. The handbrake indicator does not confirm the application of the brake blocks on the wheels. The turning force from the central bar is then translated, through a series of pivots, into a pulling force acting on a pair of Bowden cables (known as handbrake cables). These cables act together to pull on another pivot to push the brake blocks onto the wheels (figure 8). This brake block force is only applied to two wheels.

Figure 8: Handbrake moving from a 'brake off' to 'brake on' position with the handbrake cable intact.

86 Because the cables need to work together, if one of the cables fails or becomes disconnected then the handbrake will cease to apply any force to either of the brake blocks. In this condition, however, the handbrake indicator will still show that the handbrake has been applied (figure 9).

88 The handbrake cable was mechanically overloaded, leading to its failure.
