AAIB Bulletin

6/2024

Aircraft Type and Registration:	Airbus A321-253NX, G-OATW	
No & Type of Engines:	2 CFM International SA LEAP-1A33 turbofan engines	
Year of Manufacture:	2020 (Serial no: 10238)	
Date & Time (UTC):	4 October 2023 at 1151 hrs	
Location:	London Stansted Airport	
Type of Flight:	Commercial Air Transport (Passenger)	
Persons on Board:	Crew - 11	Passengers - 9
Injuries:	Crew - None	Passengers - None
Nature of Damage:	Damage to several cabin windows and impact damage to the left horizontal stabiliser	
Commander's Licence:	Airline Transport Pilot's Licence	
Commander's Age:	54 years	
Commander's Flying Experience:	4,905 hours (of which 2,300 were on type) Last 90 days - 128 hours Last 28 days - 27 hours	
Information Source:	AAIB Field Investigation

A cabin window was seen to be loose shortly after takeoff and several windowpanes were missing after the aircraft landed. The windowpanes fell out because they had been damaged by infrared energy emitted by high-intensity lights during a filming event the previous day.

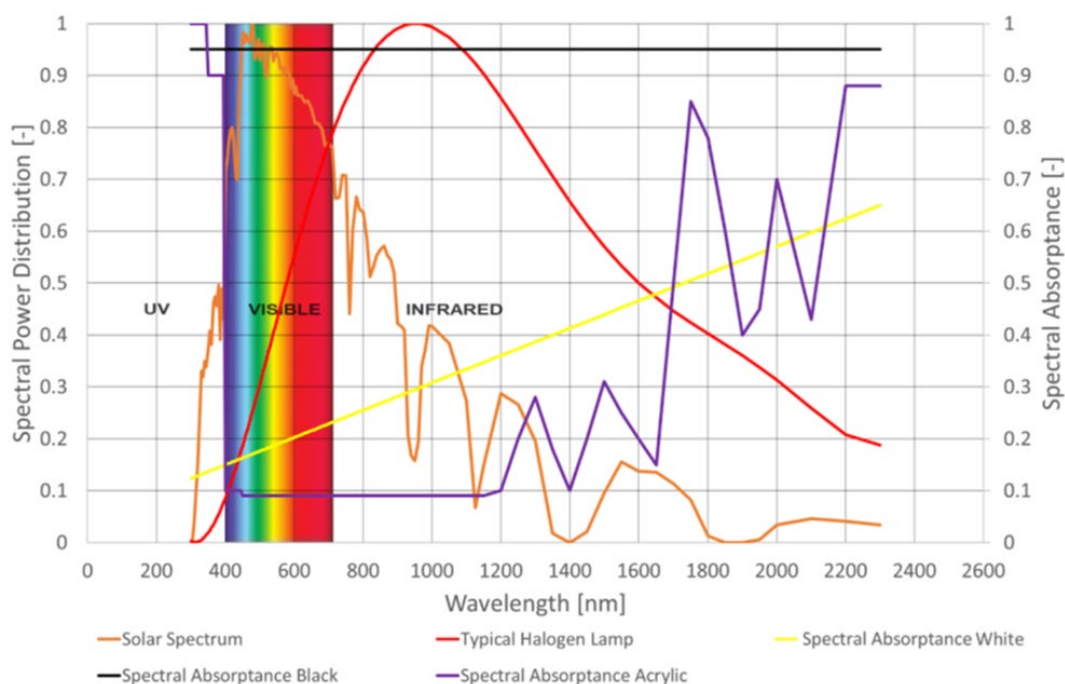
Figure 13

A typical spectral power distribution for a halogen bulb⁸ shows that most of the energy is in the infrared (IR) wavelengths (Figure 13). Energy from the sun is filtered by the atmosphere, dust and humidity, and mostly arrives at lower altitudes in the visible spectrum.

Spectral power distributions and material absorptivity
(used with permission)

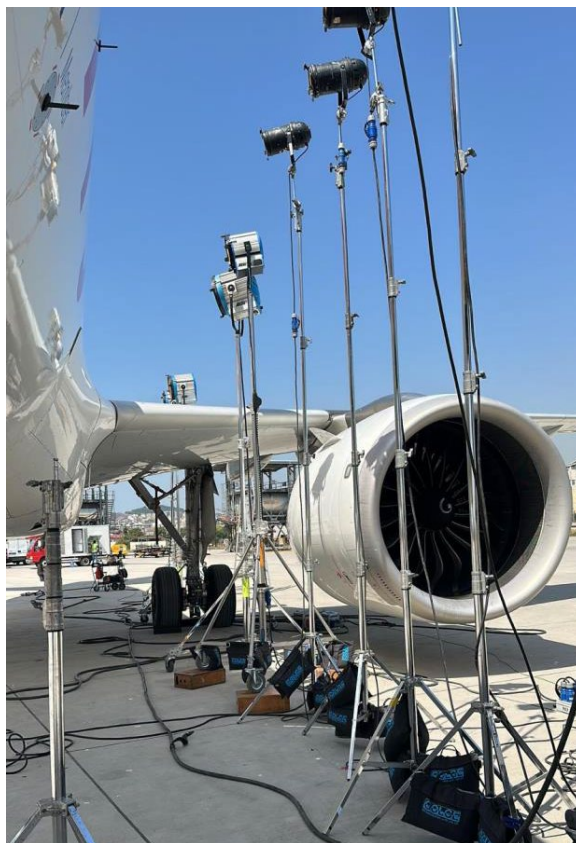
Figure 14

An Airbus A321 sustained cabin window damage during a filming event when the aircraft was outdoors. Spotlights were positioned just inboard of the engines, approximately 1.5 to 1.8 m from the cabin windows (Figure 14).

Lighting arrangement during a previous filming event
(image used with permission)

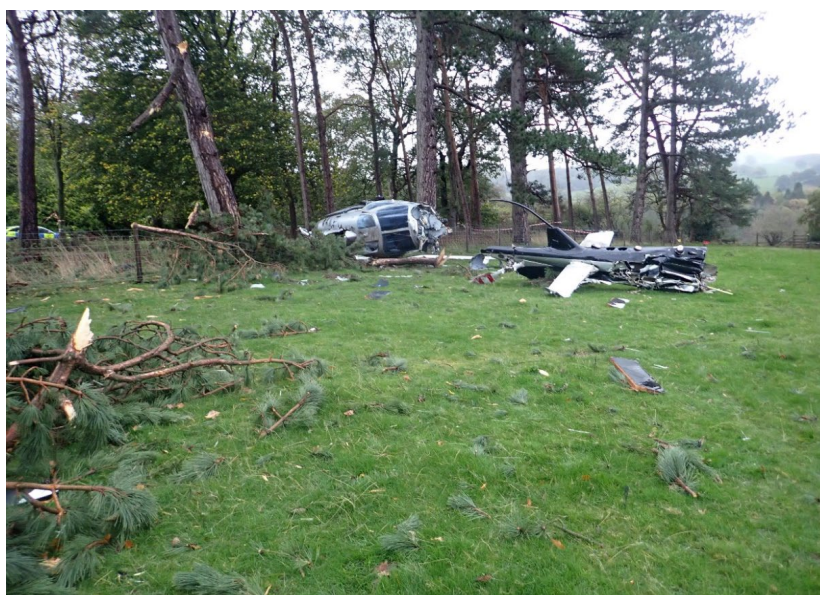
Figure 3

There was a large amount of debris spread around the surrounding area, mainly consisting of fragments from the rotor blades and branches from the trees. A detailed GNSS plot was taken of the main components of wreckage, impact marks and debris. There was no evidence of fuel leaks and there was no post-crash fire. There were clear impact marks near the top of the trunk of the tree adjacent to the helicopter wreckage and a significant swathe of branches had been cut from the top of this tree and landed adjacent to the main fuselage (Figure 3).

Ground view of main accident site

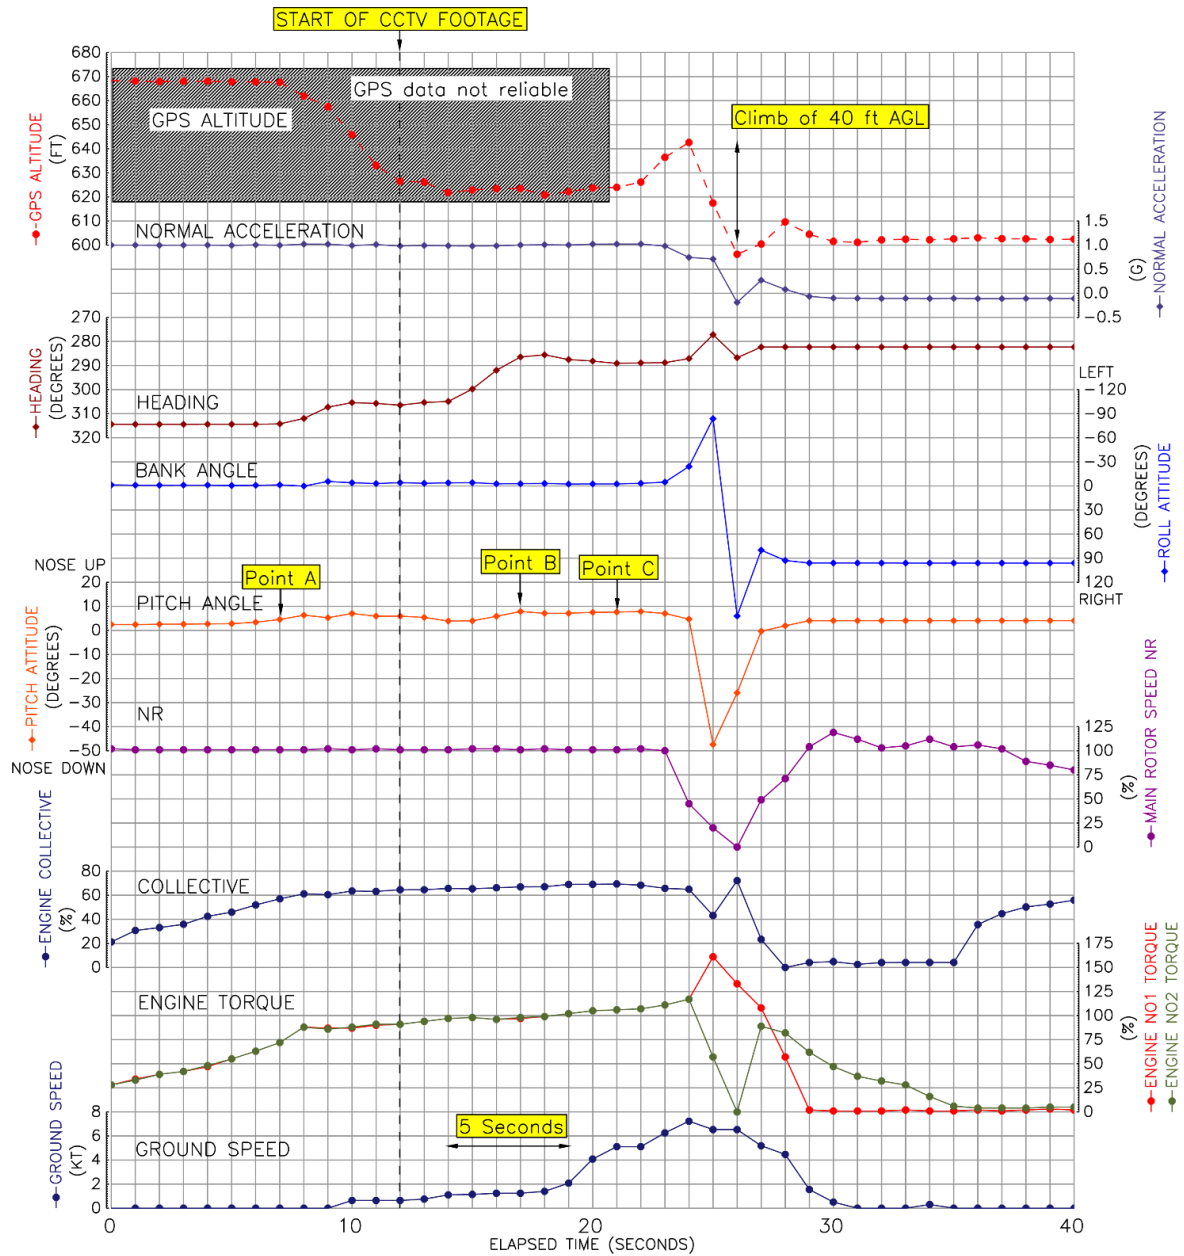
At 1722 hrs the No 1 engine was started, followed about 90 seconds later by the No 2 engine. The helicopter lifted into the hover (Figure 7 Point A) at 1726:06 hrs and made a left turn onto a heading of 305°; engine torque was 88% and the recorded fuel quantity was 405 kg. The helicopter's pitch attitude was about 6° nose-up and the collective was gradually raised, with engine torque increasing to 91%. This coincided with the start of the CCTV footage, which subsequently showed the helicopter moving slowly backwards towards the stand of trees. The engine torque continued to increase, and the helicopter climbed while also turning left onto a heading of 287°. The helicopter's pitch attitude had briefly reduced to about 3° nose-up during the turn, but then increased to nearly 8° nose-up (Figure 7 Point B and Figure 8). The pitch and roll attitude then stabilised at about 7° nose-up and -3° left roll, with the helicopter now having climbed to approximately 25 ft agl (Figure 7 Point C and Figure 9).

Figure 7
Flight data during the accident

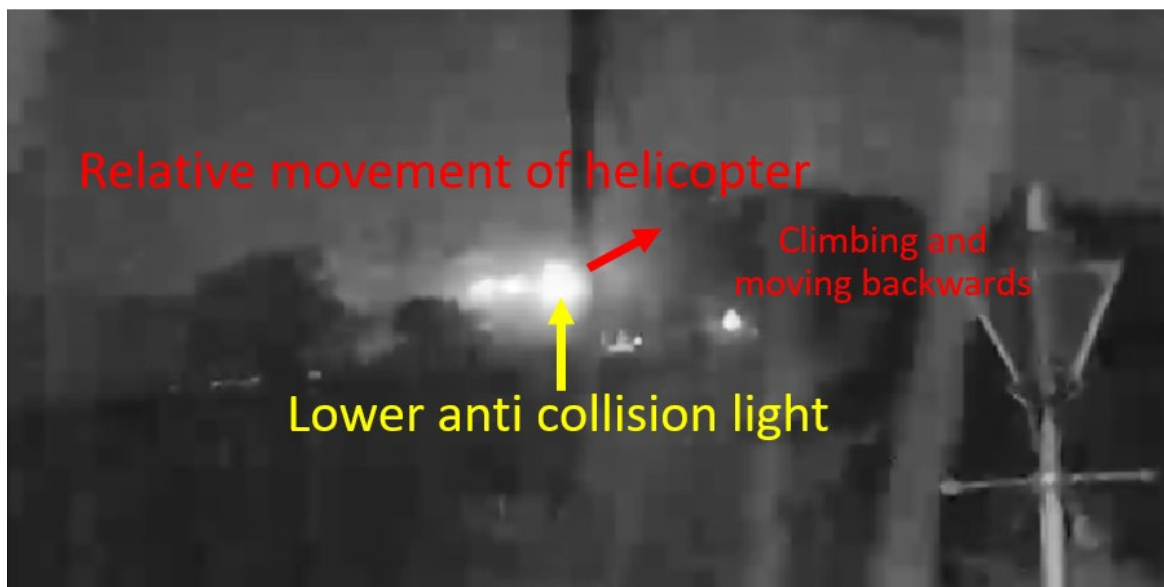
**Figure 9**

Image of helicopter shortly before striking trees

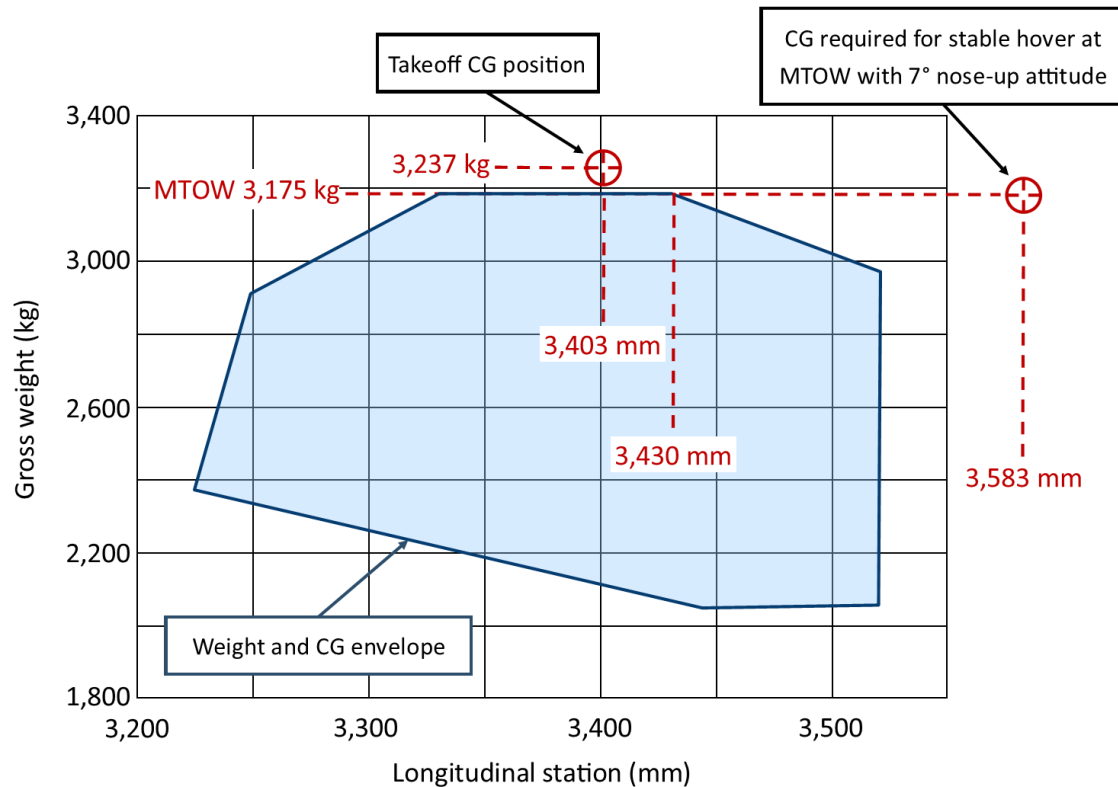
At the accident site the AAIB recovered 520 litres of fuel from the helicopter's tanks, which equated to 405.6 kg using an assumed specific gravity of 0.78. Allowing for 10 kg of unusable fuel being present in its systems when the helicopter was weighed, G-RAYN's all-up weight at the time of the accident was an estimated 3,237 kg. The corresponding longitudinal CG position would have been 3,403 mm aft of datum (Figure 12).

The manufacturer also performed simulations to establish if the helicopter could maintain a stationary hover when the pitch attitude was at 7° nose-up, as recorded during the accident takeoff. This showed that at the MTOW of 3,175 kg it was possible, but the CG would need to be set at 3,583 mm which would be outside the certified longitudinal envelope (Figure 11). With CG set at 3,430 mm, the maximum longitudinal aft position for the helicopter at MTOW, it was not possible to maintain a stationary hover with a pitch attitude of 7° nose-up.

Figure 11
Weight and longitudinal CG envelope for G-RAYN

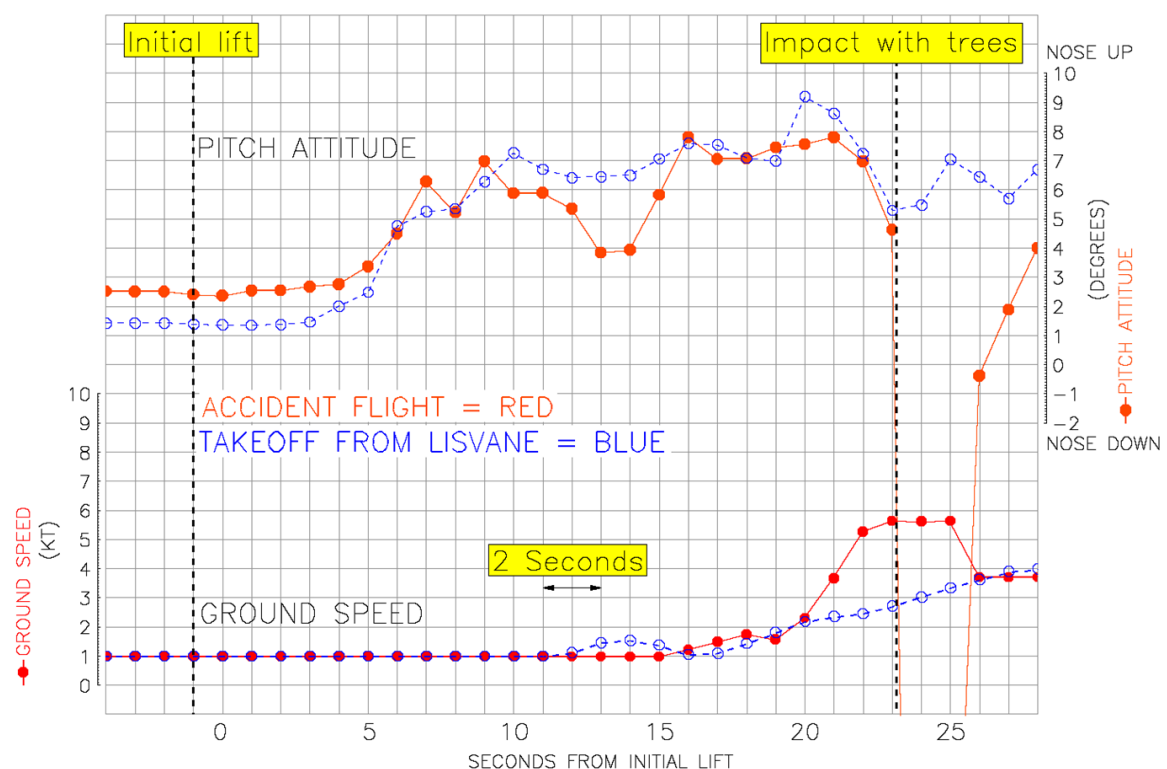
Figure 14

A comparison between the recorded pitch attitudes and groundspeeds during the Category A back-up departure flown from Lisvane that morning and the attempted vertical departure on the accident flight is shown below (Figure 14). Other than the temporary reduction in pitch attitude as the pilot turned into wind at LEA2²⁹ the pitch attitude profiles are broadly similar. The takeoff from Lisvane was a crosswind departure, whereas the helicopter was experiencing a headwind as it climbed from LEA2, this could explain the difference in rearward ground speed acceleration rates observed beyond the 20 second point on the Figure 15 chart.

Comparison of Lisvane (blue) and accident flight (red) Category A departures

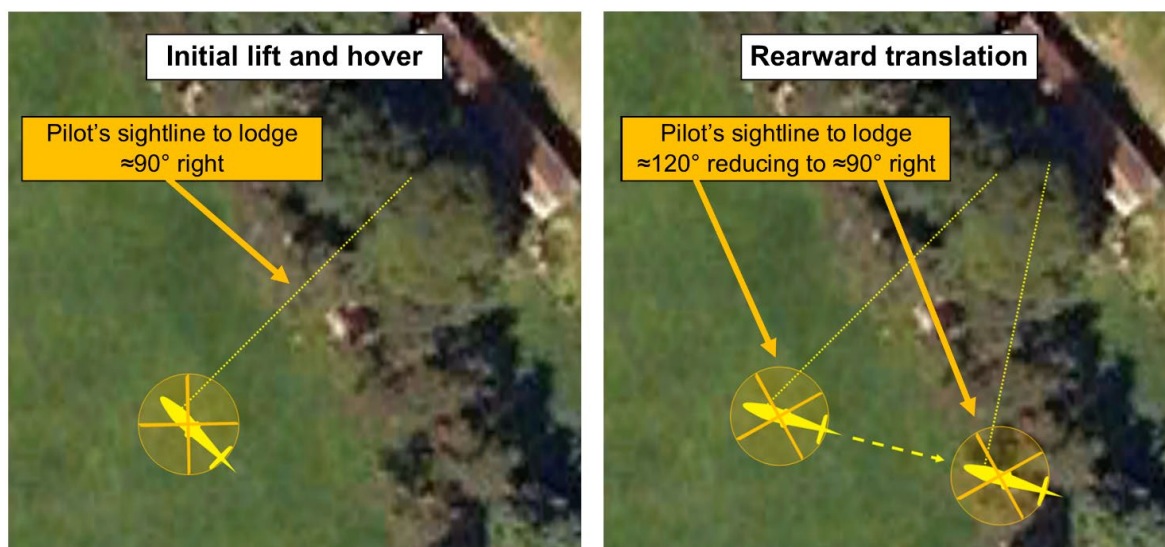
Figure 21

As the helicopter lifted into the hover, the lodge's windows would have been in the helicopter's approximate 3 o'clock position, in line with the pilot's shoulders. Having turned into wind, the chosen lateral markers would have become more difficult to see, the pilot needing to look back over his shoulder to see the lights, approximately 30° behind his shoulder line (Figure 21). The lights' change in relative position would have made it harder to discriminate between real and apparent drift, degrading their usefulness as markers. As the helicopter translated rearwards the lights would have appeared to move closer to their original orientation in the pilot's 3 o'clock position.

Representation of pilot's sightline to lodge windows during departure
(image © 2023 Getmapping plc)

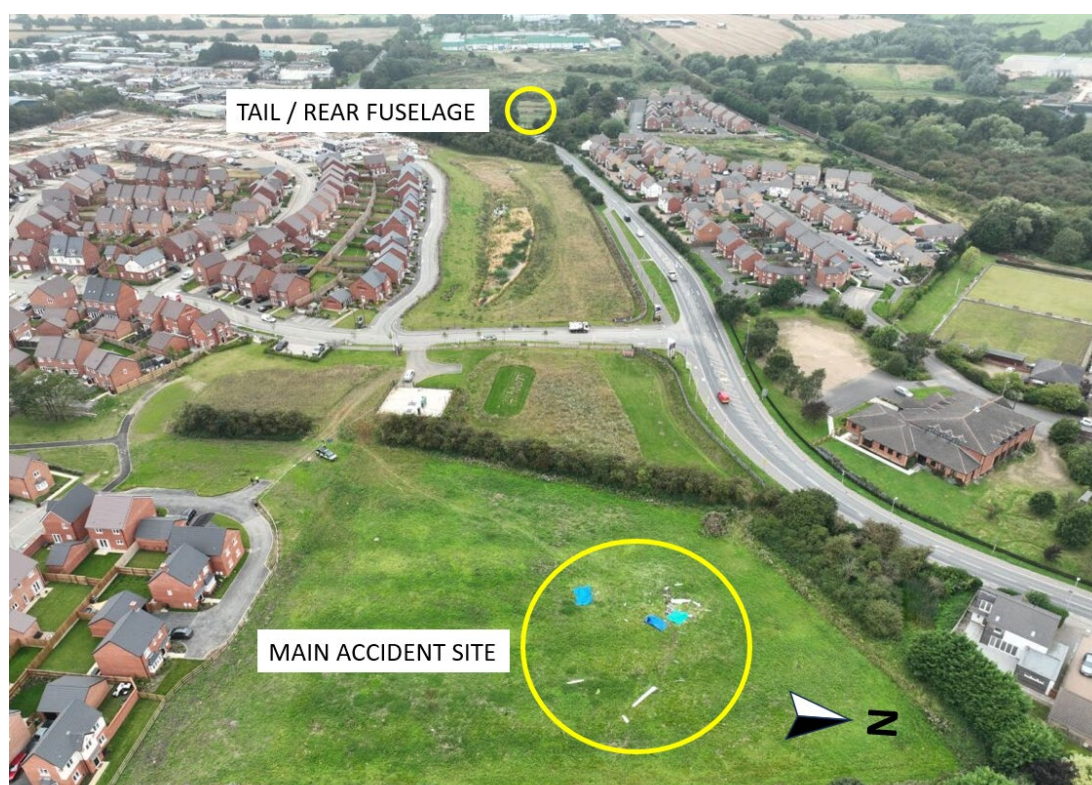
Figure 2
G-KADS accident site

The glider, minus the tail and a section of the rear fuselage, struck the ground in a grass field beside a housing estate on the southwest edge of Melton Mowbray (Figure 2). The rear fuselage and tail fell to the ground 450 m to the west of the main accident site, in an open area of vegetation.

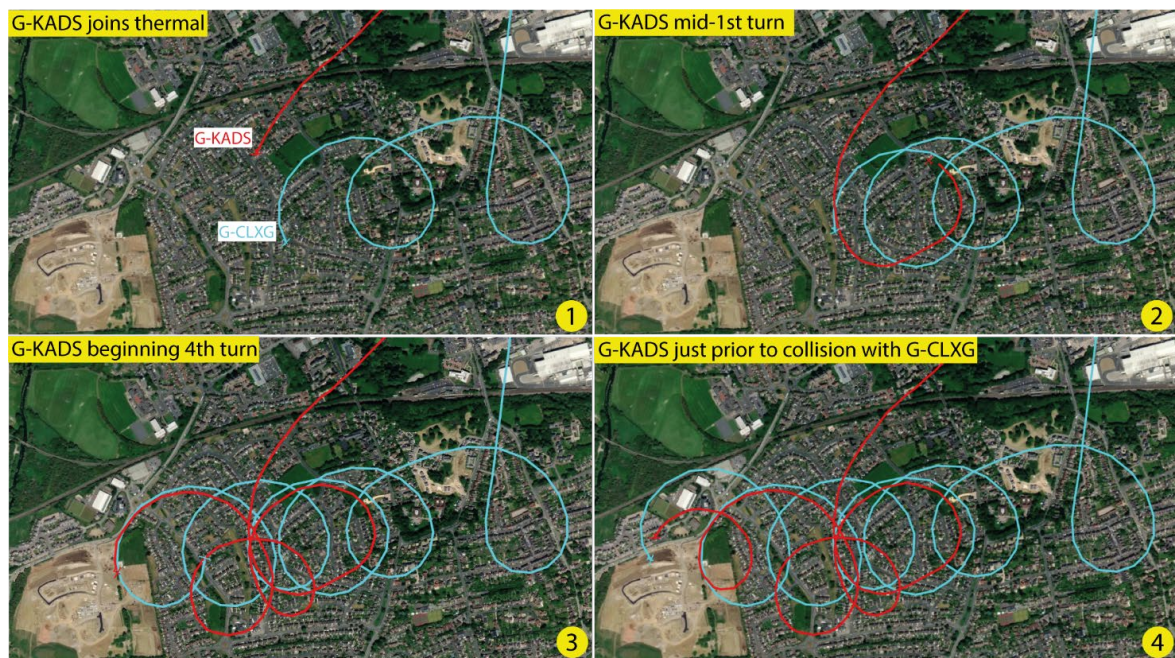
The use of FLARM devices is common on gliders, which don't always carry conventional ATC transponders. These transmissions can be received by suitably configured receivers on the ground, processed and then re-transmitted to provide other airspace users with an awareness of glider activity. The AAIB, using data from one such service provider, was able to retrieve the position information transmitted by G-KADS and this is shown, alongside the flightpath of G-CLXG, in Figure 5 as both gliders manoeuvred in the thermal.

Flightpaths of G-KADS and G-CLXG in a thermal prior to the collision

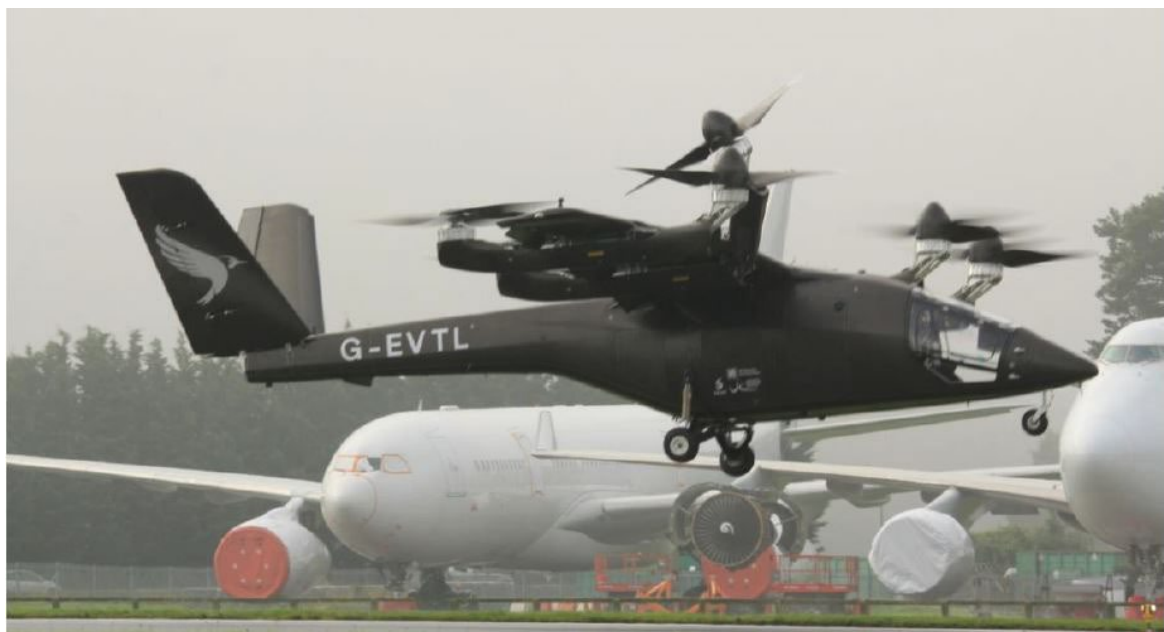
Figure 1

Routine checks were completed, and the aircraft set up according to the test card. At 0712:16 hrs aircraft flight mode was selected, and all the electric propulsion units (EPUs) began idling. At 0714:25 hrs G-EVTL completed a normal vertical takeoff with all EPUs operating. Once the aircraft was stable in ground effect, the remote pilot shutdown EPU1 in accordance with the test card. At 0714:40 hrs the remote pilot then began a gentle climb to 30 ft agl. The test card required the aircraft to be stable at this height for 10 seconds before proceeding with the flight. This was completed and the remote pilot began a gentle acceleration towards 7 kt ground speed (GS). At 0715:47 hrs, as the aircraft speed passed 2-4 kt GS, a loud 'pop' was heard, and a propeller blade was released from EPU3.

The resulting imbalance caused the structural failure of the right inboard pylon (pylon 3). Despite EPU1 restarting automatically the aircraft was unable to maintain height and at 0715:50 hrs it struck the ground on the left edge of the runway with a vertical descent rate of 19.45 ft/sec. During the impact the right wing failed outboard of pylon 3, the nose gear collapsed and there was other structural damage. There were no injuries and no damage to any third party.

Pylon 3 failure following the release of a propeller blade from EPU3
(courtesy of manufacturer)

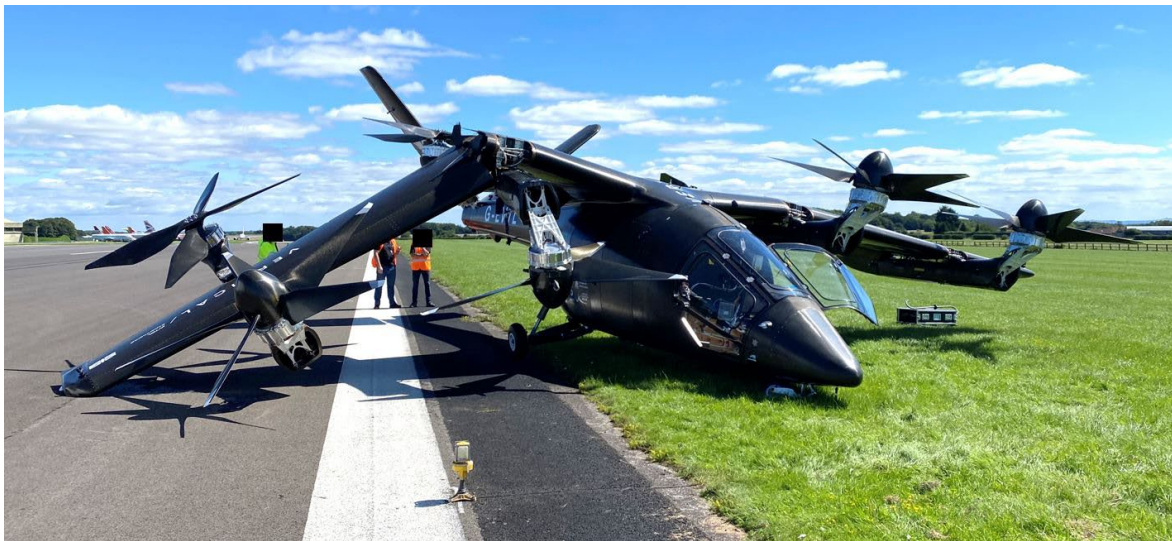
Figure 2

The aircraft hit the southern edge of Runway 26 in a level attitude with the right mainwheel on the paved runway surface and the left mainwheel and nosewheel on the grass. The right wing had broken at the inboard pylon but remained attached to the aircraft by wiring harnesses. Two propeller blades had detached from EPU3, with the blade sheath that separated in flight coming to rest 50 m from the aircraft, at its seven o'clock position. A section of blade spar that had also released came to rest close to where the sheath had landed. A second blade had detached during the ground impact as EPU3's propeller was still rotating when the aircraft touched down.

G-EVTL after the accident

The nose landing gear had collapsed and the left main landing gear oleo remained fully compressed. A number of skin-to-frame fasteners had pulled through the fuselage skin around the right main landing gear upper fitting. The right wing had failed in downward bending overload at the inboard pylon station.

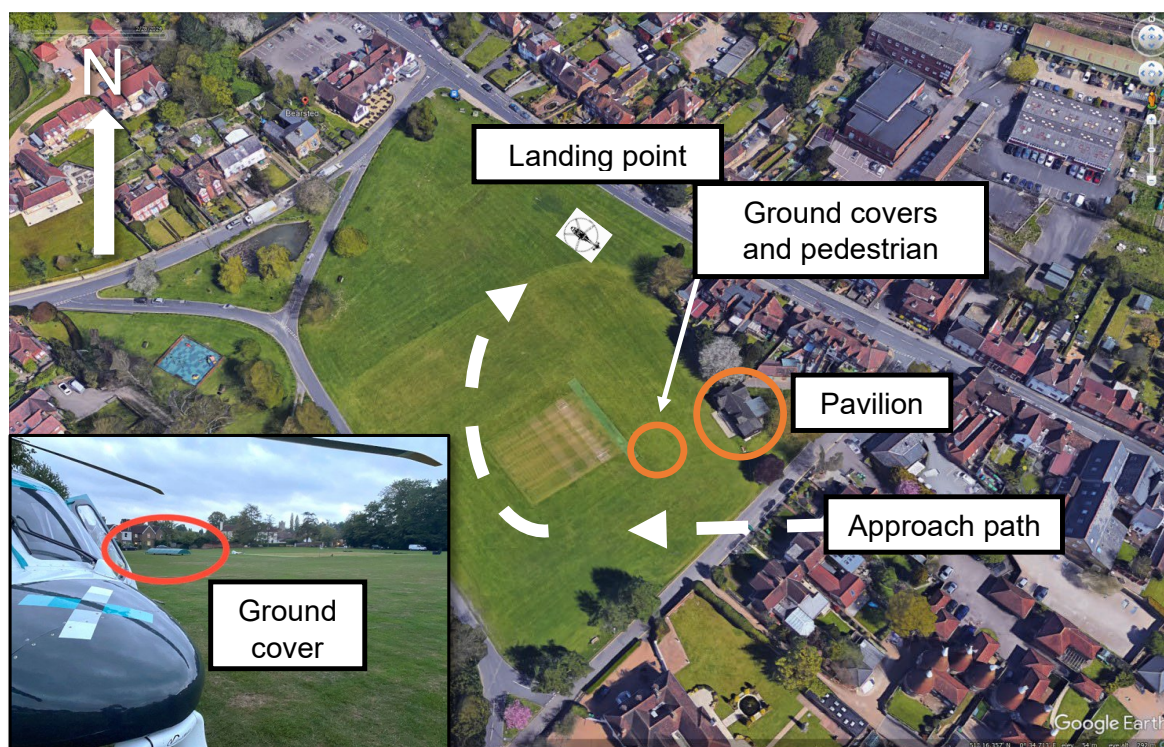
Figure 1

The crew assessed the field and established that its size, approximately 80 m by 120 m, was more than sufficient to use as a HEMS landing site¹. The crew decided on an approach track that avoided the cricket pavilion and some residential properties to the north-east of the pitch (Figure 1). This also allowed the approach to be conducted largely into wind, which was from the south-west. The crew noted that there were pedestrians at the northern end of the field and some ground covers protecting the playing surface, but the main pitch area was clear. They elected to use a helipad profile approach with a committal height of 180 ft agl to provide sufficient clearance from surface obstructions.

The cricket pitch and surrounding field

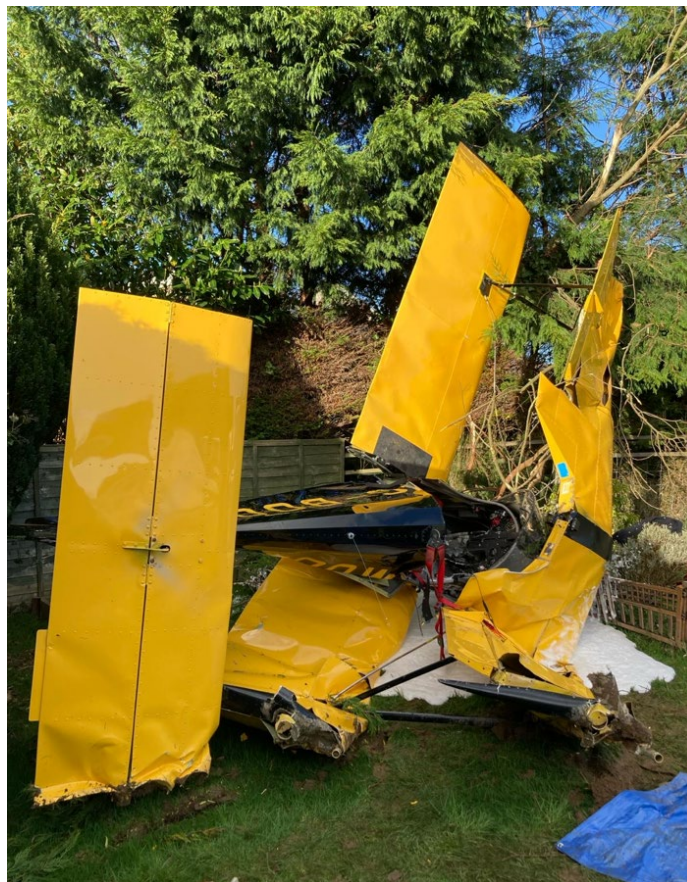
Figure 1

With the engine now producing power, the pilot decided to fly a tight right-hand circuit which he considered would also provide the opportunity to land downwind on Runway 22 if necessary. As the aircraft entered the downwind leg, at 600 ft agl, the engine power decreased to idle with significant rough running. The pilot lowered the nose below the horizon and, being too low to reach the airfield, selected a field to land in. He felt the aircraft stall with a right wing drop and he pitched the aircraft further nose down to recover, however he was now too low to reach his selected field. The engine then stopped. With a residential area ahead and a high rate of descent, he picked an open area of gardens with a line of trees to land in and intentionally stalled the aircraft into the tree line. The aircraft slid sideways from the trees, coming to rest on its right side (Figure 1). The pilot sustained a fractured wrist and some minor injuries. While he was wearing a helmet which provided some protection, the pilot sustained a minor head injury

G-BOOW accident site (used with permission)

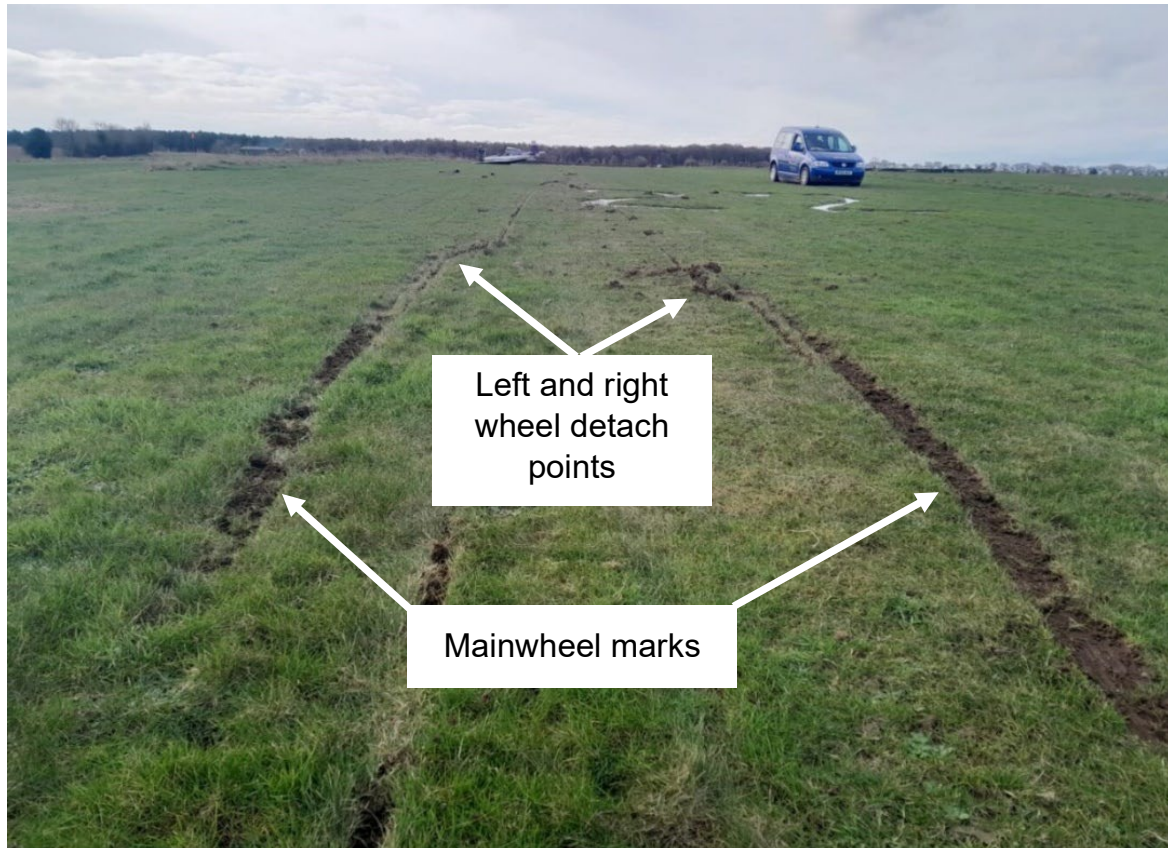
Figure 1
Runway witness marks

Witness marks in the grass surface appeared to show that the right tyre was initially not turning upon touchdown and that the right mainwheel assembly detached before the left mainwheel assembly (Figure 1).

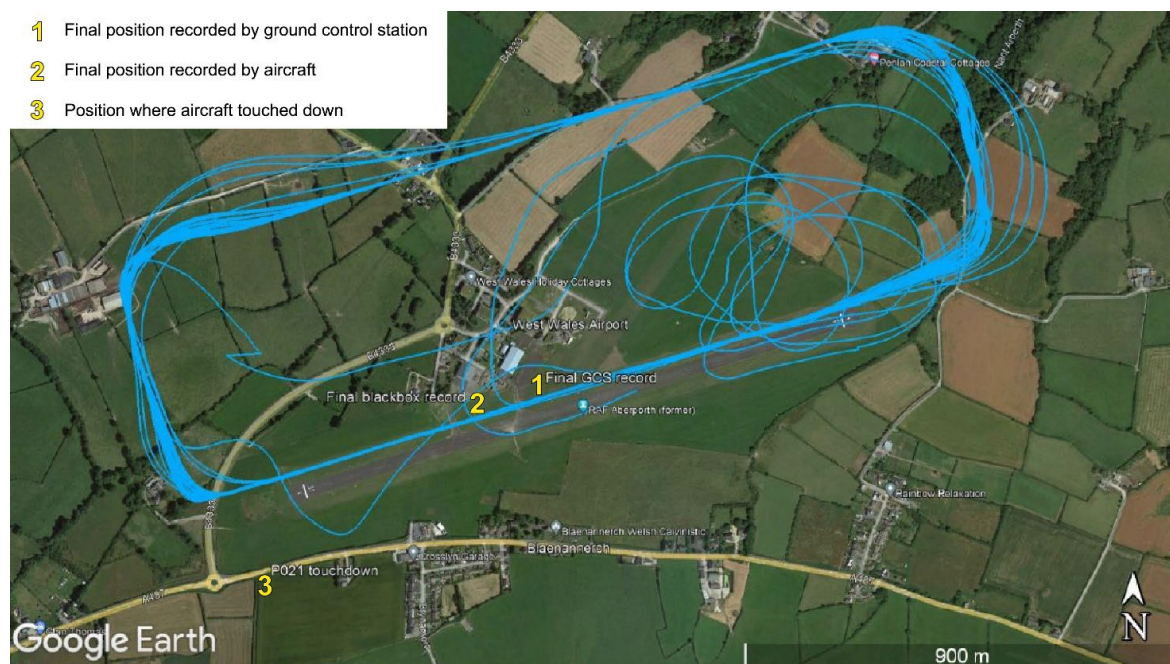
Figure 1

A number of tests were conducted to validate the autopilot and flight control systems. At 1350 hrs the RP observed that the engine had stopped, with the aircraft 1,000 ft agl over the centre of the airfield and routing along the northern edge of Runway 25. He informed the RPSO that he was taking control by saying “my bird” to which the RPSO acknowledged “your bird”. However, the RP then advised the RPSO that he was not able to gain control; the RPSO then attempted to regain control but without success.

Track of UAS Prion during accident flight

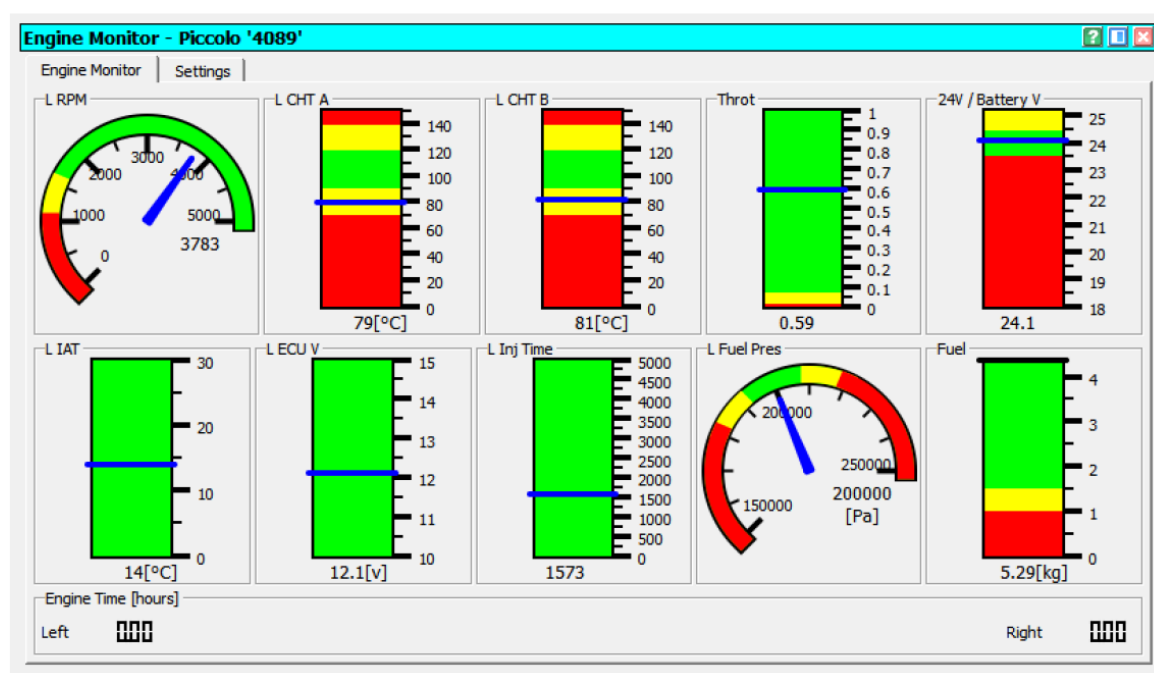
Figure 2

Engine monitor with emergency battery voltage (top right) indication

The operator identified that the after-flight check list was missing a check of the emergency battery status prior to the aircraft being connected to the ground power. It also improved the engine monitoring graphical interface flight telemetry system (Figure 2) to include voltage indication of the emergency battery to allow its charge status to be monitored in flight. This would indicate if the alternator generator system was faulty.
