Rail Accident Investigation Branch

# Rail Accident Report

## Signal passed at danger at Stafford Trent Valley Junction No. 1 22 August 2023

Report 05/2024  
June 2024

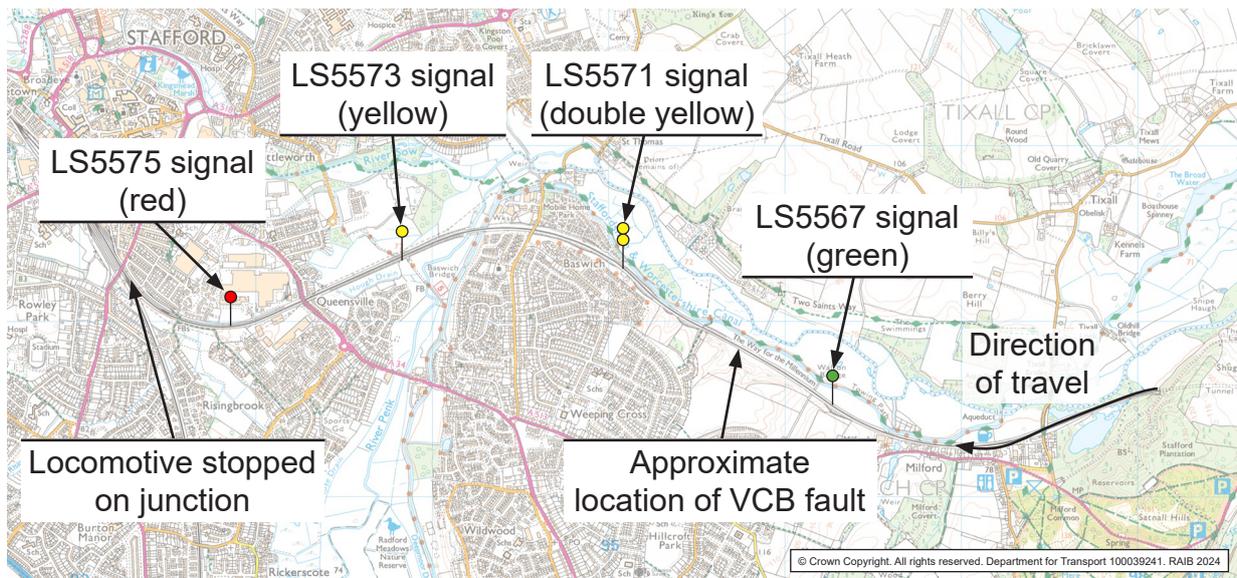
- 5 The locomotive eventually came to a stop on the points at Stafford Trent Valley Junction No. 1 (figures 1 and 2). No other trains were in the immediate vicinity, although a northbound train had passed these points on an adjacent track less than 60 seconds earlier. A second, southbound, train had not yet stopped at Stafford station when the signal allowing it to depart the station towards the junction reverted to red as a result of the SPAD.

Figure 2: Route of the train approaching Stafford Trent Valley Junction No. 1.

- 39 At 16:38 hrs, shortly after passing through Shugborough Tunnel, where the Stafford Slow lines diverge from the Stafford Fast lines, the VCB on the locomotive tripped after passing LS5567 signal, which was showing a green proceed aspect (figure 2). This occurred before the locomotive had reached LS5571 signal, which was showing a double yellow preliminary caution aspect.

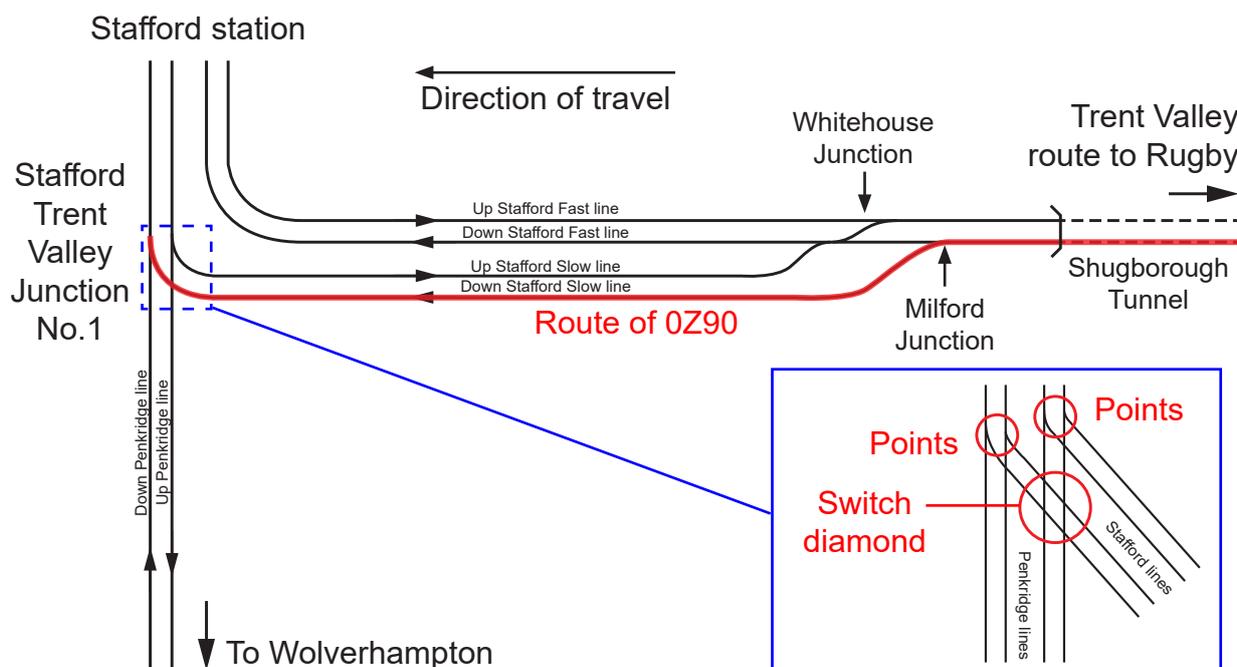
- 8 The railway approaching LS5575 signal consists of four tracks, with the Stafford Slow lines to the left and the Stafford Fast lines to the right in the direction of travel of the train involved (figure 3). The Stafford Slow lines meet the Penkrigde lines (the route to/from Wolverhampton) at Stafford Trent Valley Junction No. 1, while the Stafford Fast lines continue towards Stafford station. At the junction, the Down Stafford Slow line crosses the Up Penkrigde line at a switch diamond, which has movable blades to close the gaps in the rails for the set route (figure 4).

Figure 3: Track layout on the approach to Stafford Trent Valley Junction No. 1.

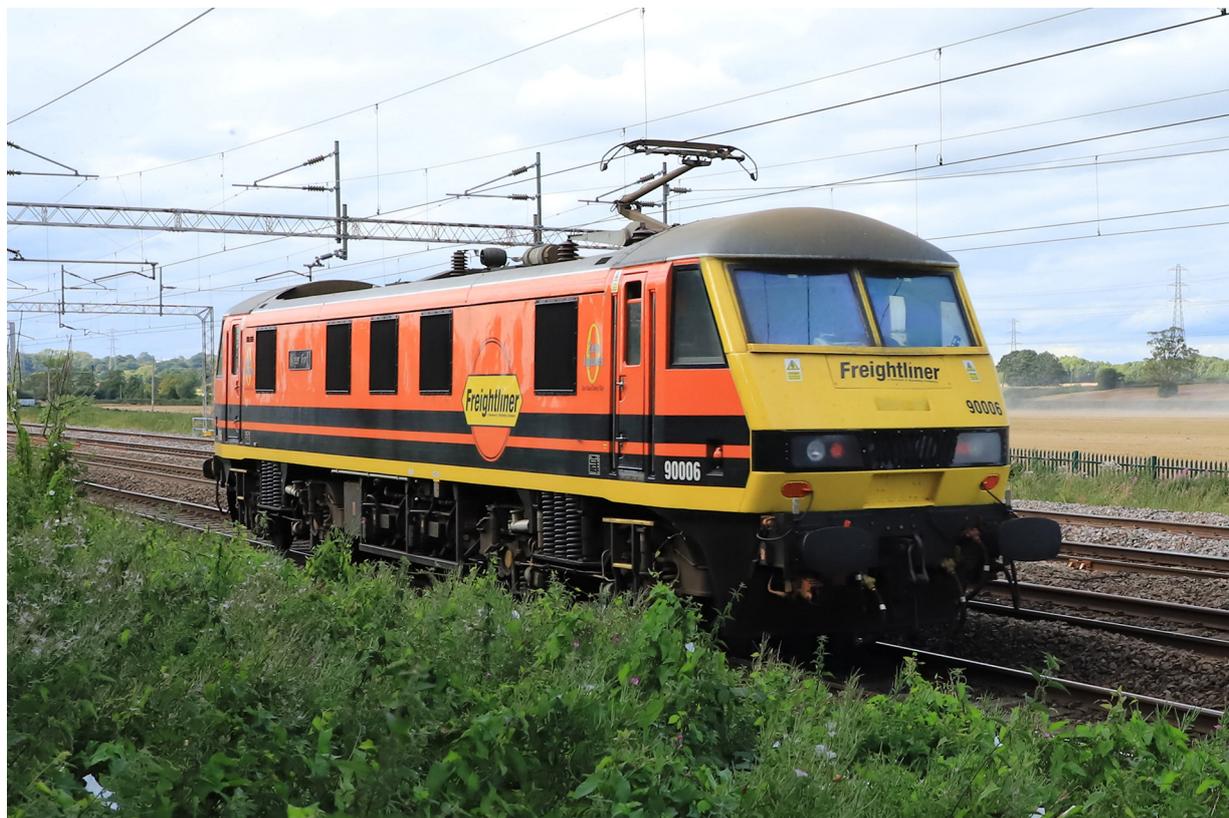
- 15 The train consisted of a class 90 electric locomotive (number 90006). It was operating as a light locomotive, so it had no wagons or coaches coupled to it (figure 5). The operational maximum speed of the locomotive was 110 mph (177 km/h), although this was operationally restricted to 75 mph (121 km/h) when hauling freight trains, and subject to further Rule Book limitations when operating as a light locomotive (see paragraph 99).

Figure 5: Class 90 locomotive during the test run (courtesy of John Neave).

- 16 The locomotive was operating as train reporting number 0Z90, the 14:27 hrs test train from Crewe to Nuneaton and back. The maintenance records for the locomotive showed that all routine maintenance had been undertaken in line with the relevant requirements, but that it was still under investigation for a known fault at the time of the incident. The fault resulted in the vacuum circuit breaker (VCB), which interrupts the electrical supply from the overhead line, tripping unexpectedly. The effect of a VCB trip is for the locomotive to lose power, but the brakes are not automatically applied. The test run was intended to check whether this fault was still present or not.

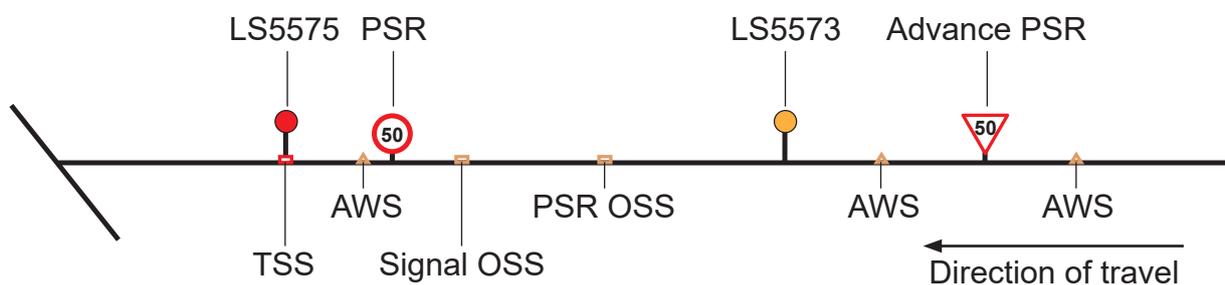
- 25 On the approach to Stafford Trent Valley Junction No. 1, all the signals are fitted with AWS equipment. TPWS equipment is also provided as follows (figure 7):

- LS5575 signal is fitted with TSS loops, set to apply the brakes on any train passing the signal when it is showing a red stop aspect.
  - LS5575 signal is fitted with OSS loops, positioned 350 metres before it, set to apply the brakes on any train passing the loops at a speed above 46 mph (74 km/h) when the signal is showing a red aspect.

- A 50 mph (80 km/h) permanent speed restriction (PSR) that starts 216 metres before LS5575 signal is fitted with OSS loops, positioned 337 metres before the speed sign, set to apply the brakes on any train passing the loops at a speed above 76 mph (122 km/h).

Figure 7: AWS and TPWS configuration approaching Stafford Trent Valley Junction No. 1.

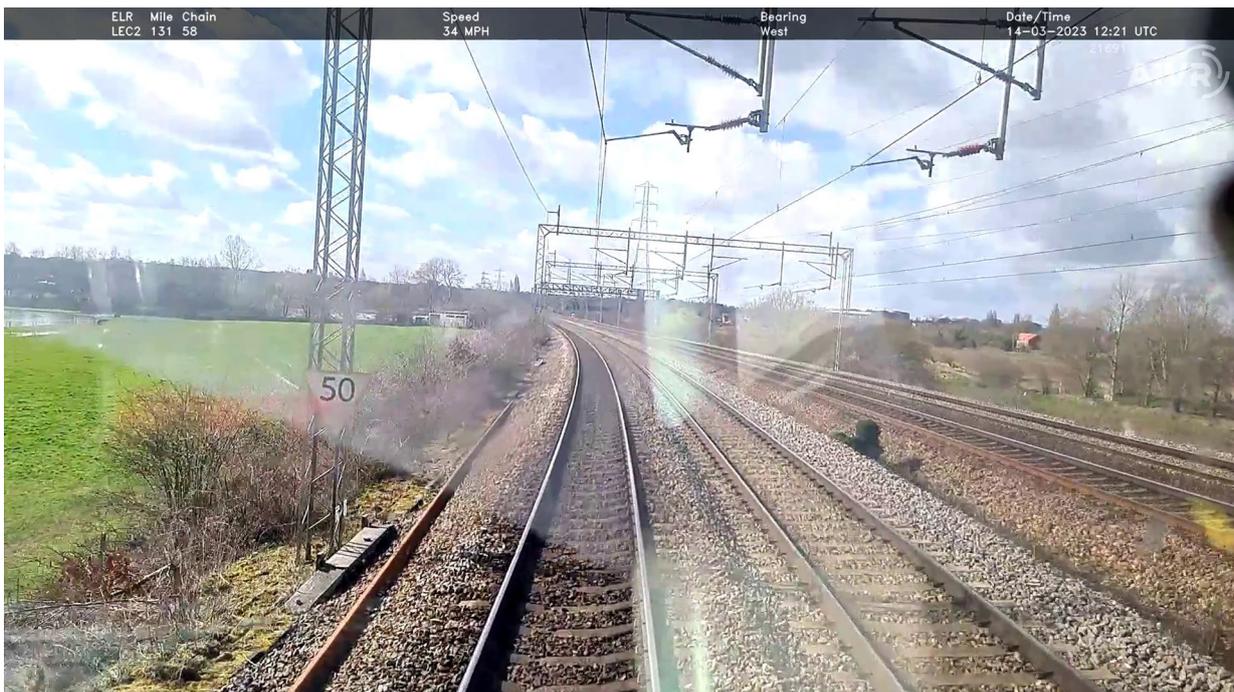
- 109 As well as losing focus on the signalling sequence and the fact that there may be a red signal ahead when they applied power and accelerated away from LS5573 signal (paragraph 66), the driver also did not recognise that they were approaching a 50 mph (80 km/h) speed restriction. This was despite the driver having passed an advance warning sign for the speed restriction (paragraph 40) approximately 400 metres before stopping at LS5573 signal (figure 15) and having acknowledged an AWS warning associated with the sign. The reasons for the driver losing awareness of the PSR AWS warning are almost certainly the same as those for losing awareness of the signalling sequence (paragraphs 66 to 78).

Figure 15: Advance warning sign located on approach to LS5573 signal (courtesy of Network Rail).

110 Had the driver recognised the upcoming 50 mph (80 km/h) speed restriction, and accelerated the locomotive accordingly, the emergency brake application the driver made when red LS5575 signal came into view would have stopped the locomotive around 540 metres earlier. This would still have been approximately 200 metres past the red signal at LS5575, but 460 metres short of fouling the points at Stafford Trent Valley Junction No. 1.
