Report on the investigation of the
foundering of the fishing vessel

Piedras

78 nautical miles south-west of Mizen Head, Ireland
on 1 June 2022

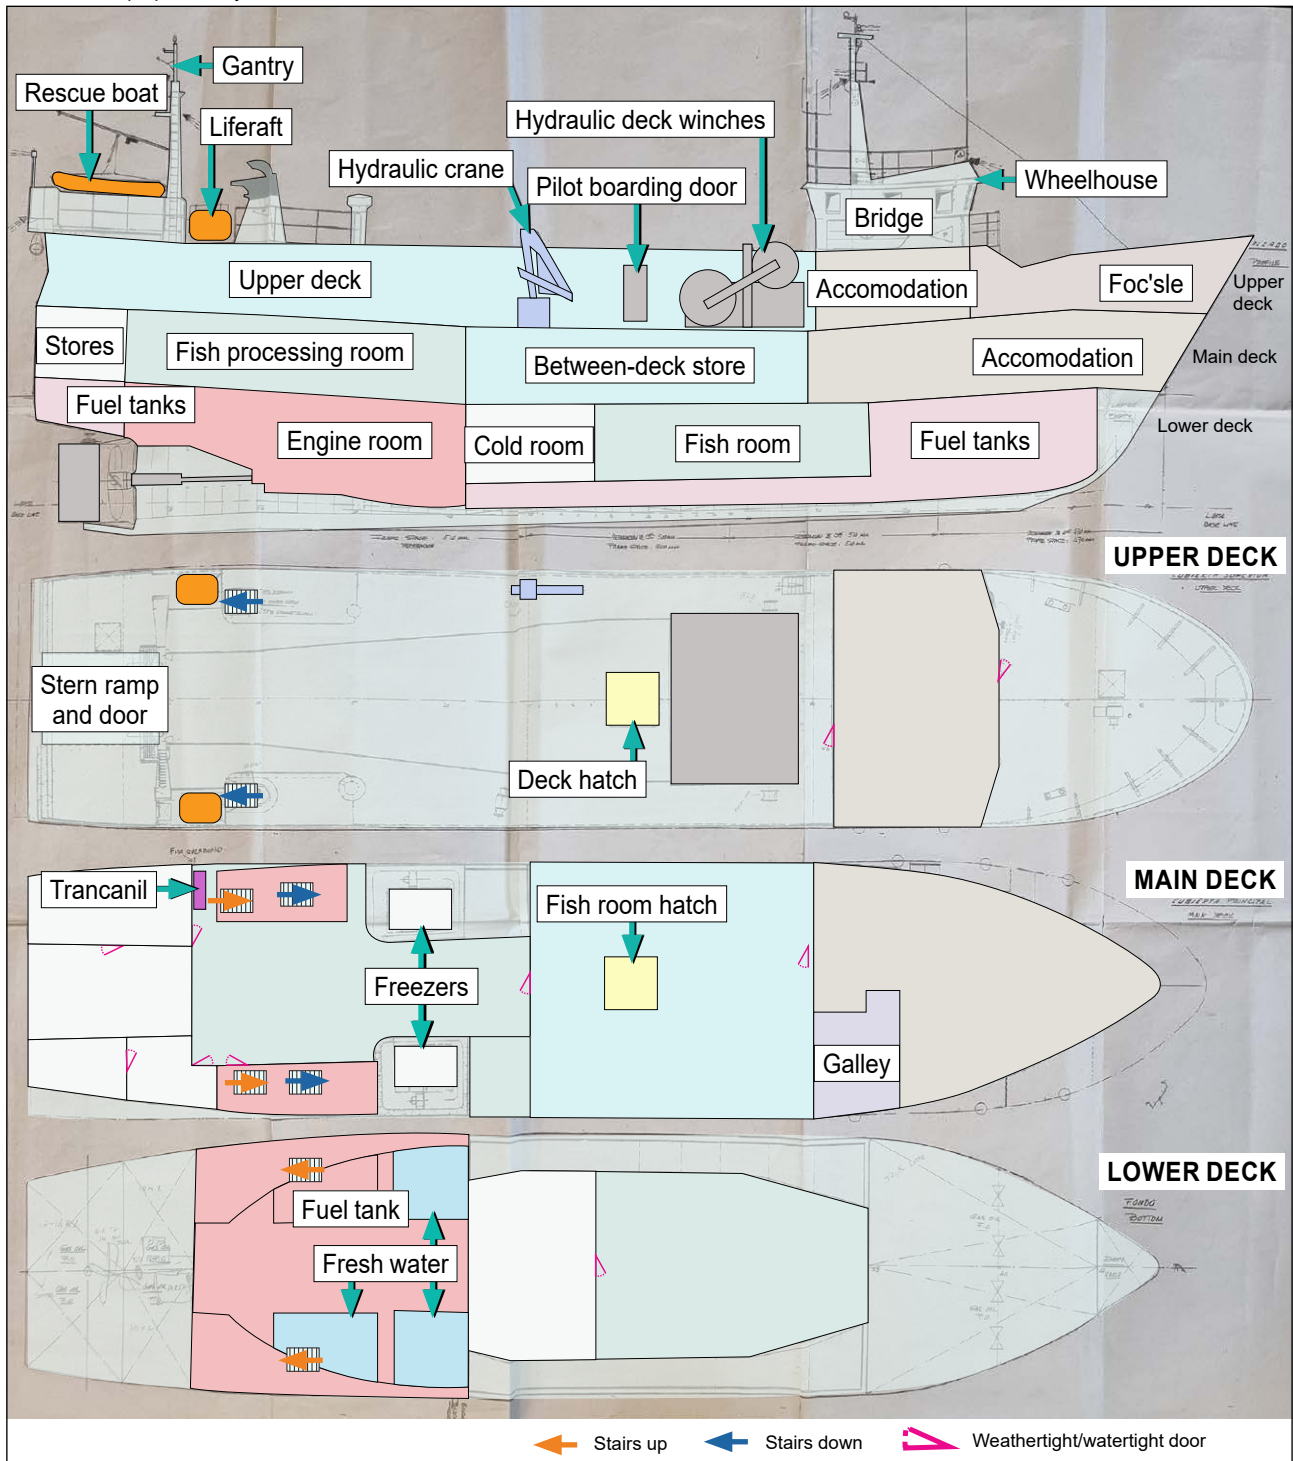
Figure 5: *Piedras* general arrangement

The general arrangement of *Piedras* (**Figure 5**) comprised a forward wheelhouse, hydraulic deck winches at the forward end of the upper deck, a fixed aft gantry above a hatch down to the fish processing room, a stern ramp and a ramp door. The upper deck had a raised gunwale and there was a pilot boarding door at the vessel's midships, on the port side. A hydraulic crane was positioned aft of the pilot boarding door; this was used to disembark the catch from the fish room via a hatch on the upper deck just aft of the hydraulic deck winches. The main deck included, from bow to stern: the crew's accommodation and a galley; a between-deck store; a fish processing room; a fish reservoir; and a steering gear compartment. The lower deck included, from bow to stern: the crew's accommodation and a galley; a fish processing room; a fish reservoir; and a steering gear compartment.

The most recent ultrasound survey of *Piedras*, during the 2020 out of water survey, had measured the thickness of the vessel's hull, deck plates, bottom plating, frames, brackets and longitudinal members. The thickness readings were within tolerance and did not demonstrate substantial corrosion. Historically, the deployment and recovery of the vessel's trawl doors during fishing operations had caused hull damage to *Piedras*, particularly in bad weather. The owner had welded metal bars to the aft transom and hull to protect the steelwork from trawl door damage but, during the 2020 dry docking, damaged hull plating between frames 10 and 14 needed to be replaced; this was due to deformation of the hull caused by the starboard trawl door striking it below the waterline, near the starboard aft freshwater tank (see **Figure 5**).

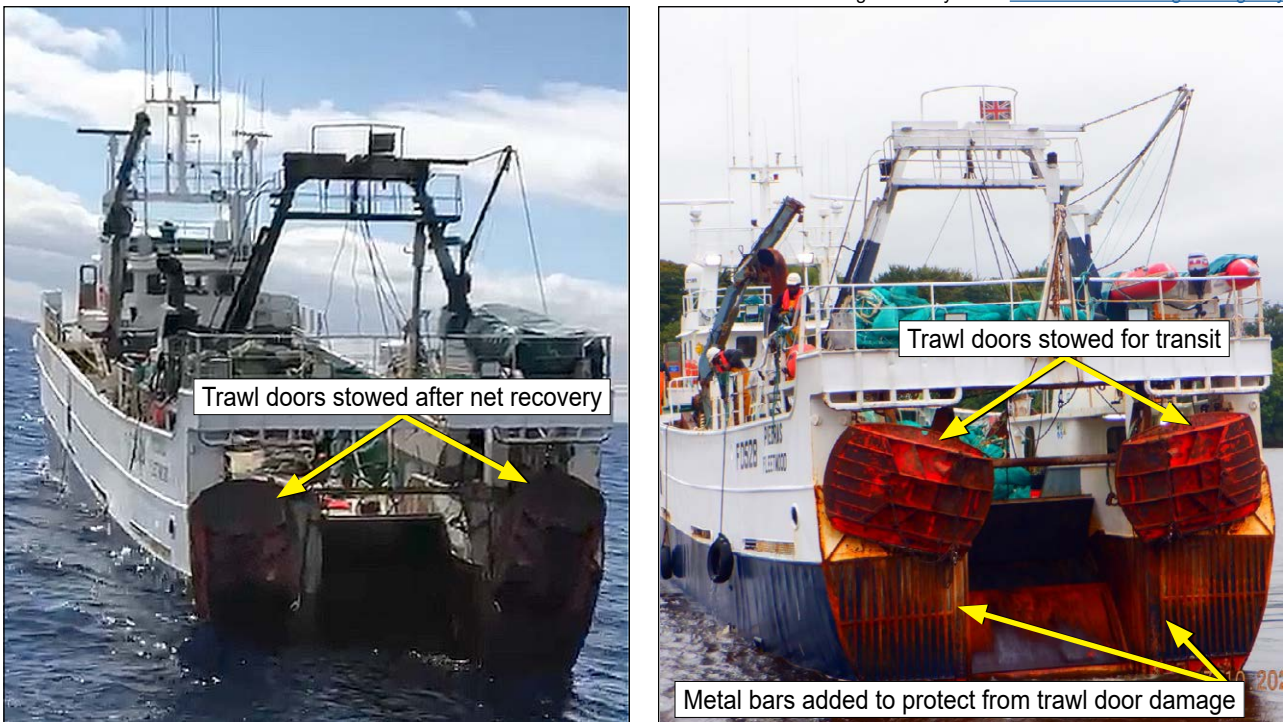
Figure 6: Piedras trawl doors

The two nets carried on board *Piedras* were stowed and deployed from a winch on the main deck. Two trawl doors, weighing 1,400kg each, were stowed at the stern when not in use (**Figure 6**); when deployed, these guided and kept the net open (**Figure 7**).
