MAIB Safety Bulletin SB2/2023, issued 24 August 2023

**Potential failure of
Deutsche Schlauchboot GmbH (DSB) liferafts
serviced by Comfer Marin SL, Marin, Spain
identified following the foundering of the fishing vessel
Piedras (FD 528)
south-west of Mizen Head, the Republic of Ireland
on 1 June 2022**

MAIB SAFETY BULLETIN 2/2023

The Marine Accident Investigation Branch is carrying out an investigation into the foundering of the fishing vessel *Piedras* (FD 528), 78 nautical miles south-west of Mizen Head, the Republic of Ireland, on 1 June 2022.

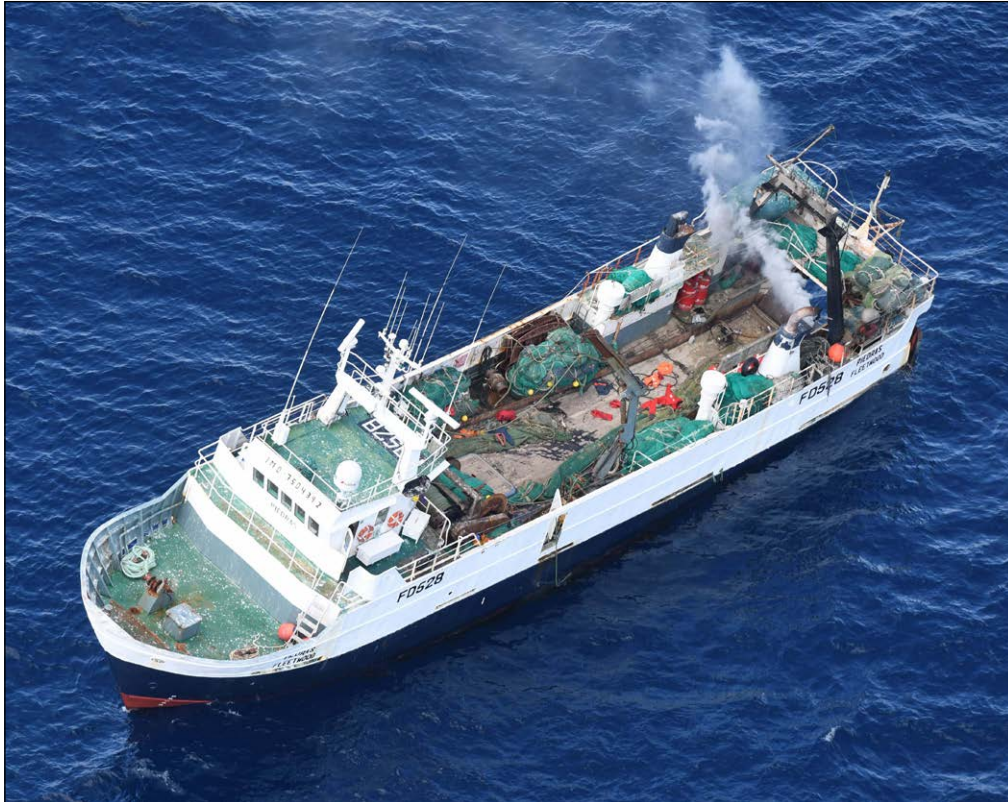
Piedras

The skipper of *Piedras* had contacted a nearby fishing vessel *Armaven Uno* and, over 2 hours into the flood, sent an undesignated distress message via the Global Marine Distress and Safety System (GMDSS). Deciding that the vessel was lost, the skipper of *Piedras* gave the order to abandon ship. The abandonment was hampered as one of its two liferafts failed to function correctly. Fortunately, the second liferaft was successfully deployed and used by the 11 crew members. By 0949, the crew of *Armaven Uno* had rescued the entire crew of *Piedras* from the liferaft. *Piedras* eventually capsized and sank to the seabed.
