Rail Accident Investigation Branch

# Rail Accident Report

## Uncontrolled evacuation of a partially platformed train at Clapham Common London Underground station, 5 May 2023

Report 03/2024  
May 2024

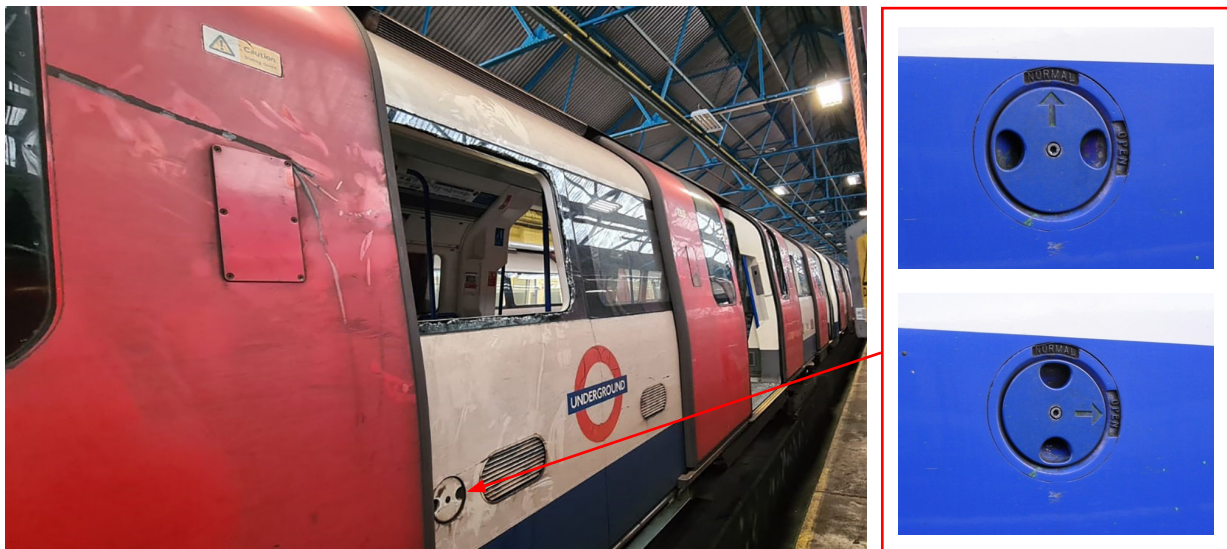
- 22 When the train is stationary, LUL station staff on the platform can manually open individual sets of doors by using a valve on the outside of the train called the outside door opening device (ODOD, also commonly referred to as an 'open-door valve' or 'butterfly cock').

Figure 7: Train 065 at Golders Green depot after the incident. Inset images show ODOD in normal / doors closed (top inset) and open / doors open (bottom inset) positions. Images courtesy of LUL.

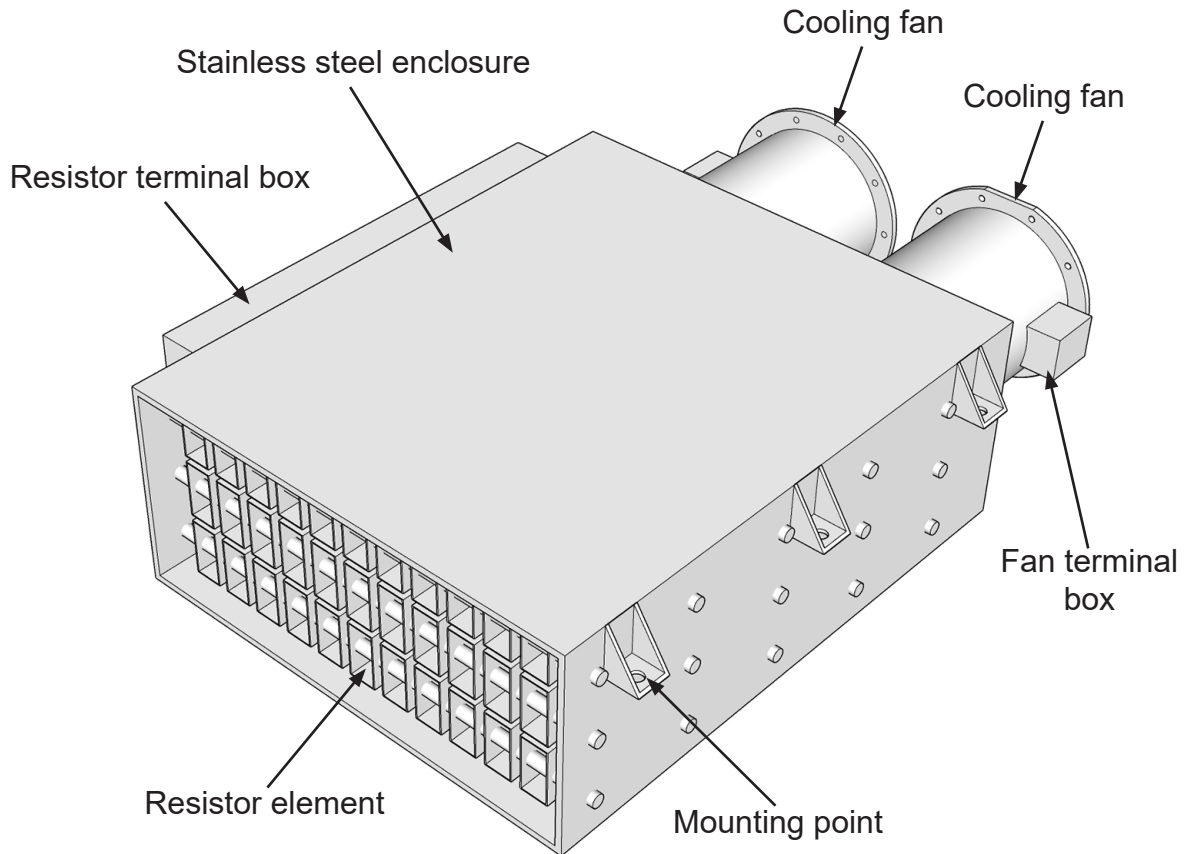
Rheostatic and regenerative braking are seen as preferable to friction braking because they avoid generating brake dust and reduce wear on components, such as brake blocks. On Northern line trains, the brake resistors used during rheostatic braking comprise a grid made up of metallic resistive elements separated by insulated ceramic dividers and are forced air cooled with a dual fan arrangement (figure 13). There are brake resistors on each car of the train fitted with traction motors (cars 1, 3, 4 and 6).

Figure 13: Diagram of a brake resistor used on 1995 stock trains.

- 52 Although the heating of clean resistor grids does not normally produce strong odours or smoke, trains operating in the tunnel environment will collect organic matter and other debris over time. If there is a sufficient build-up of this material, the heat produced on the surface of the grids can produce smoke or a burning smell. Although this is technically a different issue to the dust that is generated by friction braking, witness and documentary evidence shows that any smoke or smell from resistors heating up is also commonly referred to as 'brake dust' by LUL operational staff.

63 LUL and Alstom engineers inspected the train after the incident and confirmed that a strong burning smell was present within the passenger saloon of car 4. A subsequent inspection of the underframe of car 4 found burnt residue and a red clay-like substance on the brake resistor grid (figure 15). Independent analysis of the substances found showed that this was a mixture of organic material and a red magnetic clay substance. LUL confirmed the substance was grinding paste which is used for rail grinding activities on LUL infrastructure.
