Maritime &  
Coastguard  
Agency

# SS Richard Montgomery: Survey report 2023

April 2023

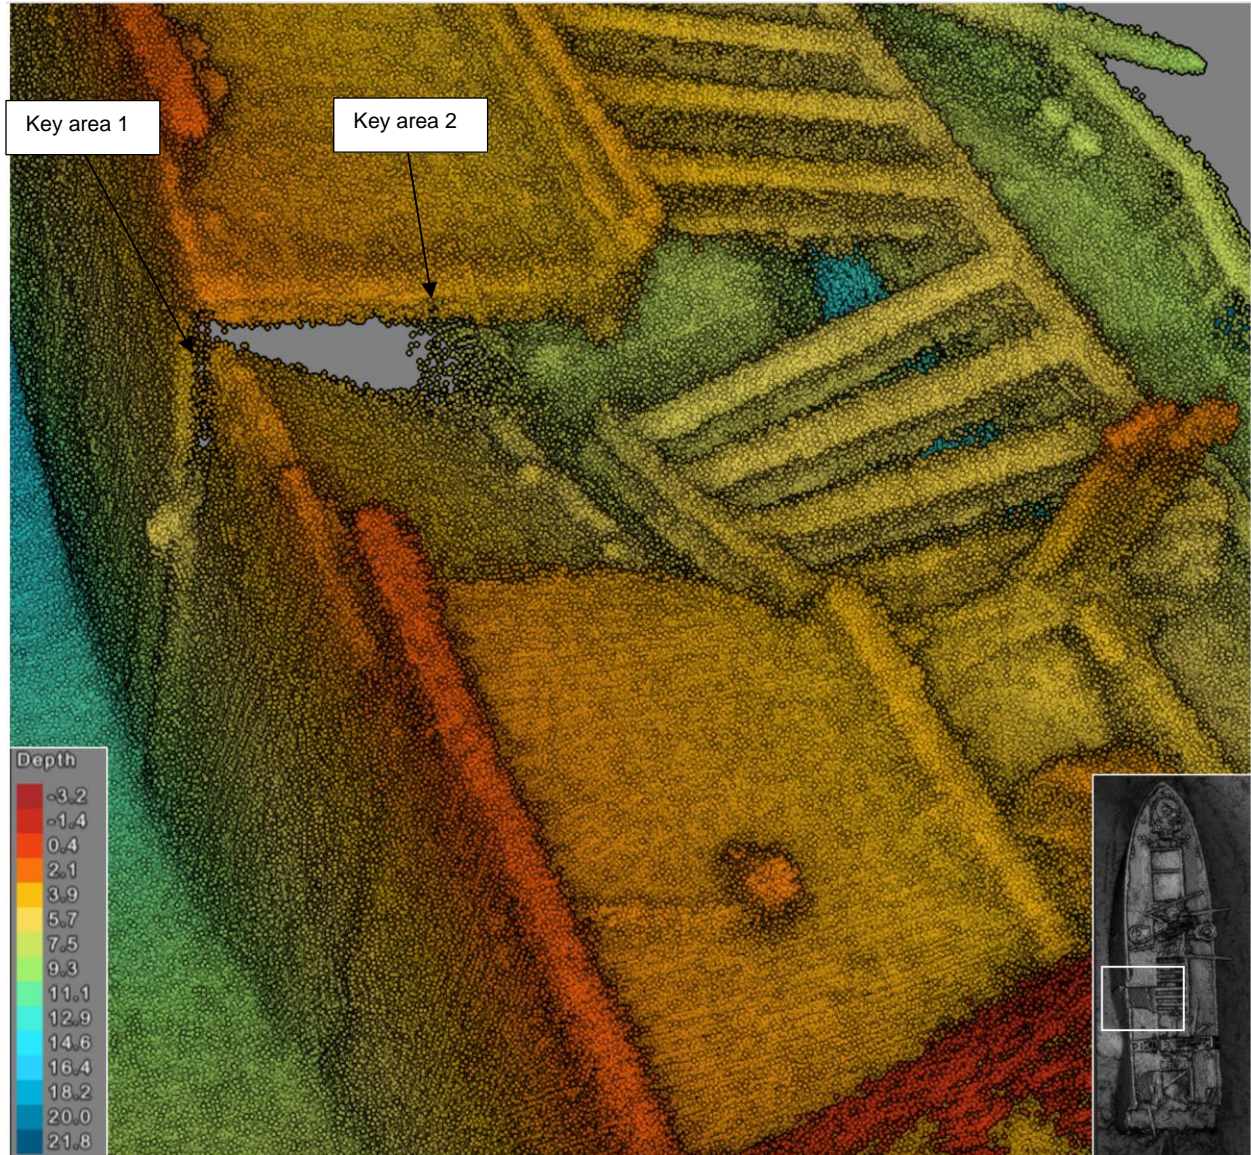
4.1.2 Key area 1, crack in the hull (port side, forward section) (Figure 6).

4.1.3 Key area 2, collapse of cargo hold 2 deck (port side, forward section) (Figure 6).

Figure 6. Point cloud image of key areas 1 and 2.

The forward section of the SSRM is seriously hogging almost exactly halfway along the no. 2 hold hatch. This hogging has resulted in a crack appearing on the upper part of the port side while the lower part of the starboard side is significantly buckled giving the appearance that the forward part of the wreck is splitting in two and pivoting about the starboard rim of hold 2. The flexing of the upper deck has caused a portion of the upper deck and half of the no. 2 hatch cover supports to collapse through into the 'tween deck space.

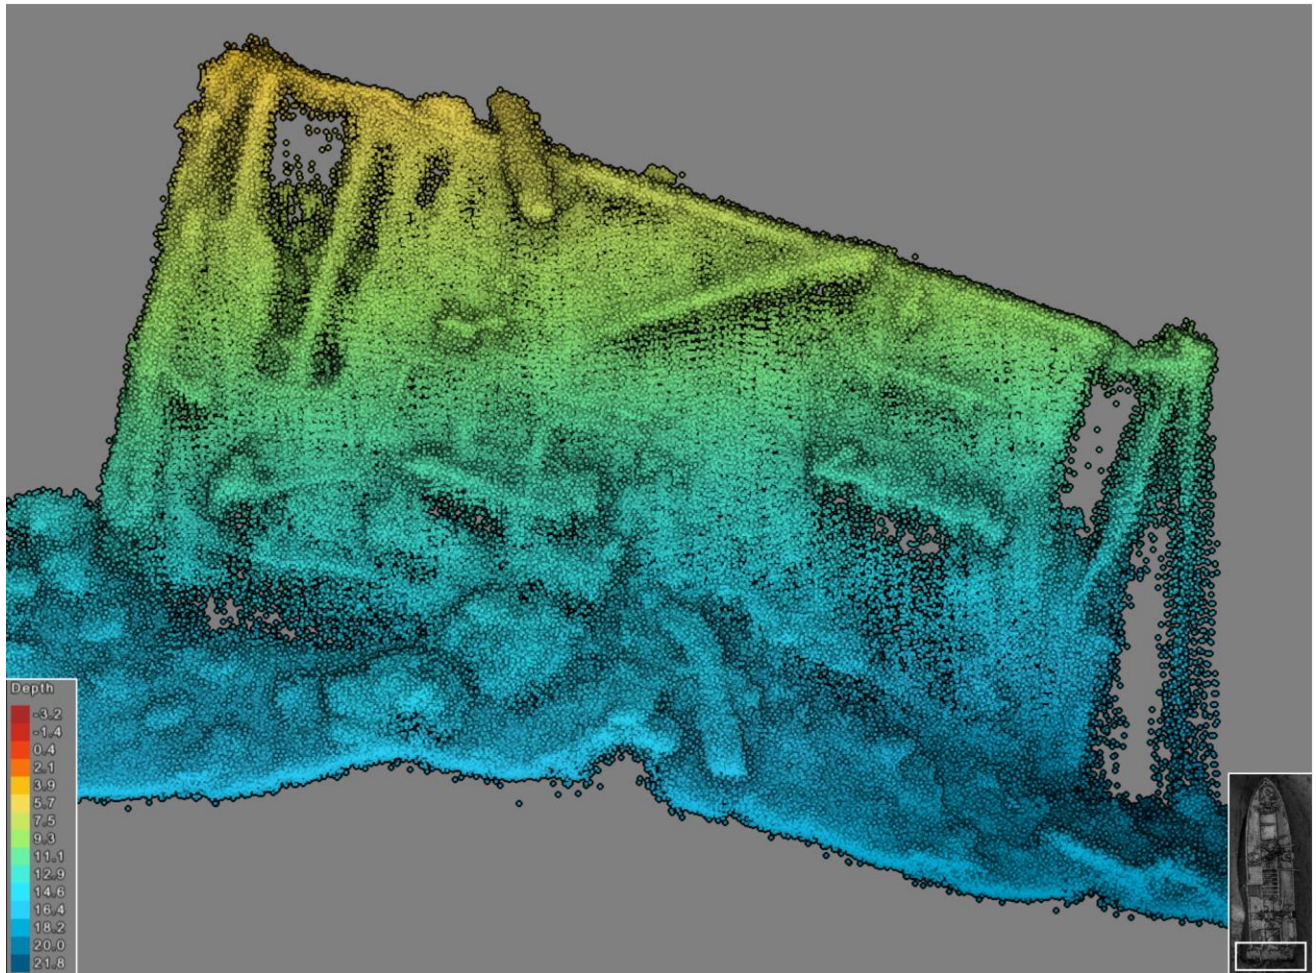
4.1.4 Key area 3, aperture (aft end, forward section) (Figure 7).

Figure 7. Point cloud image of the apertures, key area 3.

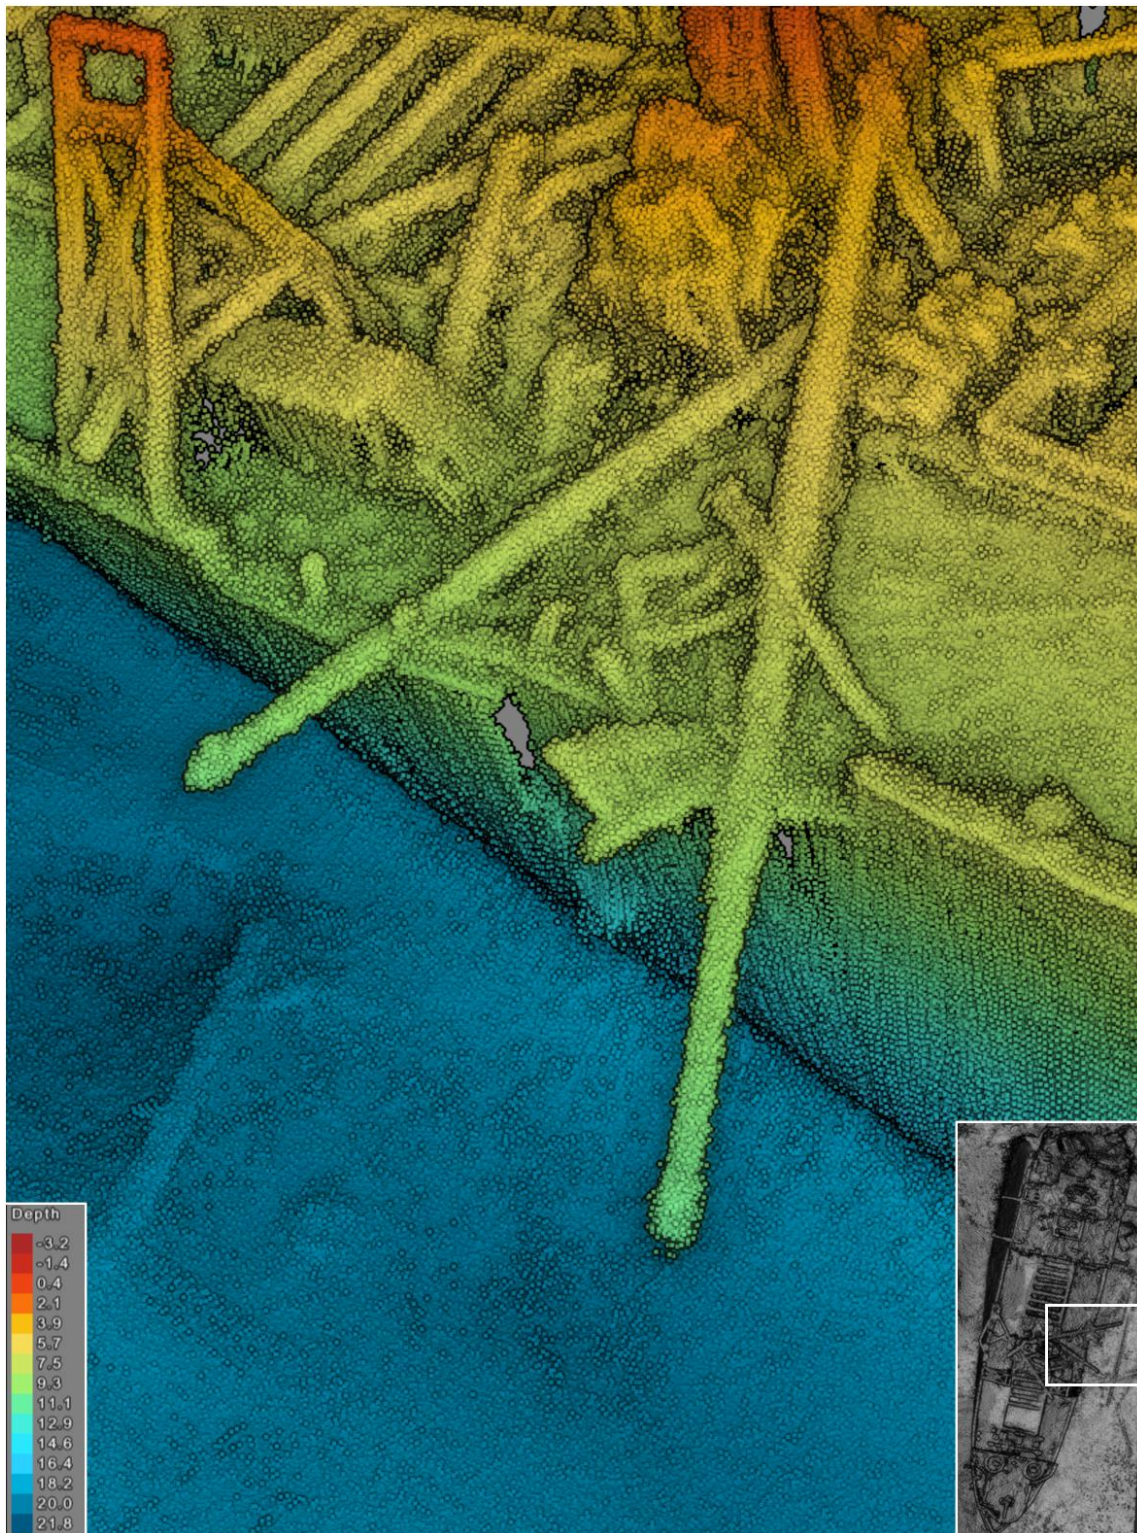
4.1.5 Key area 4, split in the hull (starboard side, aft section near the aft mast house) (Figure 8).

Figure 8. Point cloud image of the split in hull, key area 4.

Key areas 4 and 5 represent the two ends of the same feature, namely a transverse crack across the rear hull section. Like the forward section, the rear section is hogging and potentially breaking in two about halfway along its length. The split appears to be occurring just forward of the mast with the mast remaining upright with respect to the stern part as it drops away from the forward part.

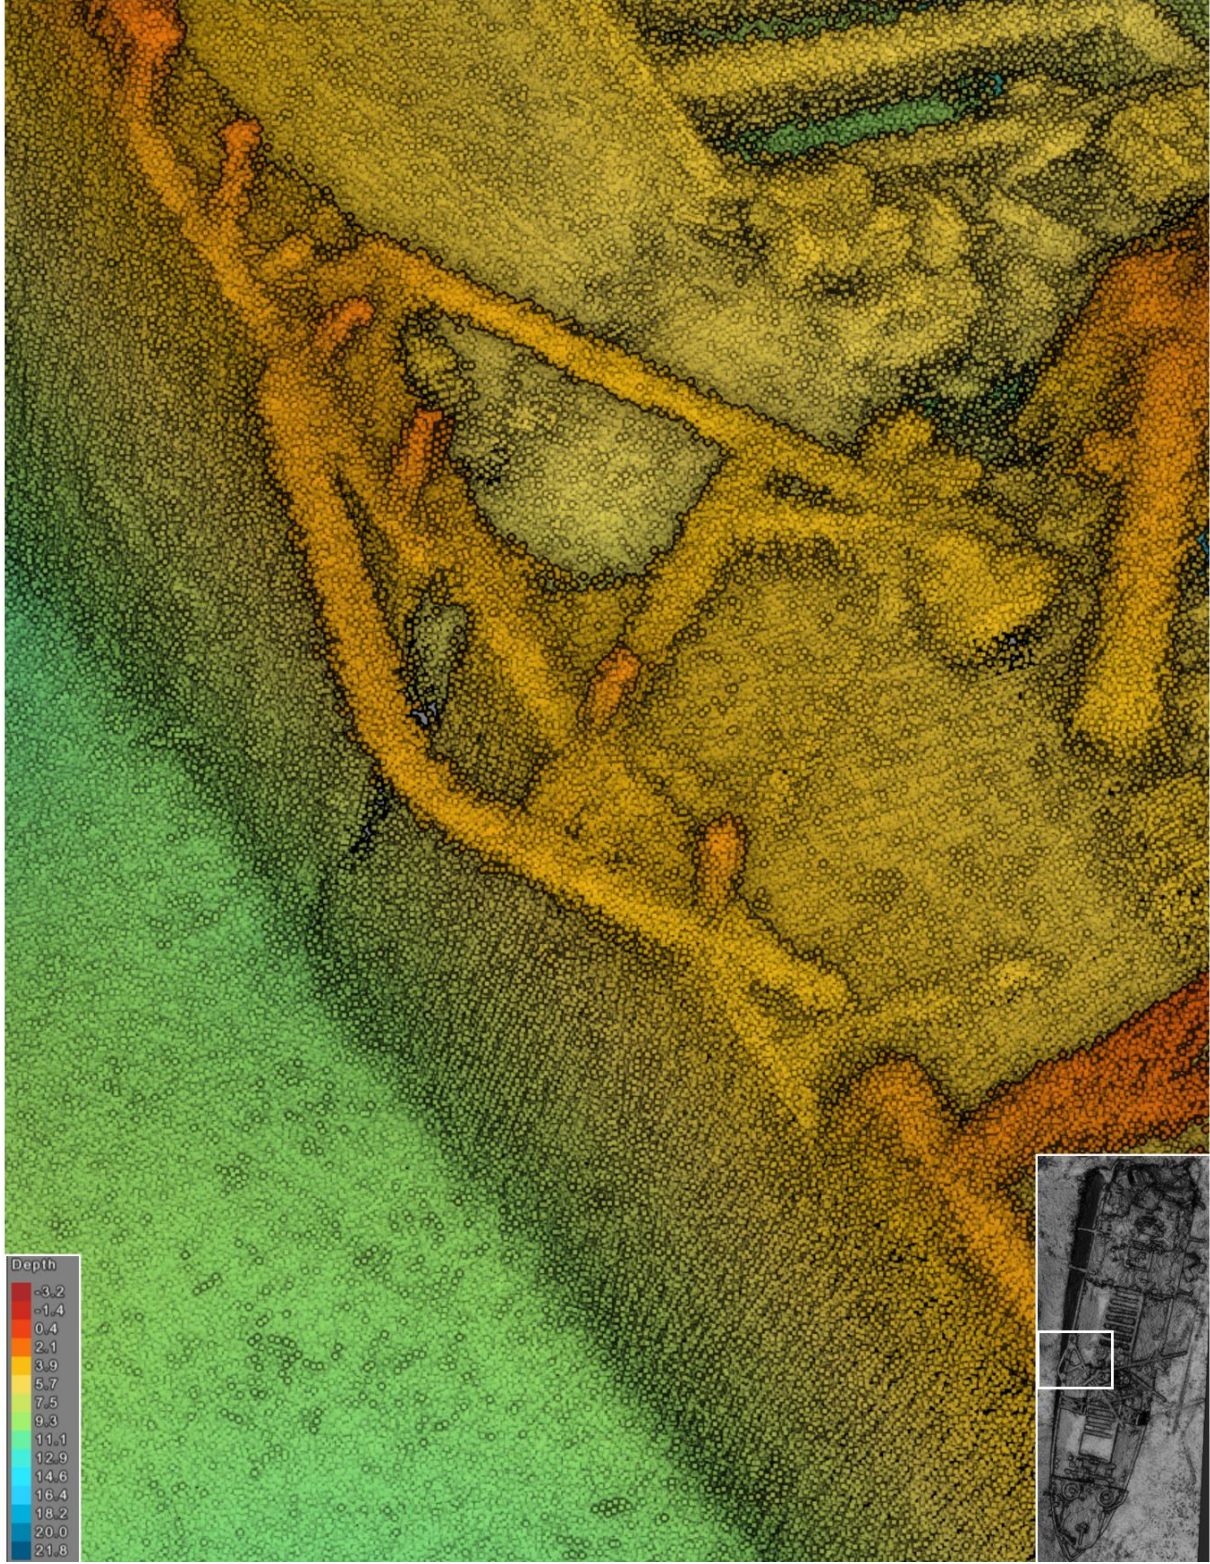
Key area 5, split in deck and split in the hull (aft section, port side) (Figure 9).

Figure 9. Point cloud image of the split in deck, key area 5.

One notable change has been observed comparing the 2022 survey and the 2023 survey. The port side deck has collapsed between the 'tween deck hatch and the outer railings. A noticeable height difference of 0.55m has been observed (Figure 21). The total length of this collapse has been observed to exceed 6m (Figure 22) in north/south direction from the probable transversal split mentioned in section 4.2.6. This area has no ID, but because of the proximity to a key area it is proposed that an ID is assigned to it.

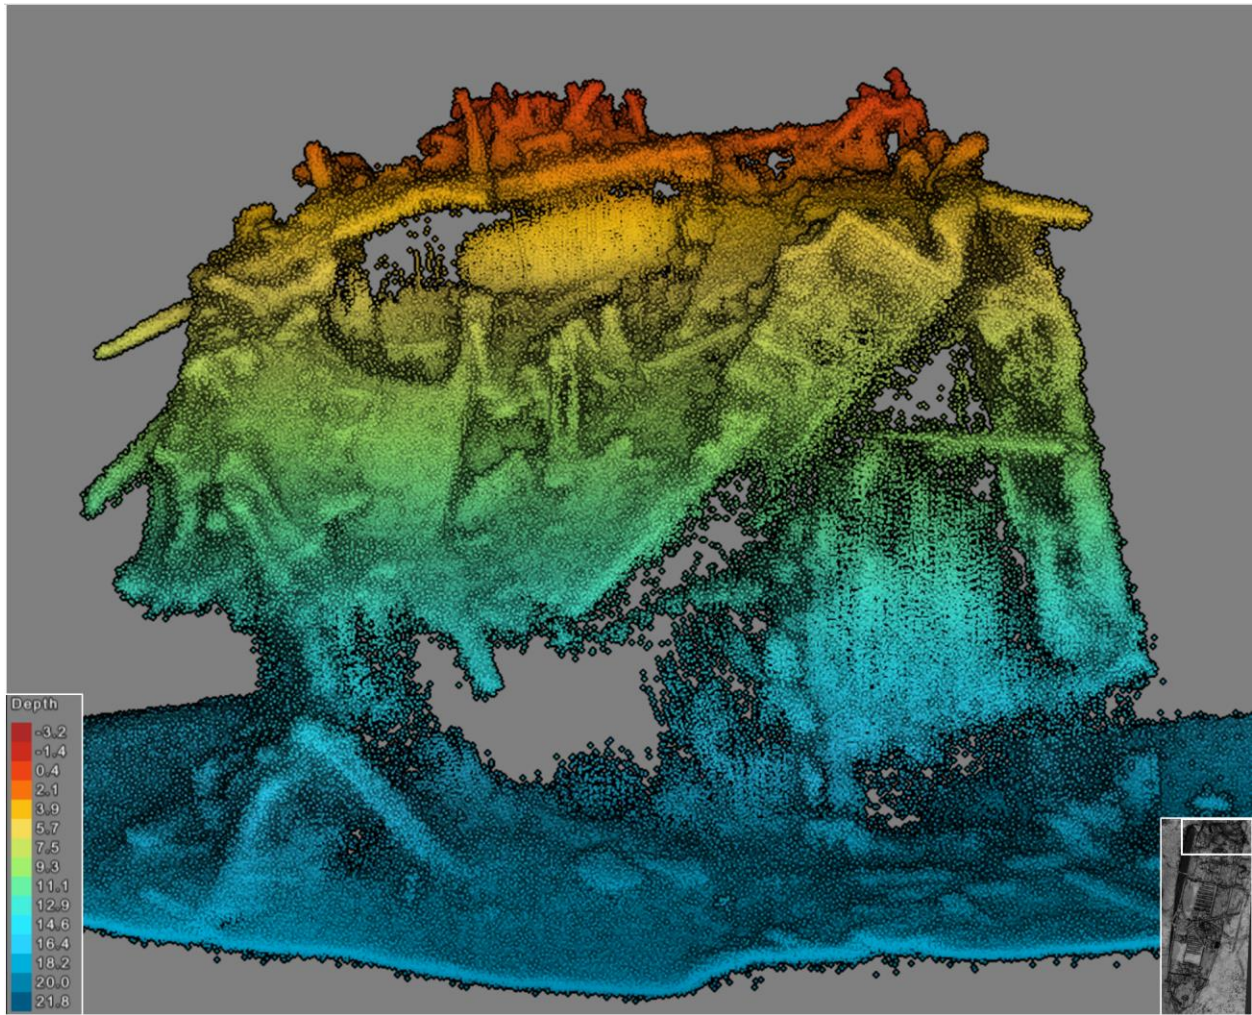
**4.1.6** Key area 6, boiler room casing, collapsing bridge deck and the collapsing boat deck (forward end, aft section) (Figure 10).

Figure 10. Point cloud image of the collapsing bridge area, key area 6.

This area was left unsupported when the ship broke in two back in 1944. Consequently, it has been badly affected by wave and current action and is steadily collapsing and falling into the gap between the two halves of the vessel. This area has showed significant degradation in earlier surveys and continues to do so between the 2022 and 2023 surveys.

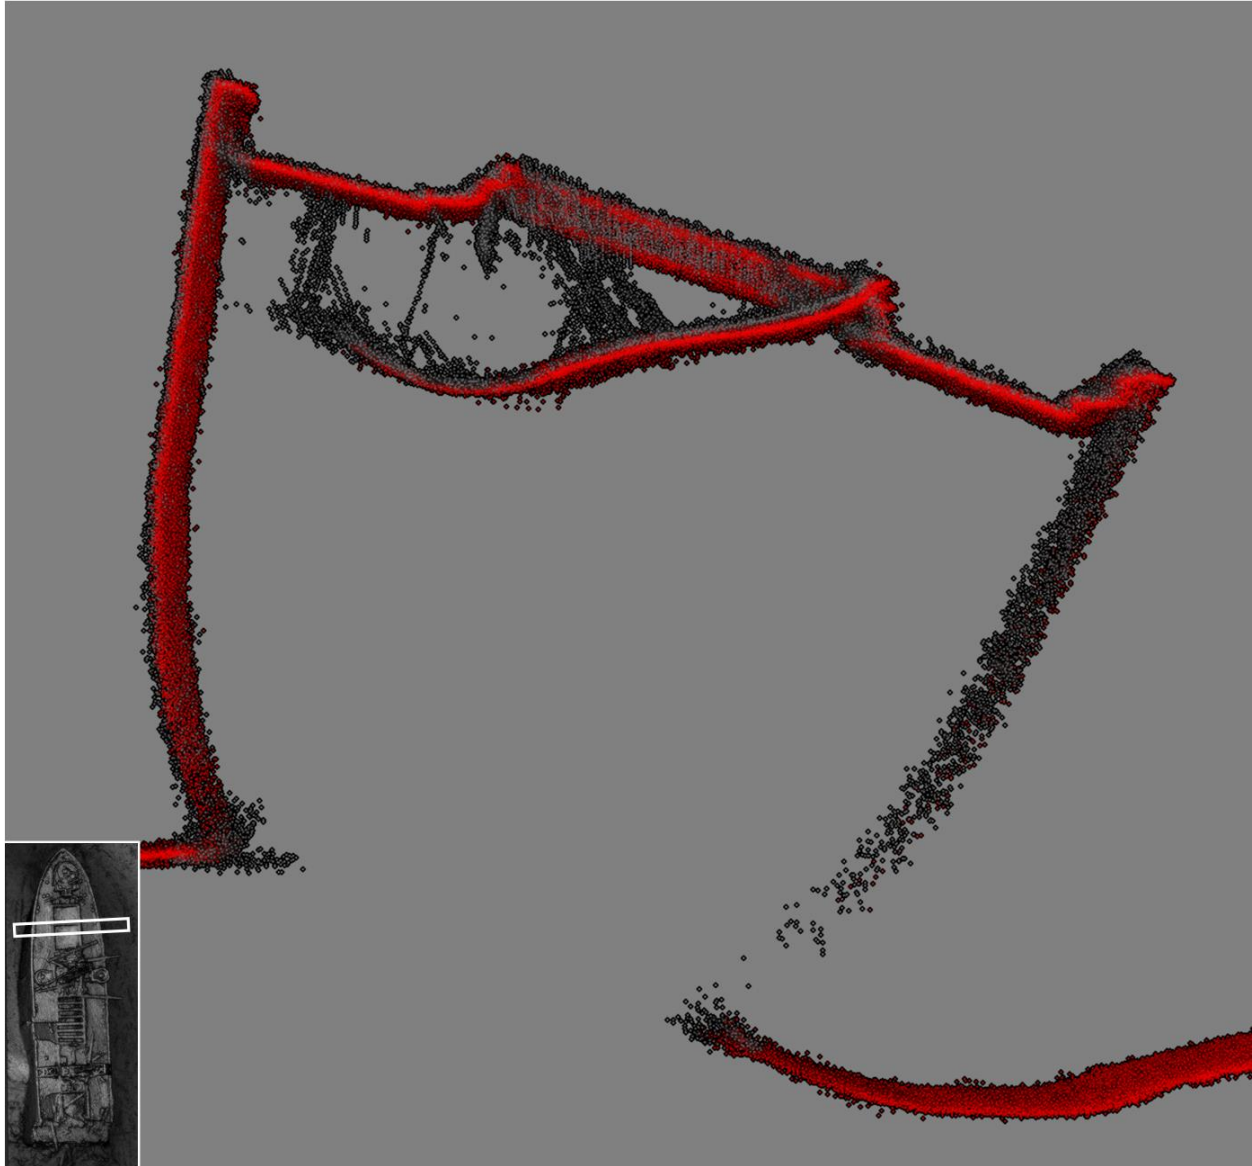
The hatch cover is missing as are all but one of the hatch cover supports. Sediment has settled in the 'tween deck space to a considerable depth, filling the starboard side to the top of the starboard side hatch coaming. The port side remains clear above the horizontal from the starboard hatch coaming. Apart from some undulations in the sediment surface there is no difference between the level identified by the 2022 full survey and the 2023 full survey (Figure 27, Figure 28). Comparisons between the 2022 and 2023 full surveys regarding sedimentation has been difficult in some areas as there has been a high level of noise in the 2022 survey. Because of this it has been difficult to determine what has been sediment or noise (see circle in Figure 28).

Notably there is no indication that the second deck nor the second deck hatch covers have collapsed. However, it is possible, but is very unlikely, that the sediment has filled both the 'tween deck area and the lower hold.

Figure 27. Cross section through the hull at the forward end of no. 1 hatch. Red full survey 2023, grey full survey 2022.

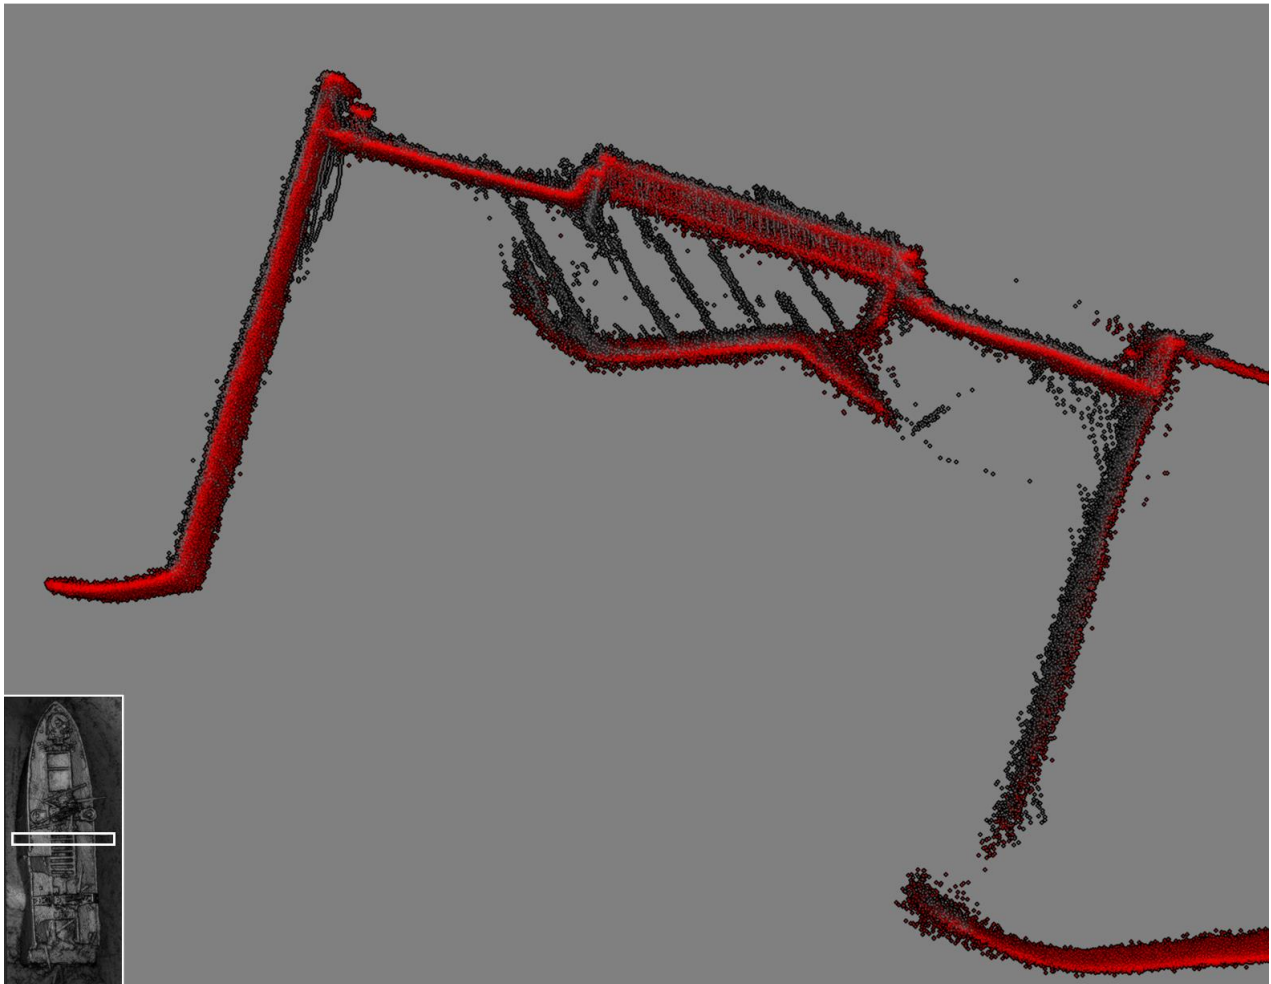
Sediments are visible in hold 2, but not to the same extent as in hold 1. The sediments have not filled the starboard side of the 'tween deck area up to the coaming seen in the no.1 hatch (Figure 29, Figure 30, Figure 31). This may be because of cracks in the hull sides at this location which could allow water to flush through and so remove the upper most sediment layers. A previous

report (2022) suggested is also possible that the second deck has partially collapsed where it joins the port and starboard hull (Figure 30), but data collected in the full survey 2023 cannot confirm or deny that statement. However, there is evidence of a reduction in the amount of sediment in the aft end of hold 2 (Figure 31, white circle) of approximately 70cm, which might suggest that the hatch to the second deck may be compromised at this location.

Figure 29. Cross section through the hull at the forward end of no. 2 hatch. Red 2023 full survey, grey 2022 full survey.

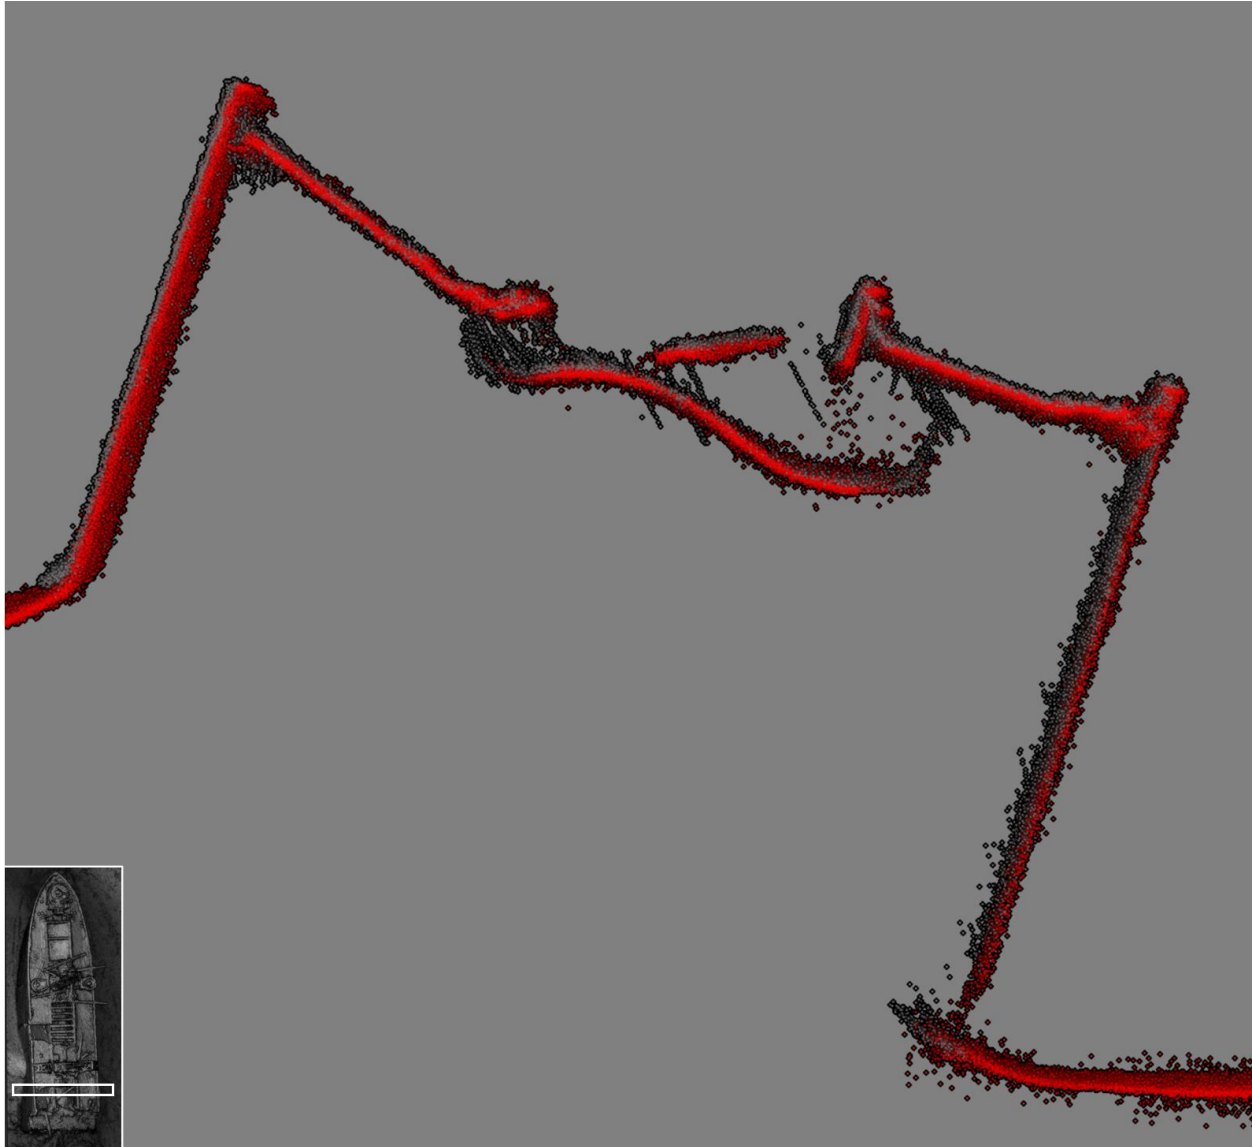
4.4.4 Hold 3 is the rearmost hold of the forward section. The rear bulkhead of this hold forms the rear of the forward section, the vessel having broken in two immediately aft. Although the lower hold remained with the forward section, the bulkhead at the rear of the ‘tween deck space and the section of the upper deck above it were carried away leaving this area open. The outer hatch cover has gone as have all the cover supports although there is a beam, most likely a cover support, lying on the starboard side (Figure 32).

Figure 32. Cross section through the hull at the forward edge of no. 3 hatch. Red full survey 2023, grey full survey 2022.

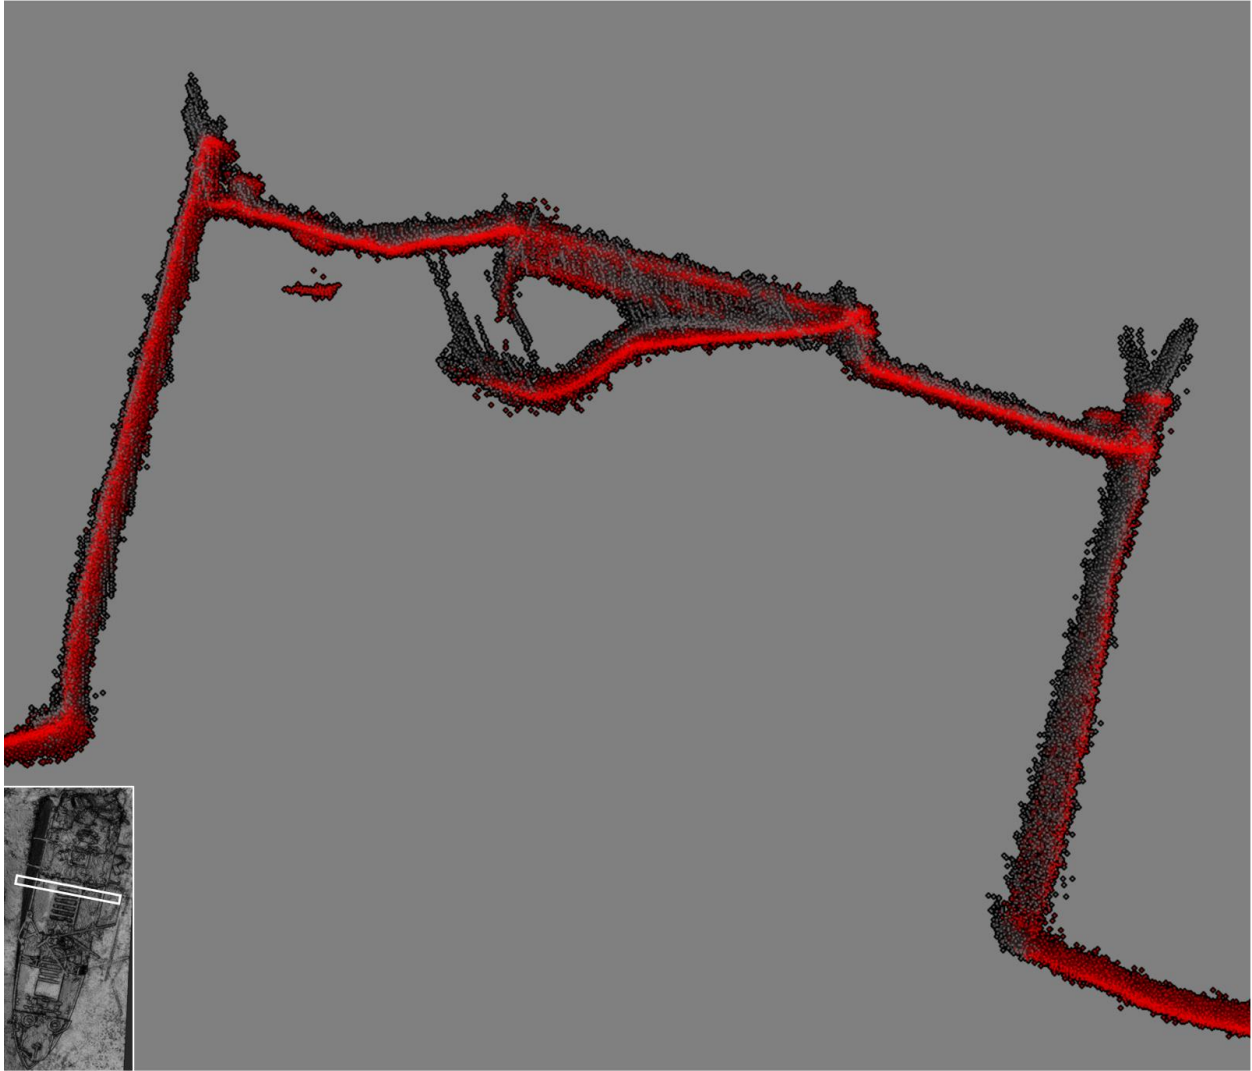
coaming (Figure 34). There is a slight difference in sediment depth on the starboard side between the 2023 and 2022 full surveys.

Figure 34. Cross section through the hull at the forward end of no. 4 hatch. Red full survey 2023, grey full survey 2022.

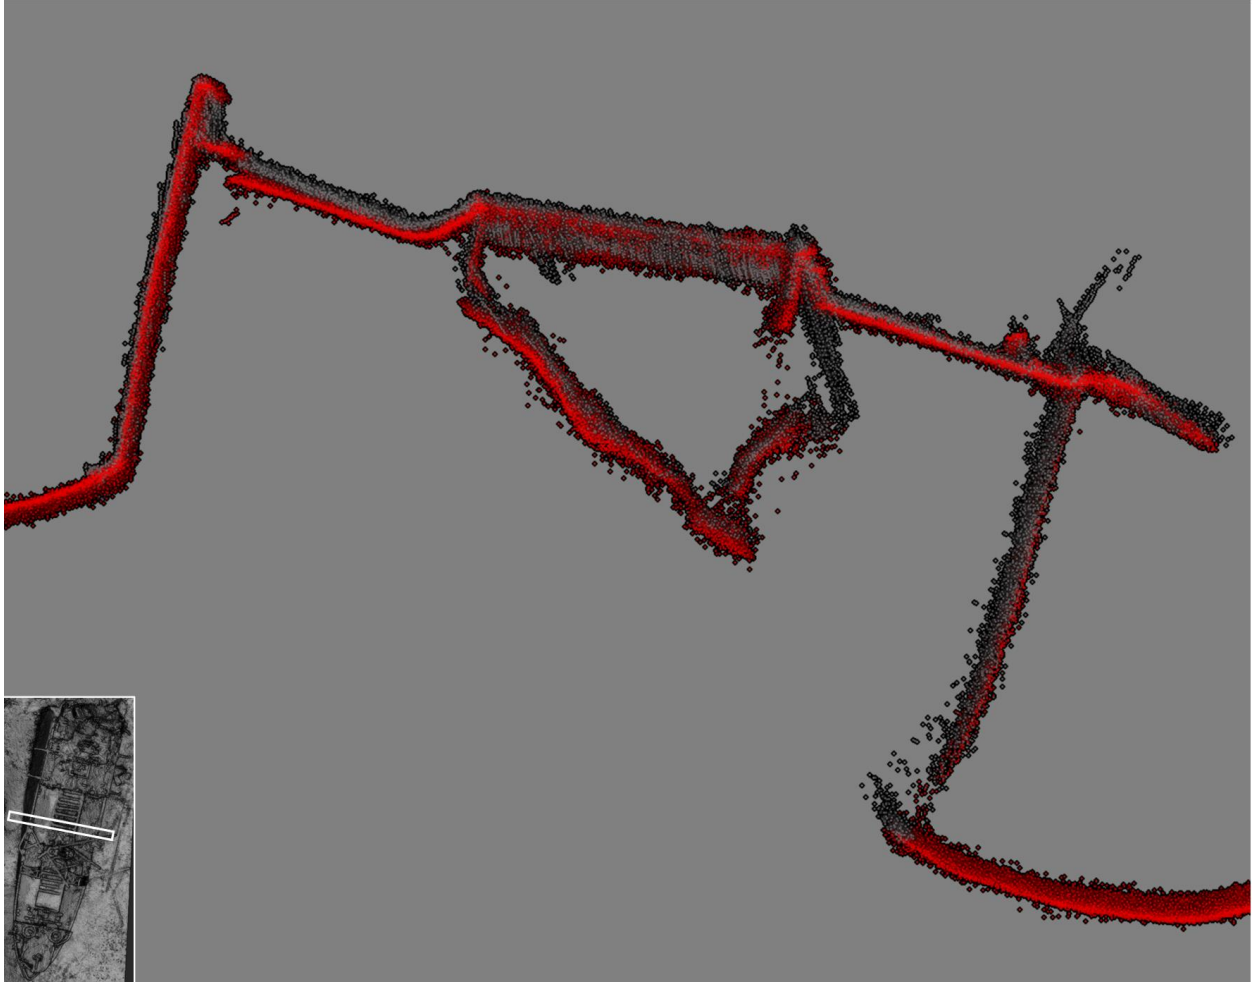
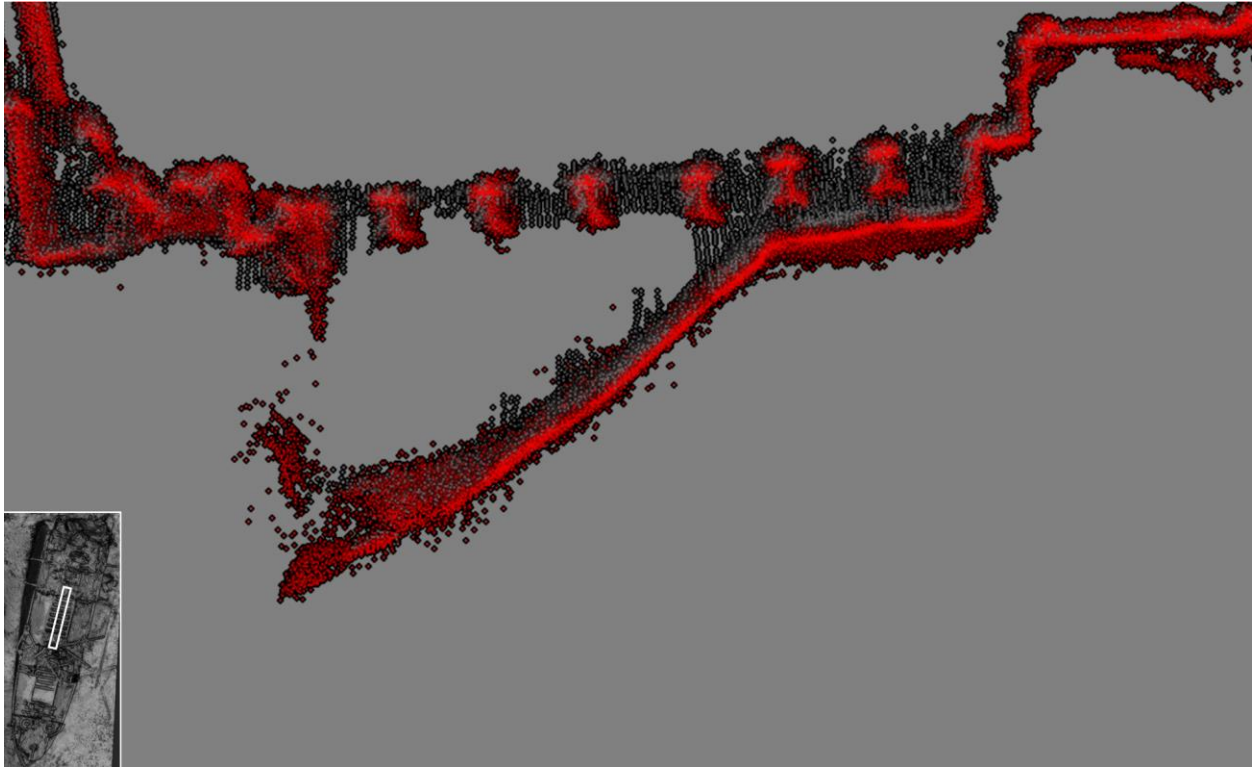
The rear of the hatch area shows the sediment layer descending below the level of the second deck due to some form of collapse (Figure 35, Figure 36), probably a partial collapse of the lower hatch cover which occurred between 2010 (where the survey showed the sediment above the second deck) and the 2017 survey where the sediment was just below the second deck. The data from the full survey 2023 does not differ from the 2022 data. However, comparisons between earlier surveys were not possible as that data has not been supplied.

Figure 35. Cross section through the hull at the rear end of no. 4 hatch. Red full survey 2023, grey full survey 2022.

Figure 36. Longitudinal cross section through hold 4. Red full survey 2023, grey full survey 2022.

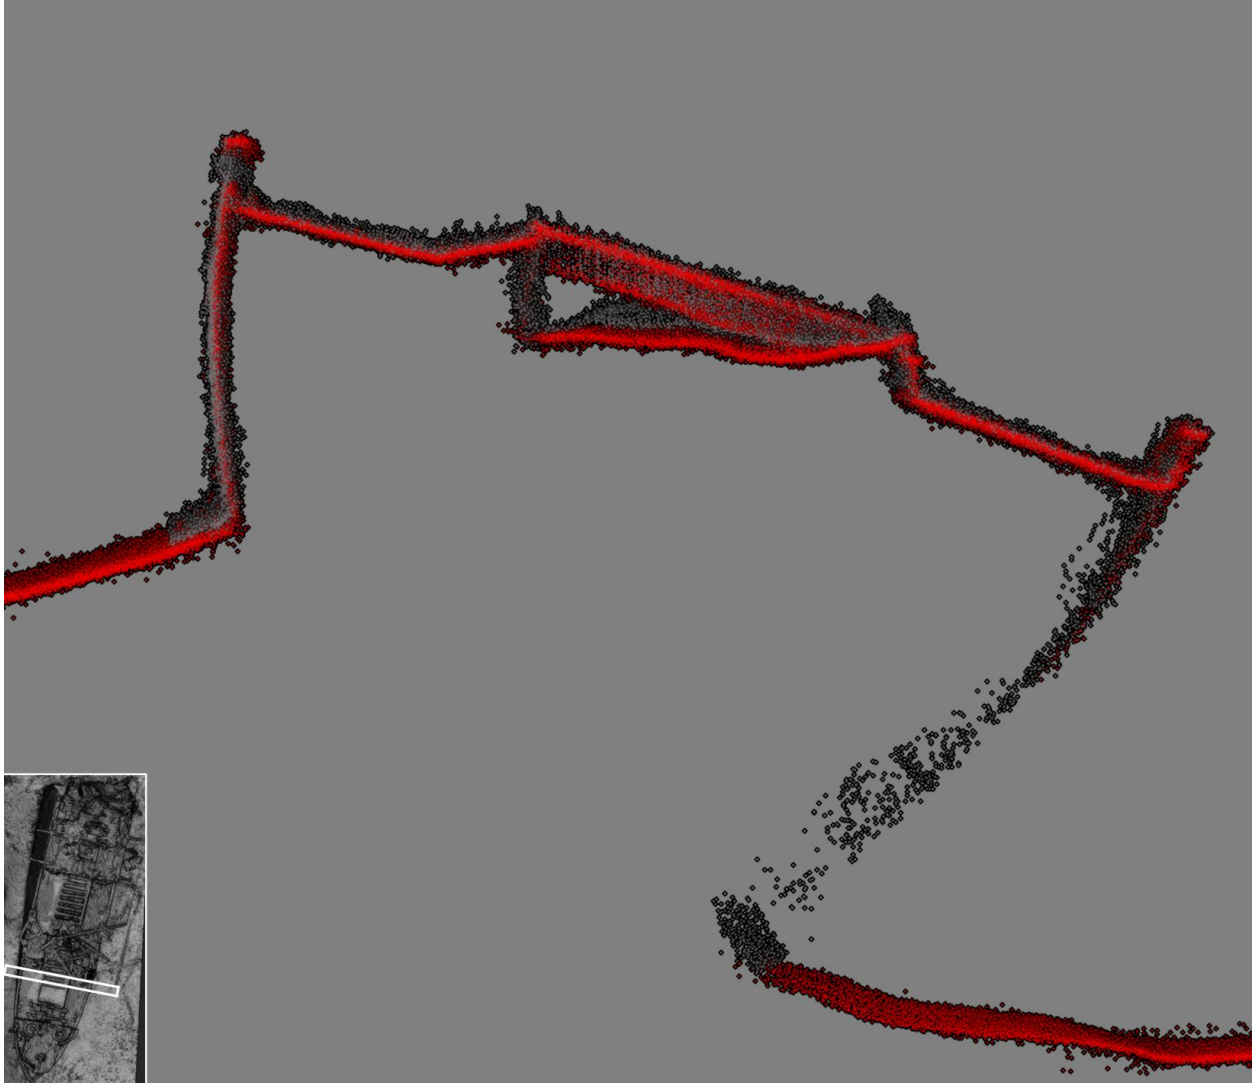
Hold 5 is the rear most hold. The forward four of the six hatch cover supports remain in place. Sediment levels in the 'tween deck space looks like hold 1, in that the starboard side is filled while the port side remains clear above the level of the horizontal from the top of the hatch coaming (Figure 37). There is no indication that the second deck or the lower hatch cover have collapsed. There is less sediment in this hold in the 2023 full survey than the 2022 full survey but no indication of any structural differences.

Figure 37. Cross section through the hull at the forward of no. 5 hatch. Red full survey 2023, grey full survey 2022.
