Report on the investigation of
the contact of the chemical tanker

Ali Ka

with Oikos Jetty 2

on 25 October 2022

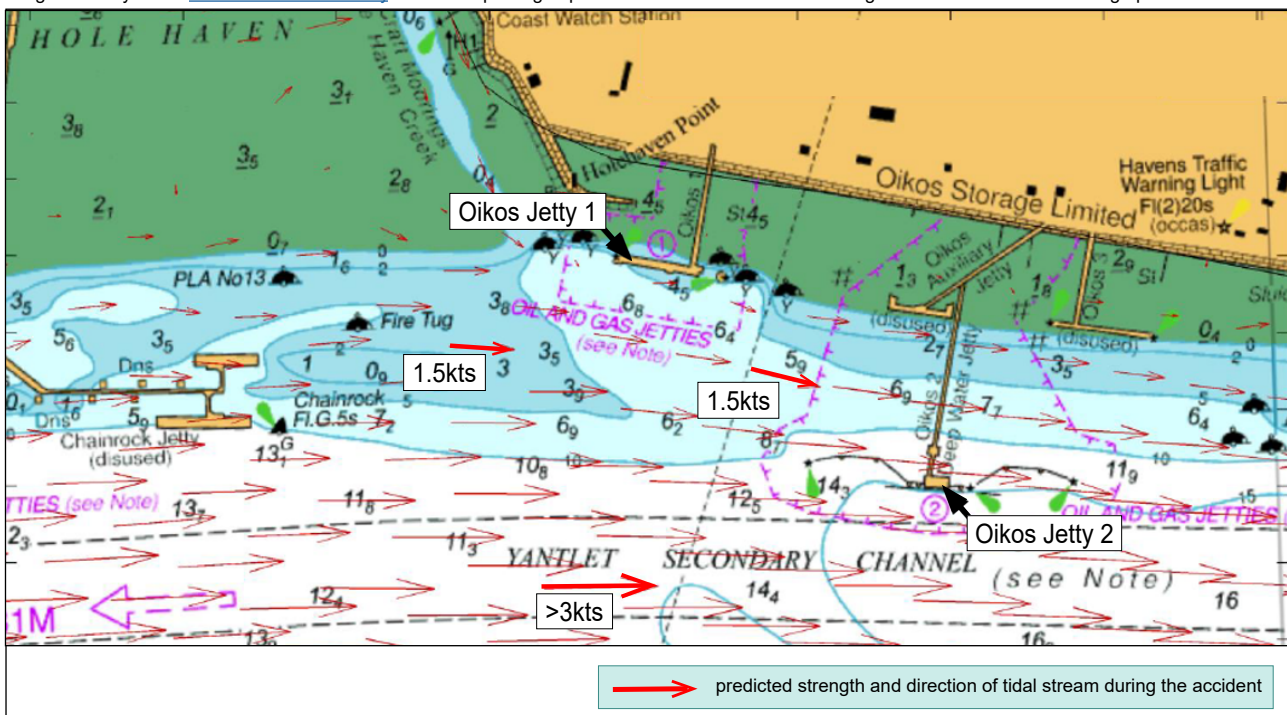
Figure 8: Tidal stream at Oikos on 25 October 2022 at 0427 UTC+1 (high water plus 3.5 hours)

The night of 24/25 October 2022 was dark with moonrise occurring at 0727, and sunrise at 0738. Visibility was good. Predicted tidal heights at Coryton (adjacent to Oikos) were 3.29m at 0400 and 2.16m at 0500. The actual tidal heights observed on 25 October 2022 were approximately 0.1m above predictions. At 0400, the wind was 15kts from the south-west and it was just over 3 hours after high water at Thames Haven. The tidal stream was ebbing towards the east at approximately 0.5kts just off the berth at Oikos 1, increasing to over 3kts in the Yantlet Channel (**Figure 8**).

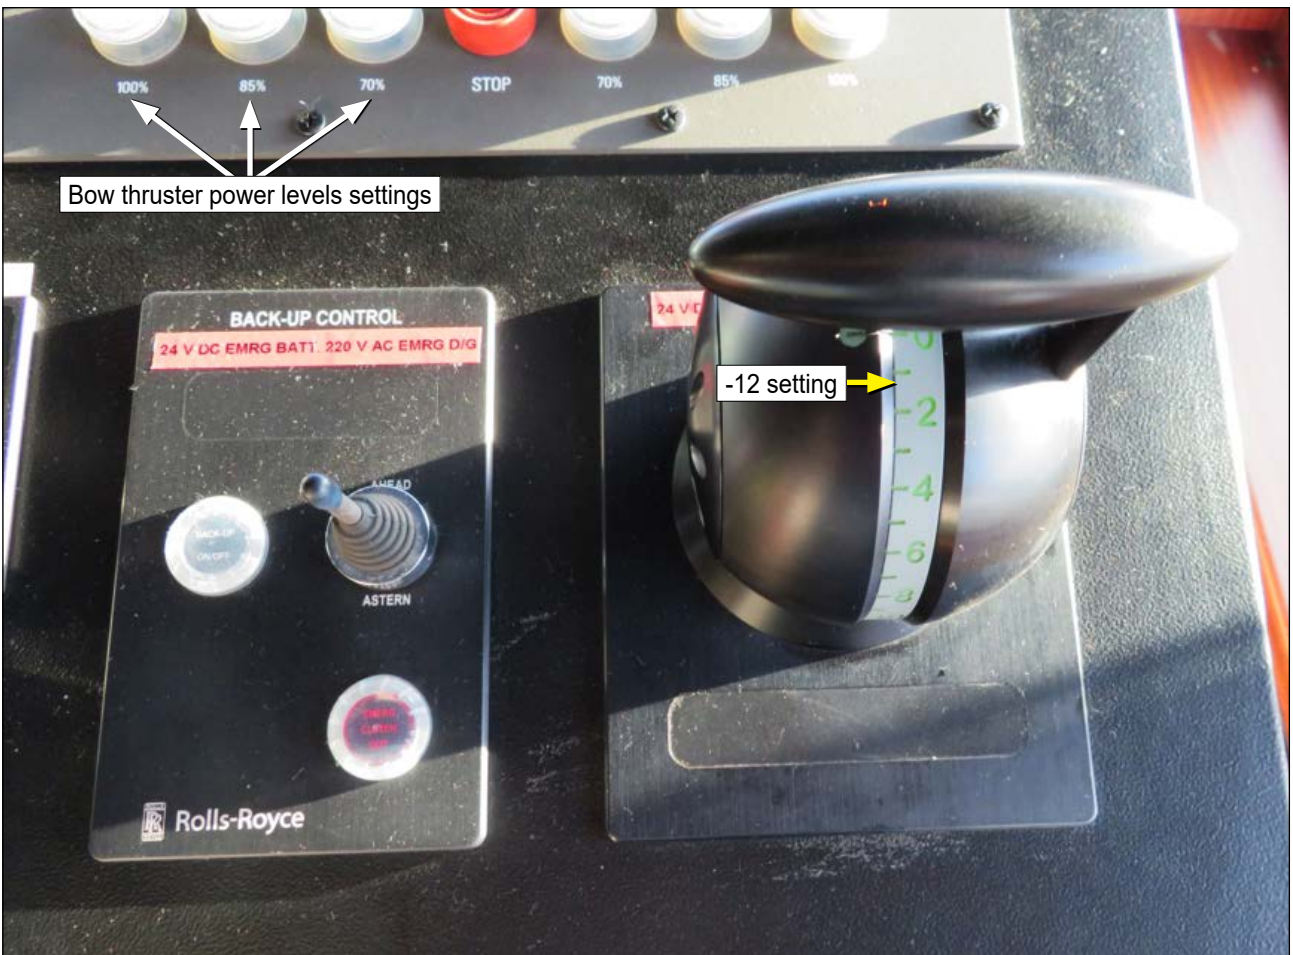
Figure 10: Propulsion control unit

The ship's top speed was 15kts and manoeuvring was normally conducted below 3.5kts as the bow thruster became ineffective above that speed. The master briefed pilot A that, when operating astern propulsion (**Figure 10**), a setting of -12 produced a *neutral effect* and stated that astern propulsion was *lazy* and *very, very slow*. The bow thruster had three power level settings: 70%, 85% or 100%, to either port or starboard. The master also stated that the bow thruster might alarm if set to 100%.

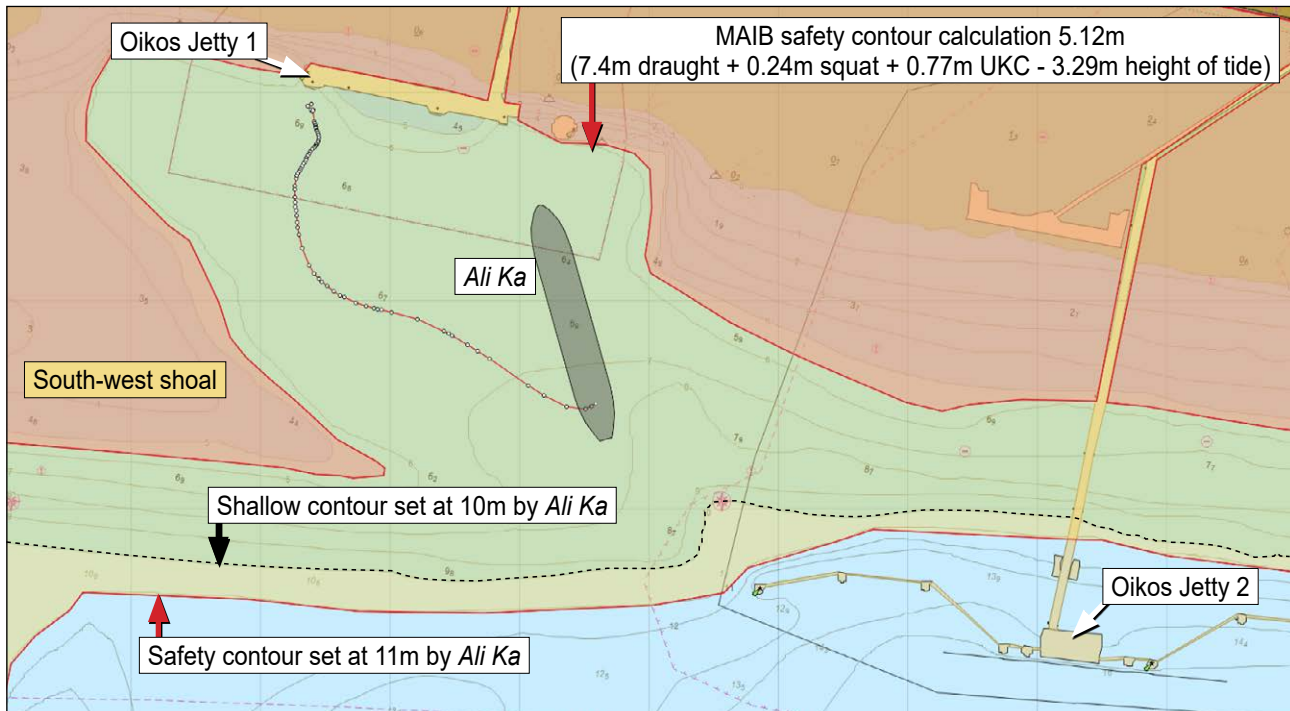
Figure 15: Depth contours relevant to *Ali Ka*'s departure from Oikos 1

checklists did not suggest recording the ECDIS safety settings in use. Consequently, there was no link from the checklists to explicit monitoring of the ship's horizontal proximity to ECDIS contours in the list of roles and responsibilities. Without this link, in this case where 1m contours were available through the high-density ENC's of the area, and where *Ali Ka* had marked the area off Oikos 1 as unsafe (**Figure 15**), there was limited drive towards effective monitoring of safe navigation while under pilotage. This was not recognised by pilot A or the master and so the bridge team did not subsequently provide effective support during the manoeuvre.
