AAIB Bulletin

7/2024

Boeing 737-8K5	G-FDZS	4-Mar-24	3
----------------	--------	----------	---

ATR 72-202	G-NPTF	17-Jan-23	13
------------	--------	-----------	----

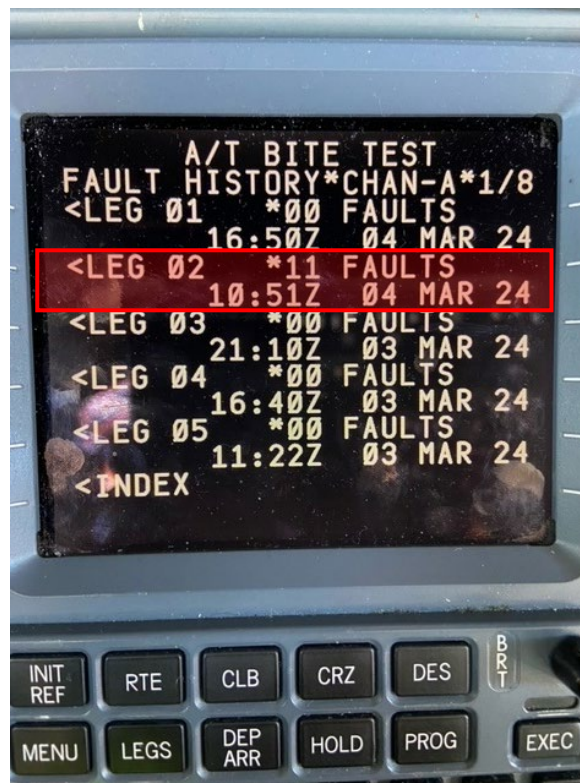
Figure 2

The MCDU allows maintenance personnel to interrogate the health of several aircraft subsystems, including the A/T, and to investigate any logged faults. The fault history for the A/T, (Figure 2), shows that 11 faults were logged for the incident flight to Las Palmas - LEG 02 - but no faults were logged on the return flight to the UK, or on the preceding day.

A/T fault history for the incident flight and the preceding day

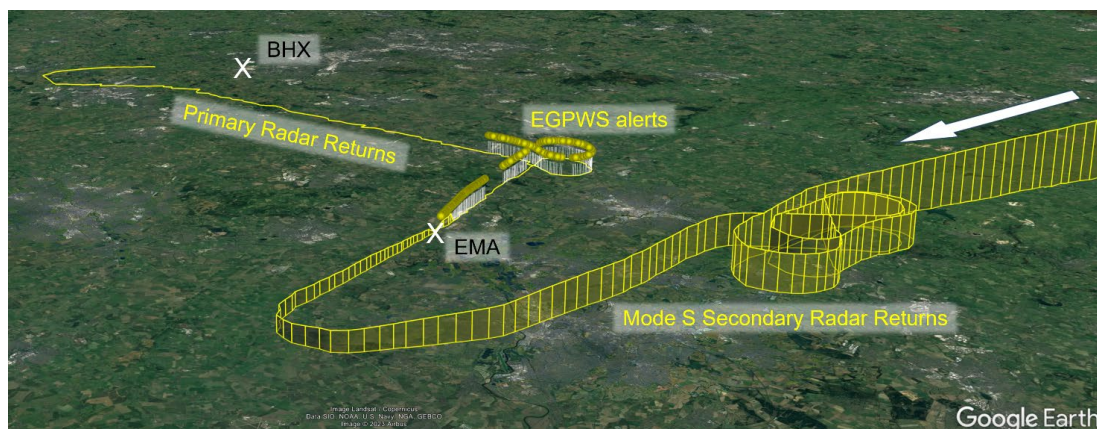
Figure 3
Radar ground track

The recorded radar track data for the approach to EMA and diversion to BHX are shown in Figure 3. The radar returns for the approach to EMA included pressure altitude from the aircraft's Mode S transponder. However, from 0418:51 hrs, with the aircraft within a nautical mile of the runway at about 400 ft aal, the transponder transmissions stopped, and the aircraft continued to be tracked only by primary radar for the remainder of the flight.

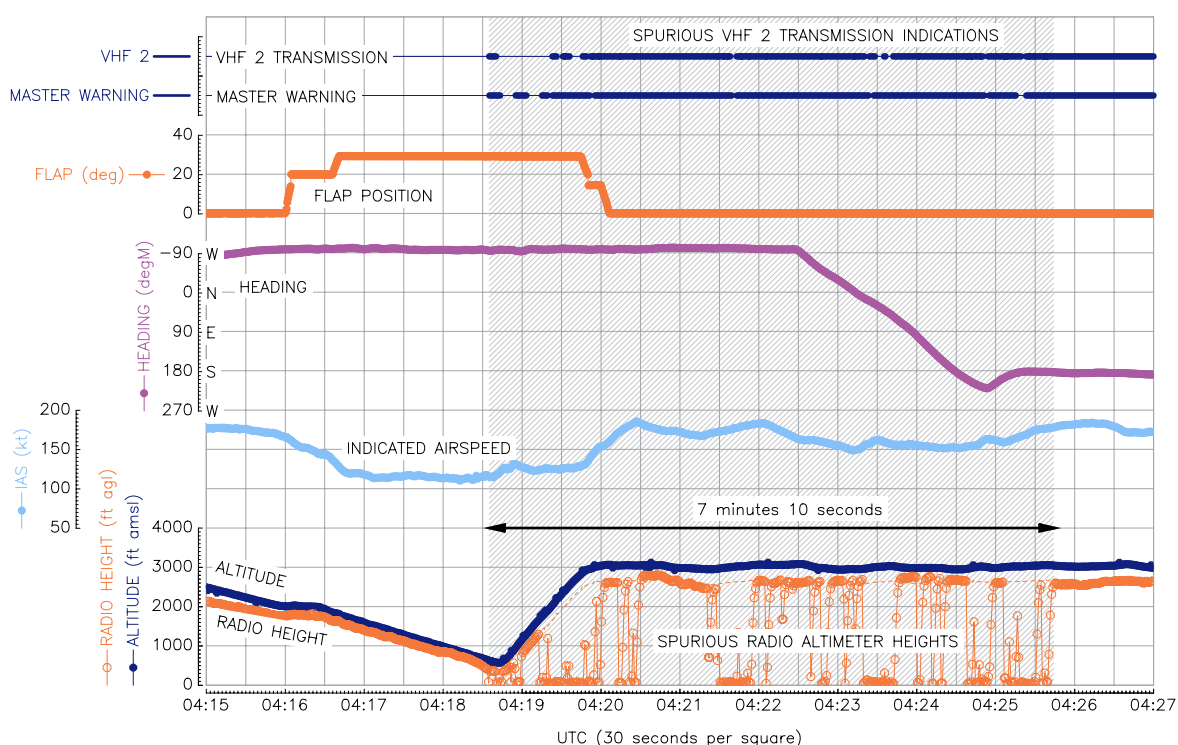
Figure 4
FDR data

Data from the aircraft's FDR show that just after 0418 hrs the master warning alert was triggered together with spurious VHF 2 transmission indications and radio altimeter heights (Figure 4). The spurious heights were intermittent over a period of seven minutes and ten seconds and were sufficiently low to trigger 31 EGPWS alerts (2x "PULL UP", 6x "TERRAIN, TERRAIN", 6x "TOO LOW TERRAIN", 12x "TOO LOW GEAR" and 5x "BANK ANGLE, BANK ANGLE") – see Figure 3 for the location of the aircraft during these EGPWS alerts. Note that some of the alerts coincided with others so not all were heard on the CVR.

The spurious VHF 2 transmission indications continued for the remainder of the flight as did the master warning alert.

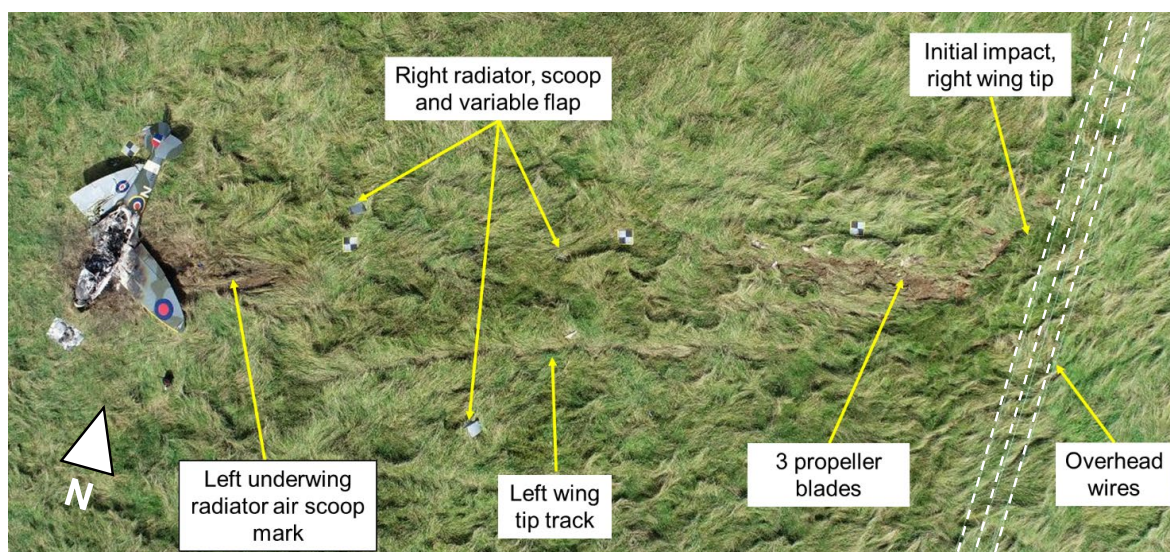
Figure 1

The aircraft came to rest in a field approximately 100 m from a road opposite houses. The initial impact point was directly below 11kV power lines that crossed the field in a north/south direction; there was no evidence the aircraft touched any of the power lines during the accident (Figure 1). The ground marks showed the right wingtip hit the ground first with significant force. The impact mark and trail of debris suggested the aircraft was travelling in a westerly direction. Three propeller blades and a substantial part of the spinner were found together a short distance from the first impact point. Gouging and disruption to the soil from there on showed the aircraft to have carried on forwards until the left radiator fairing on the underside of the left wing ploughed into the soil causing the aircraft to rotate to the left before coming to a stop. The aircraft remained upright throughout the accident sequence. A fire, centred on the cockpit area, caused extensive damage to the centre of the aircraft.

Accident sight overview

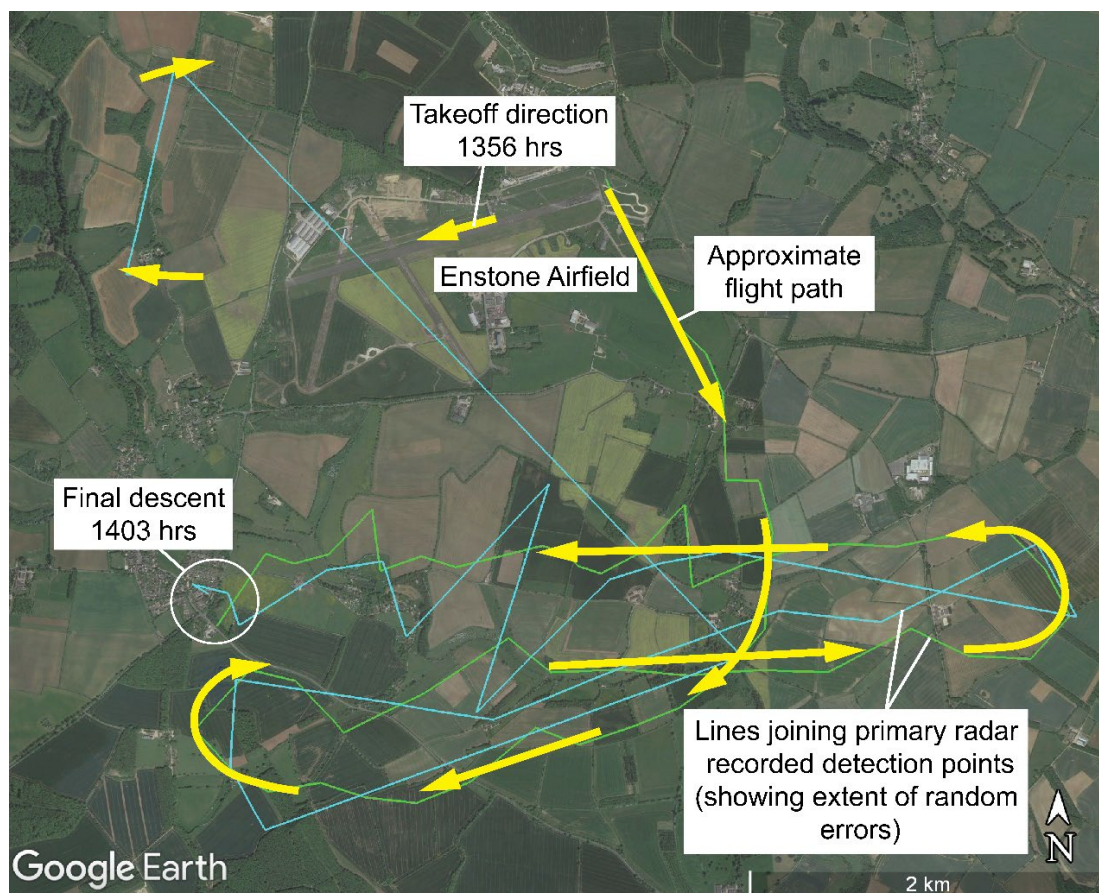
Figure 2
Approximate flight path

The aircraft was fitted with a transponder but there was no secondary radar detection of the aircraft. There was also no track recorded by the ground network associated with the electronic conspicuity device. The flight was detected and recorded by NATS primary radar. This provided the approximate flight path over ground when the aircraft was high enough to be in view of the radar installations but does not provide altitude information (Figure 2).

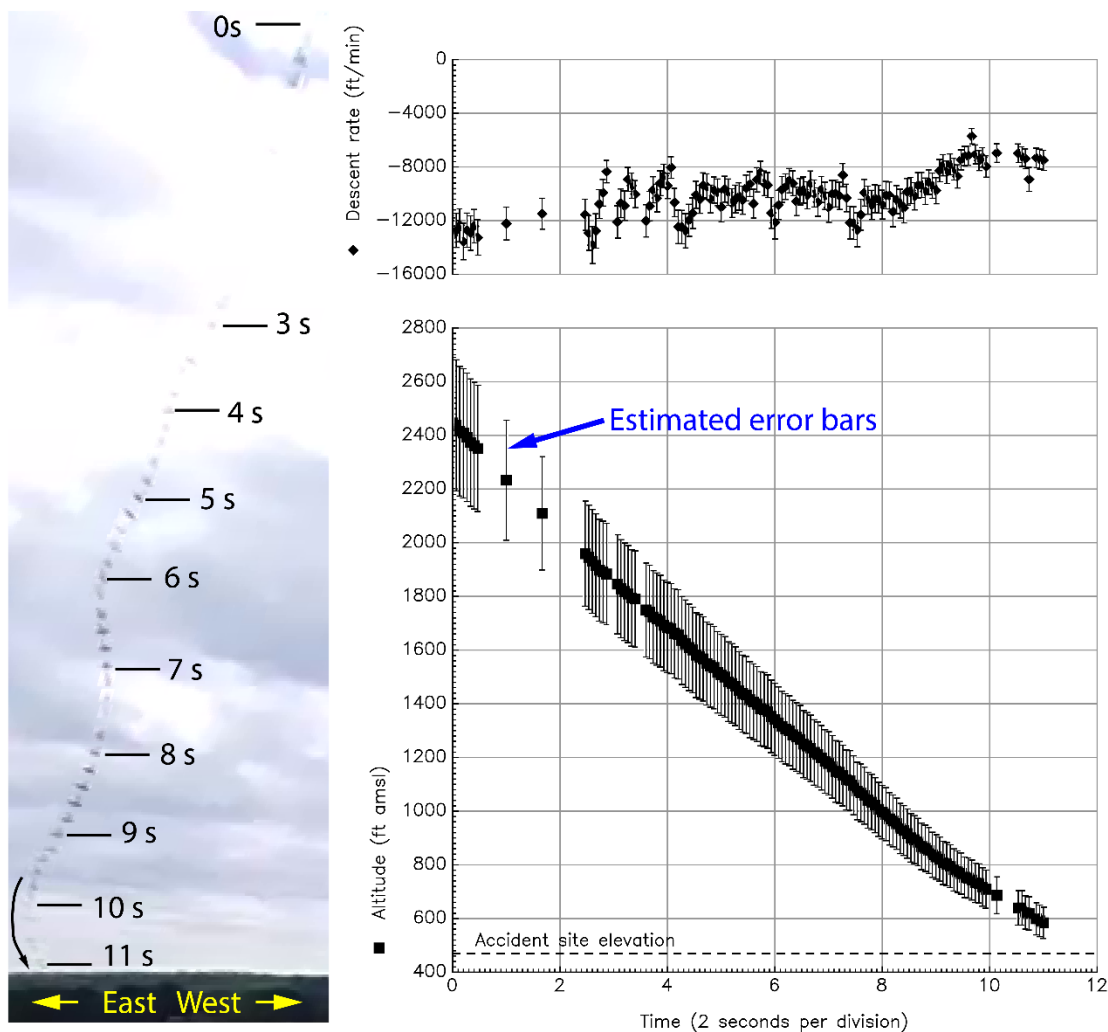
A south facing airfield CCTV camera recorded the last part of the final descent from approximately 2 km away. It did not show the aircraft at the entry to the descent which witnesses reported as being between 3,000 to 4,000 ft. Figure 3 shows a compounded image of the aircraft every 0.2 seconds extracted from a version of the recording that has been corrected for lens distortion and perspective. The aircraft size in the image is small compared to the image pixel size; however, rotation during the descent is still visible. The CCTV captured the descent which was generally from west to east ending with a flight path with an increasing component to the west. Combining the CCTV with the location of the accident site itself and the approximate ground track provided by the primary radar recording enabled calculation of the aircraft altitude profile. The derived data is shown in Figure 3. The errors associated with the calculations are shown as error bars. These are larger at high altitude due to distance uncertainty, but the resultant descent rate data is less sensitive to these errors.

Compound undistorted CCTV image and analysis of the final descent

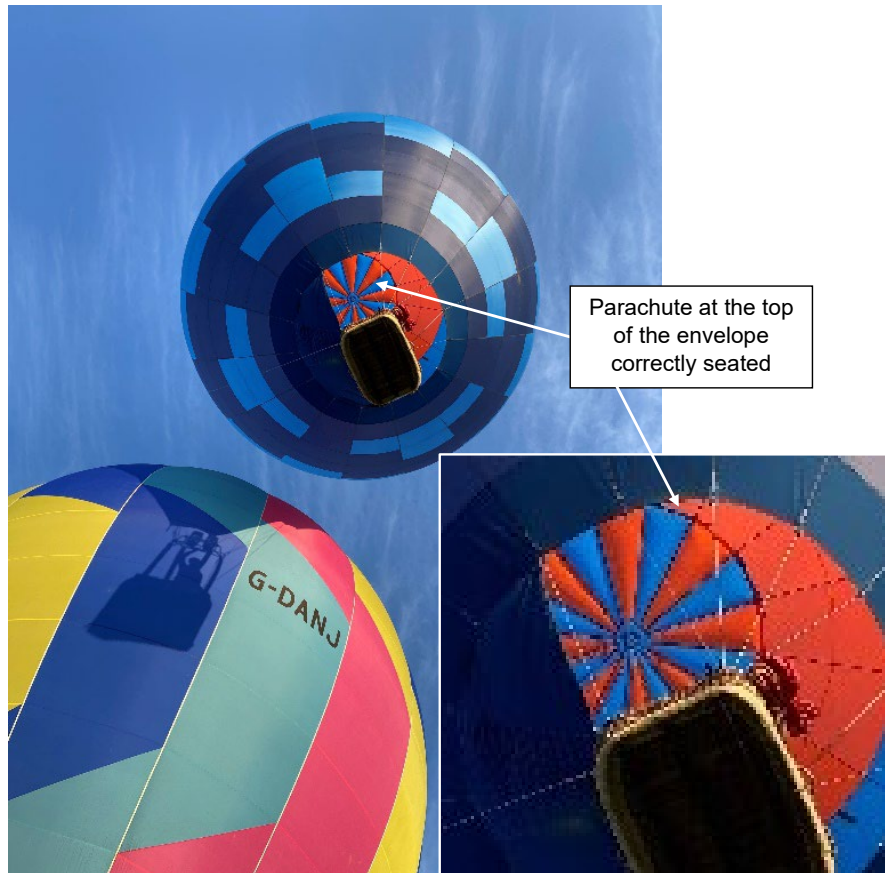
Figure 4

G-CMFS just after launch showing the parachute correctly seated

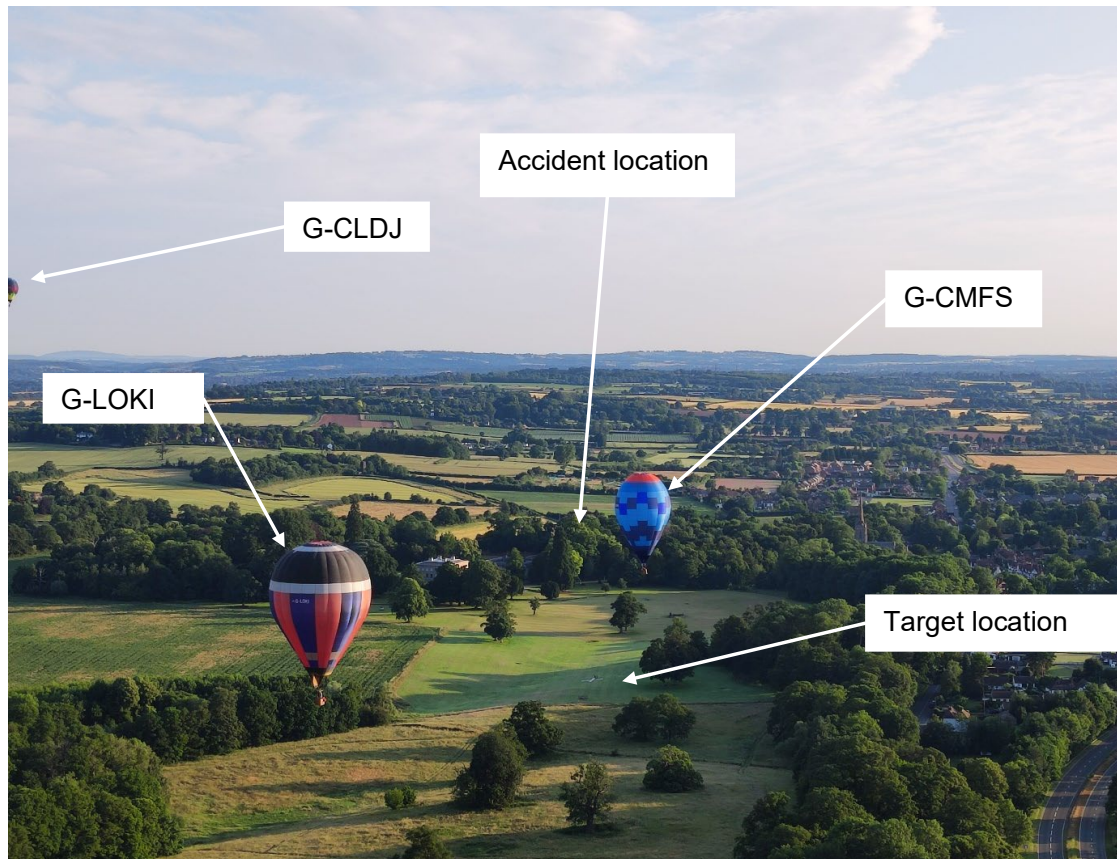
G-CMFS was the next balloon to approach the target. The pilot's electronic logger recorded that he dropped his marker at 0618:02 hrs at an altitude of 499 ft. The marker landed approximately 40 m from the target. G-CMFS was then seen to climb rapidly. G-LOKI and G-DANJ were close behind, followed by G-CLHS (which had flown at a lower altitude in slow wind so had taken longer to reach the target). Figure 5 was taken from G-CLHS as the balloons approached Ombersley Park.

Balloons approaching the target at Ombersley Park (taken from G-CLHS)

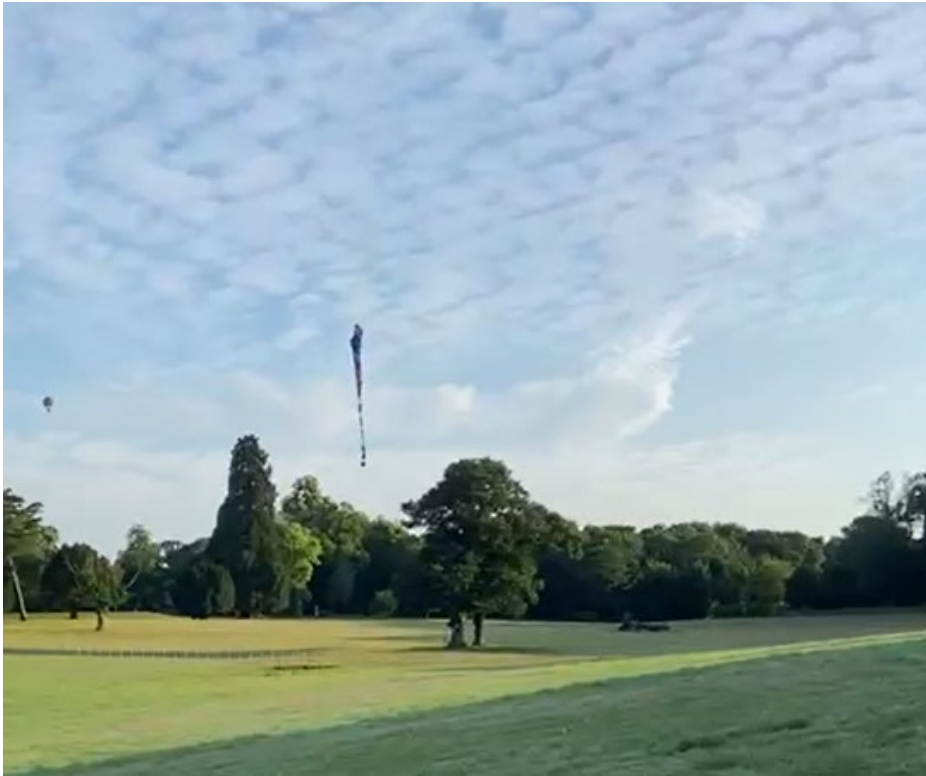
Two scorers were on the ground at the target location and they filmed and photographed the balloons as they approached the target. The footage showed G-CMFS's pilot approaching the target then climbing away and dropping his marker. 46 seconds later, one of the scorers saw G-CMFS falling and, as they both looked around their camera captured the final moments of G-CMFS's descent. Figure 6 was extracted from the video.

G-CMFS descending to the ground with the balloon streamered

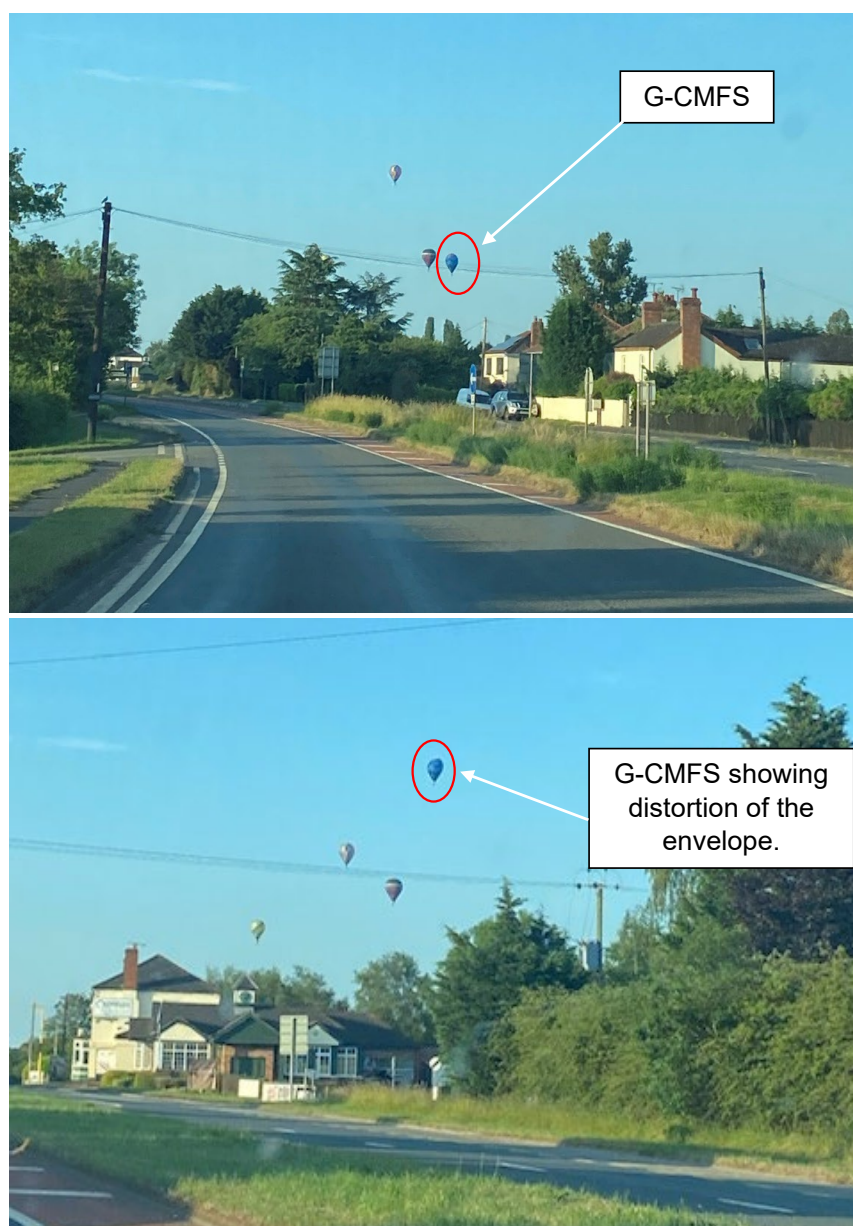
Figure 7

One couple at a petrol station on the A449 saw the balloons flying and took some photographs, which were all time-stamped at 0518 hrs (Figure 7). One of them commented that, within seconds of taking the second photo, "the blue one didn't look inflated properly, it looked like it did not have enough air in it". They described that one side of the balloon looked like it was pushed in at its widest part and "it looked like a half-moon shape". As this happened, they instantly saw the burner come on but described that "it caught the right side

of the balloon” with “the flame on the outside of the balloon”. They then saw the basket fall to the ground. They described seeing “just the basket” and what looked like “a long piece of string”. They said it looked like “tissue paper or a shoelace with a thin flame and black smoke”, “just a basket on its own dragging a piece of string”.

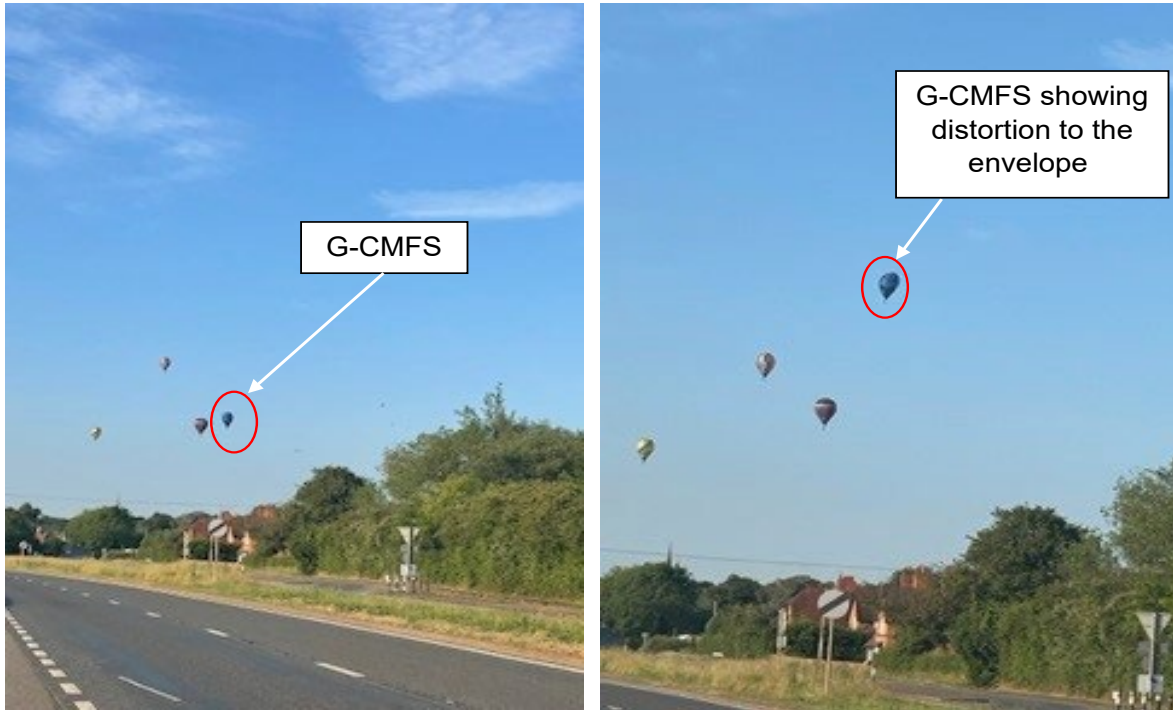
Figure 8

Another witness also took some pictures from the A449 (Figure 8), all time stamped at 0518 hrs. A further witness on the A449 recalled that the burner was still burning during the descent, but there was no fire other than the flame from the burner. A witness, who was 150 – 200 m away from the eventual accident location, was watching G-CMFS as it ascended. He described hearing a “loud puff” and said it was like all the air suddenly disappeared from the balloon, “like the top had opened up” or “someone had lifted the lid on it”. He said there was no fire or explosion.

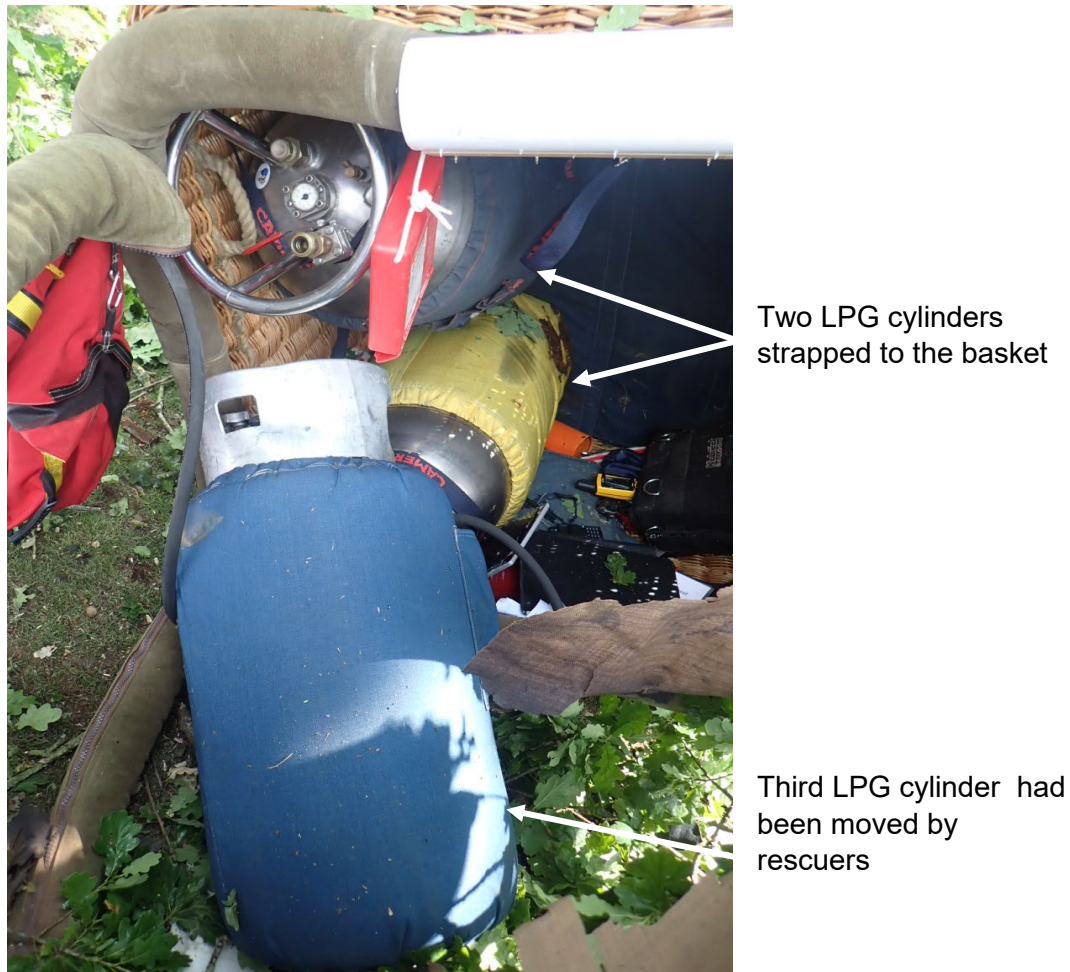
Inside the basket were two LPG cylinders used to provide fuel to the burners, a blue jacketed steel cylinder and a yellow jacketed titanium cylinder (Figure 15). The yellow cylinder was still strapped to the corner of the basket and connected to the burners by a flexible fuel supply hose. The blue cylinder was not fully strapped to the basket with the lower buckle undone. A third blue jacketed aluminium LPG cylinder, not connected to the burners or strapped into the basket, was found loose on the ground just outside the open end of the basket. Witnesses stated that this tank had been unbuckled and moved out of the way of the basket to provide room to administer first aid to the pilot.

Three LPG cylinders with one loose and resting on the ground

Whilst the loose cylinder was empty of fuel, the yellow jacketed cylinder, shown in Figure 15, was connected to the burners and was found to be approximately half full. The blue jacketed cylinder seen at the top of Figure 15 that was partially strapped to the basket, was not connected to the burner unit and had a damaged contents gauge. It was found to be full during fuel transfer to an undamaged cylinder.

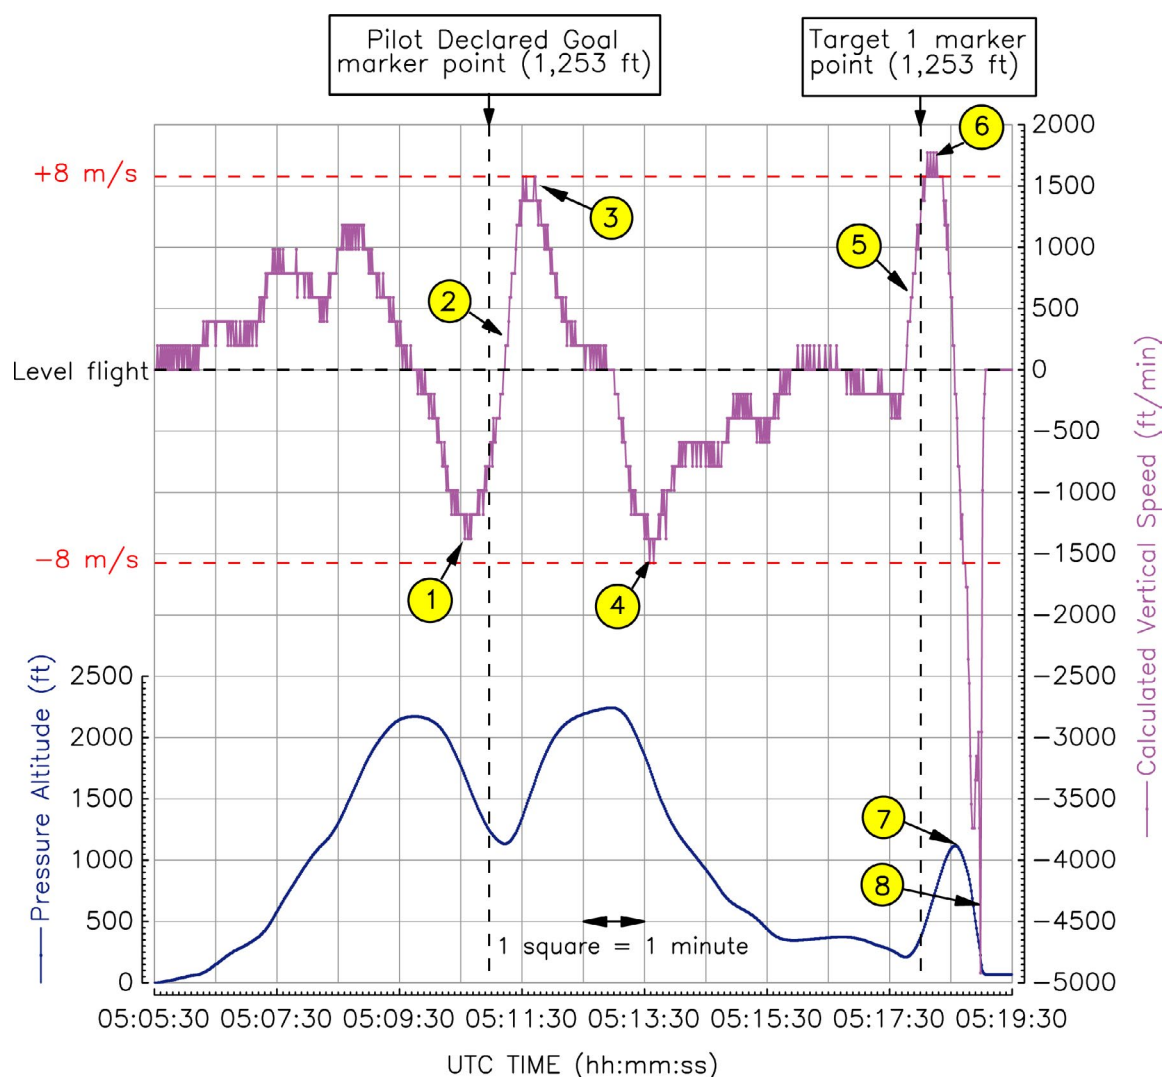
A competition logger was recovered which logged barometric altitude and GPS position and altitude data once per second. Climb and sink rate information was calculated from the barometric altitude data which was accurate to ± 1 m/s. Figure 16 shows the variation in barometric altitude (blue curve) and calculated vertical speed profile (purple curve).

On several occasions during the accident flight, the data indicated that G-CMFS flew at close to the maximum climb and descent rates allowed by the competition rules⁵ (± 8 m/s, or about $\pm 1,575$ ft/min). This is illustrated by points 1, 3 and 4 in Figure 16.

Altitude (blue) and vertical speed (purple) profile of the accident flight

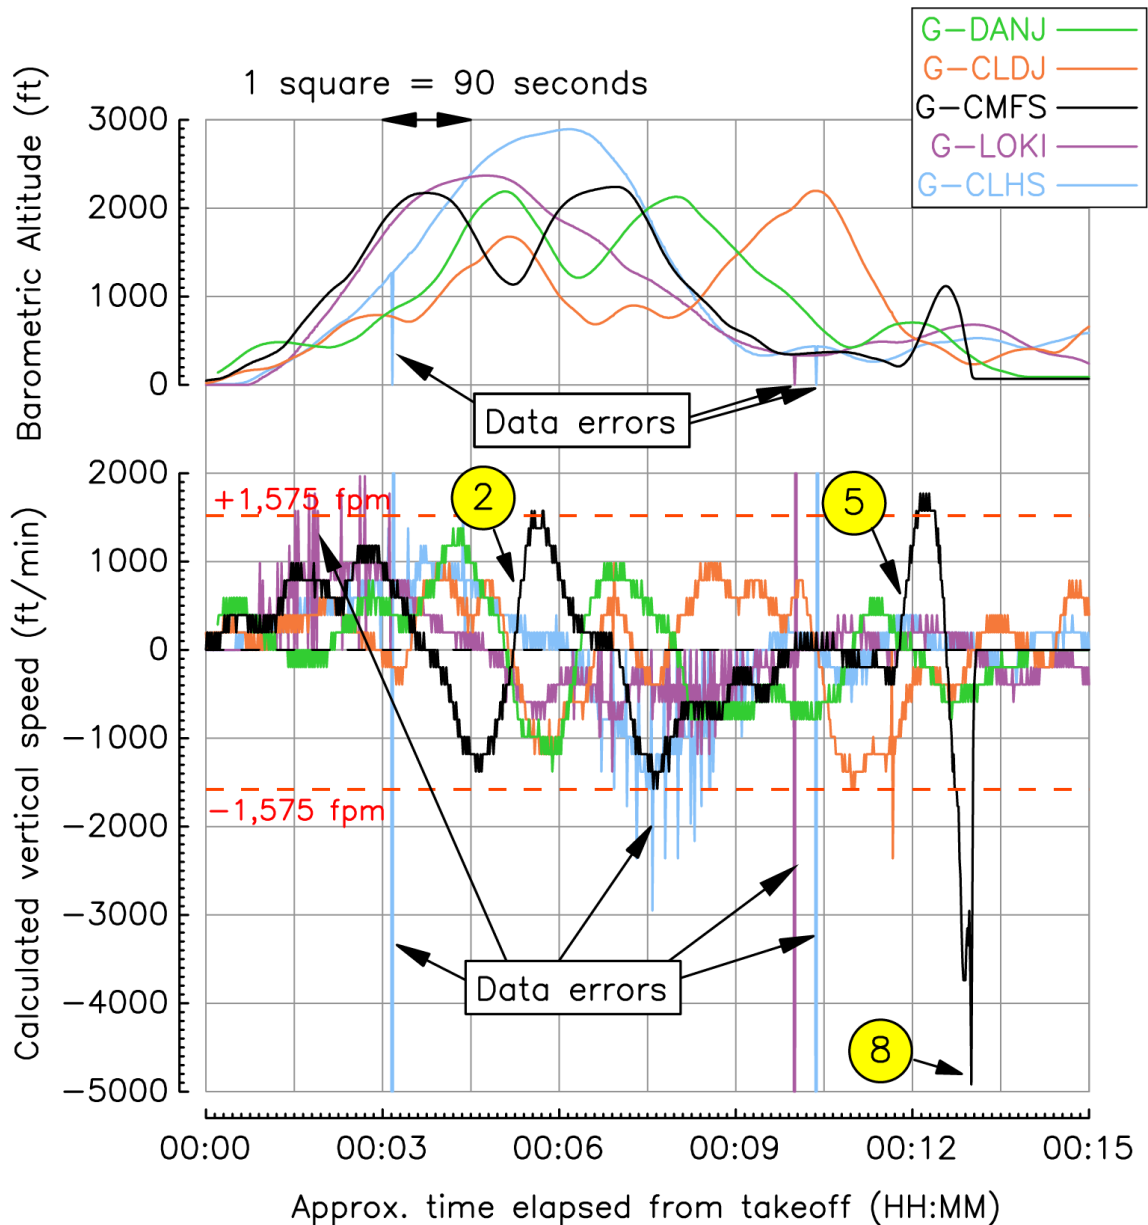
Figure 17

The AAIB obtained data from the other competitors' balloon sensors, which had been streamed to the cloud. Their height and calculated vertical speed data was compared against that from G-CMFS by aligning the data at their approximate takeoff times⁸, illustrated by Figure 17. Some data exhibited errors for undetermined reasons.

Comparison of altitude and vertical speed for each competitor.

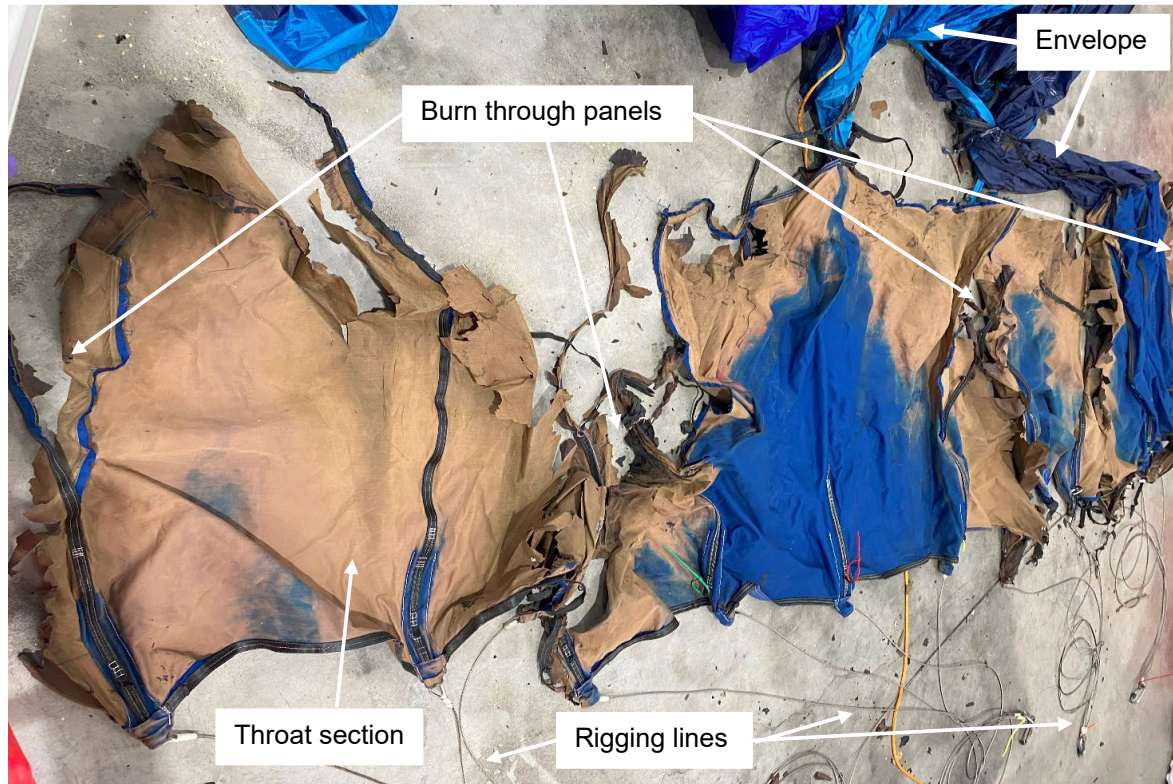
Figure 21

Heat resistant material that formed the throat of the balloon showing multiple, vertical heat damaged areas and burn through

The throat material was in poor condition having been significantly damaged by heat from the burners (Figure 21). There were several burn-throughs and the horizontal load tape attached to the upper edge of the throat panels had melted, separating most of the throat material from the envelope.

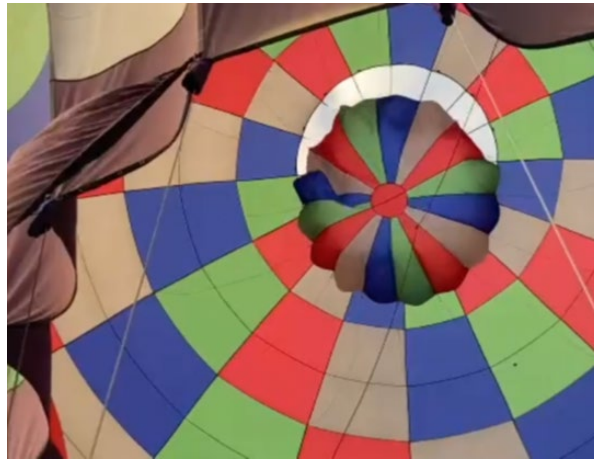
Figure 23

An identical envelope to G-CMFS was made available to the AAIB, and a series of four ground-tethered tests were conducted at a manufacturer's facility to observe the parachute's characteristics during operation. The tests showed that the parachute tended to 'float' when activated for between four and five seconds, before snapping back to seal the aperture at the top of the envelope (Figure 23).

Parachute 'floating' during ground testing

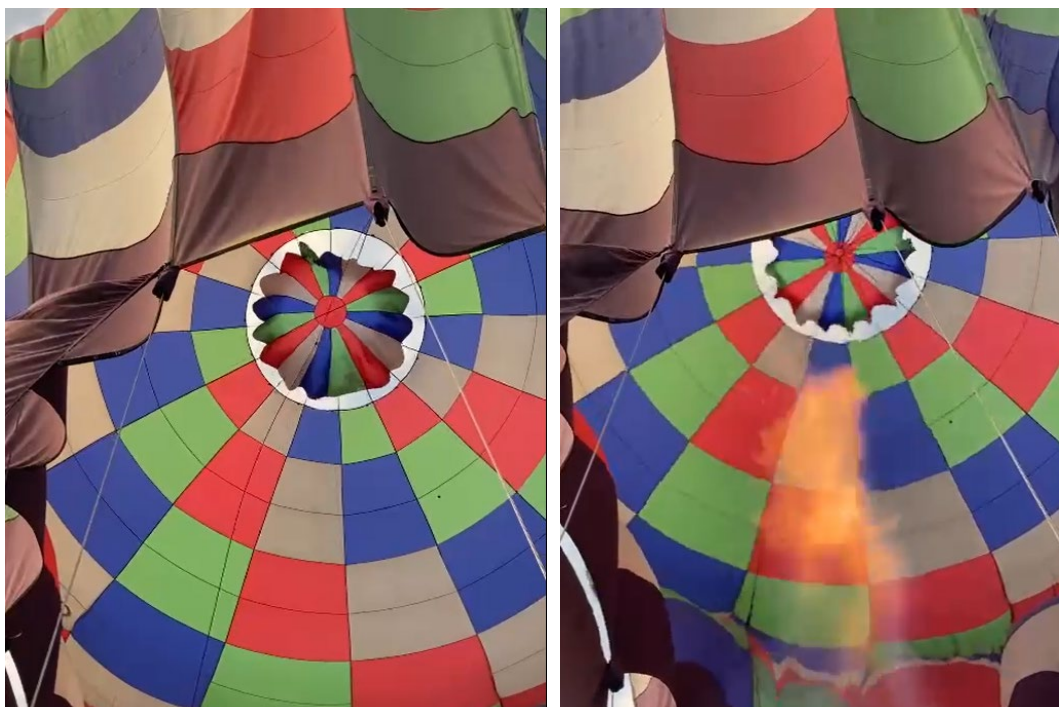
Figure 24

When the parachute operating line was pulled for approximately six seconds, the parachute stalled (Figure 24 left) and the envelope started to collapse before the burners were promptly activated to reseal the parachute and re-inflate the envelope (Figure 24 right).

Parachute stalled (left) and burners used to reseal the parachute and re-inflate the envelope as it started to collapse (right)

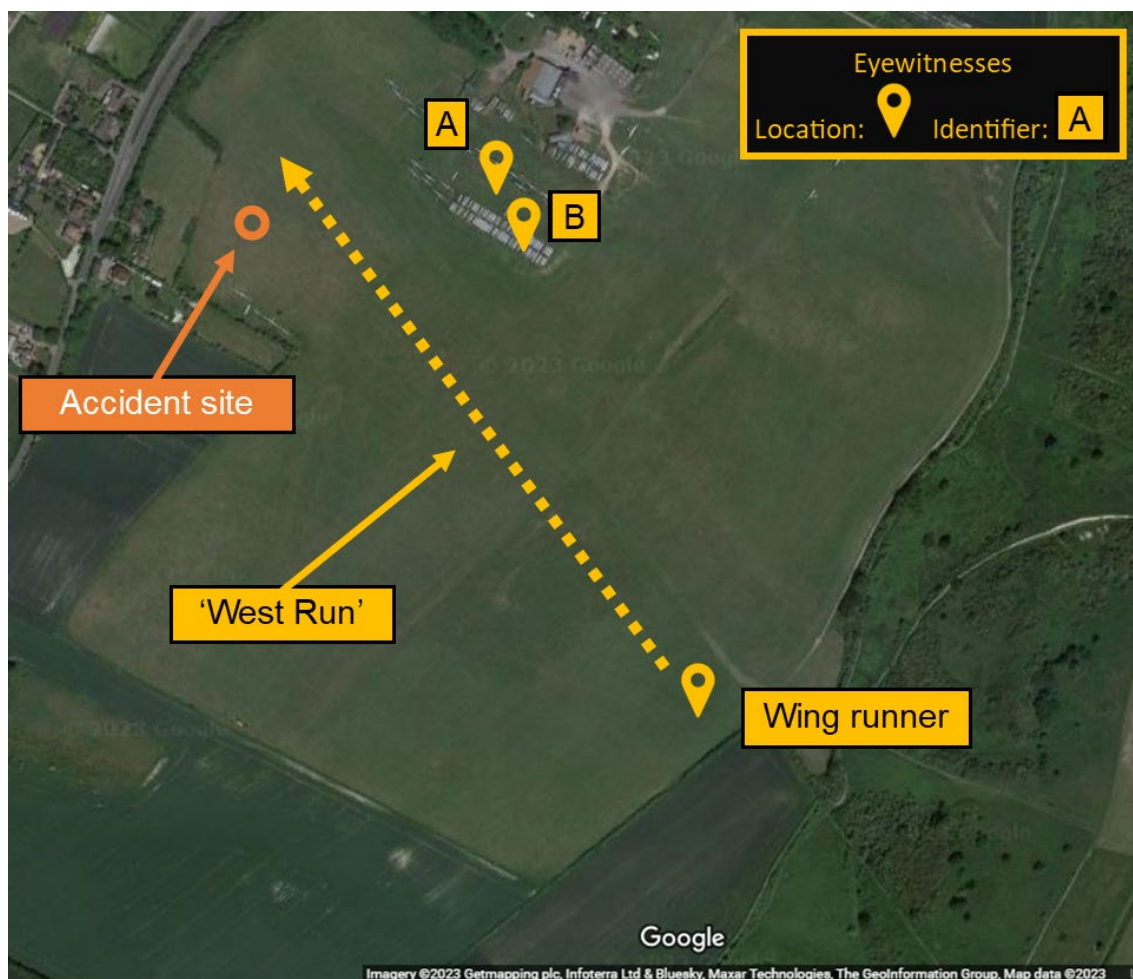
Figure 1

Overview of Dunstable Airfield, including accident site and eyewitness locations

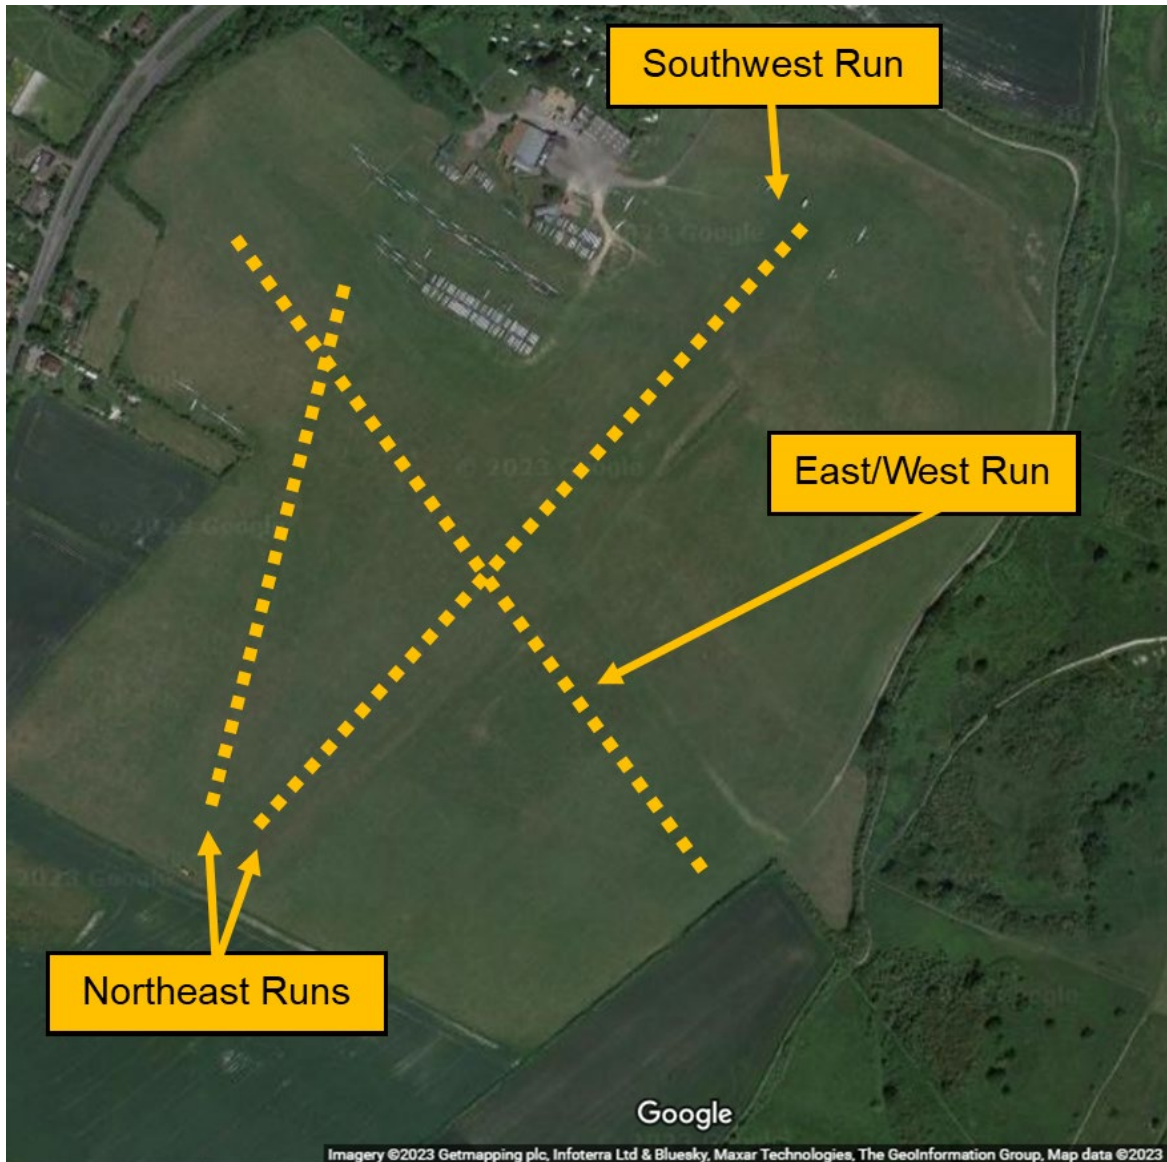
Figure 5

Launch runs at Dunstable Airfield

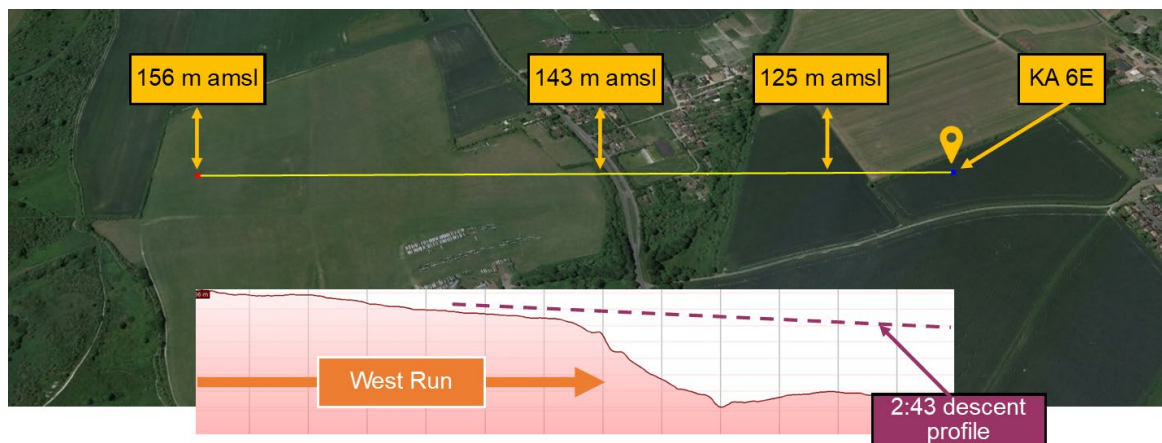
Figure 6

The West Run's average gradient is 2.4% downhill from the launch point to the airfield's north-western boundary. Beyond the boundary the ground falls away more steeply toward the B489 road, residential buildings, and trees before rising gently over open farmland beyond (Figure 6). In part to avoid overflying the hazards west of the road, but also for noise abatement considerations, tug pilots aerotowing on the West Run would aim to turn right onto a more north/northeasterly track once safely airborne.

Cross sectional elevation of the West Run^{4,5}
(imagery ©Google Earth 2023)
