Rail Accident Investigation Branch

Rail Accident Report

**Member of staff struck by a train at St Philips
Marsh depot, Bristol
26 September 2023**

Report 08/2024
July 2024

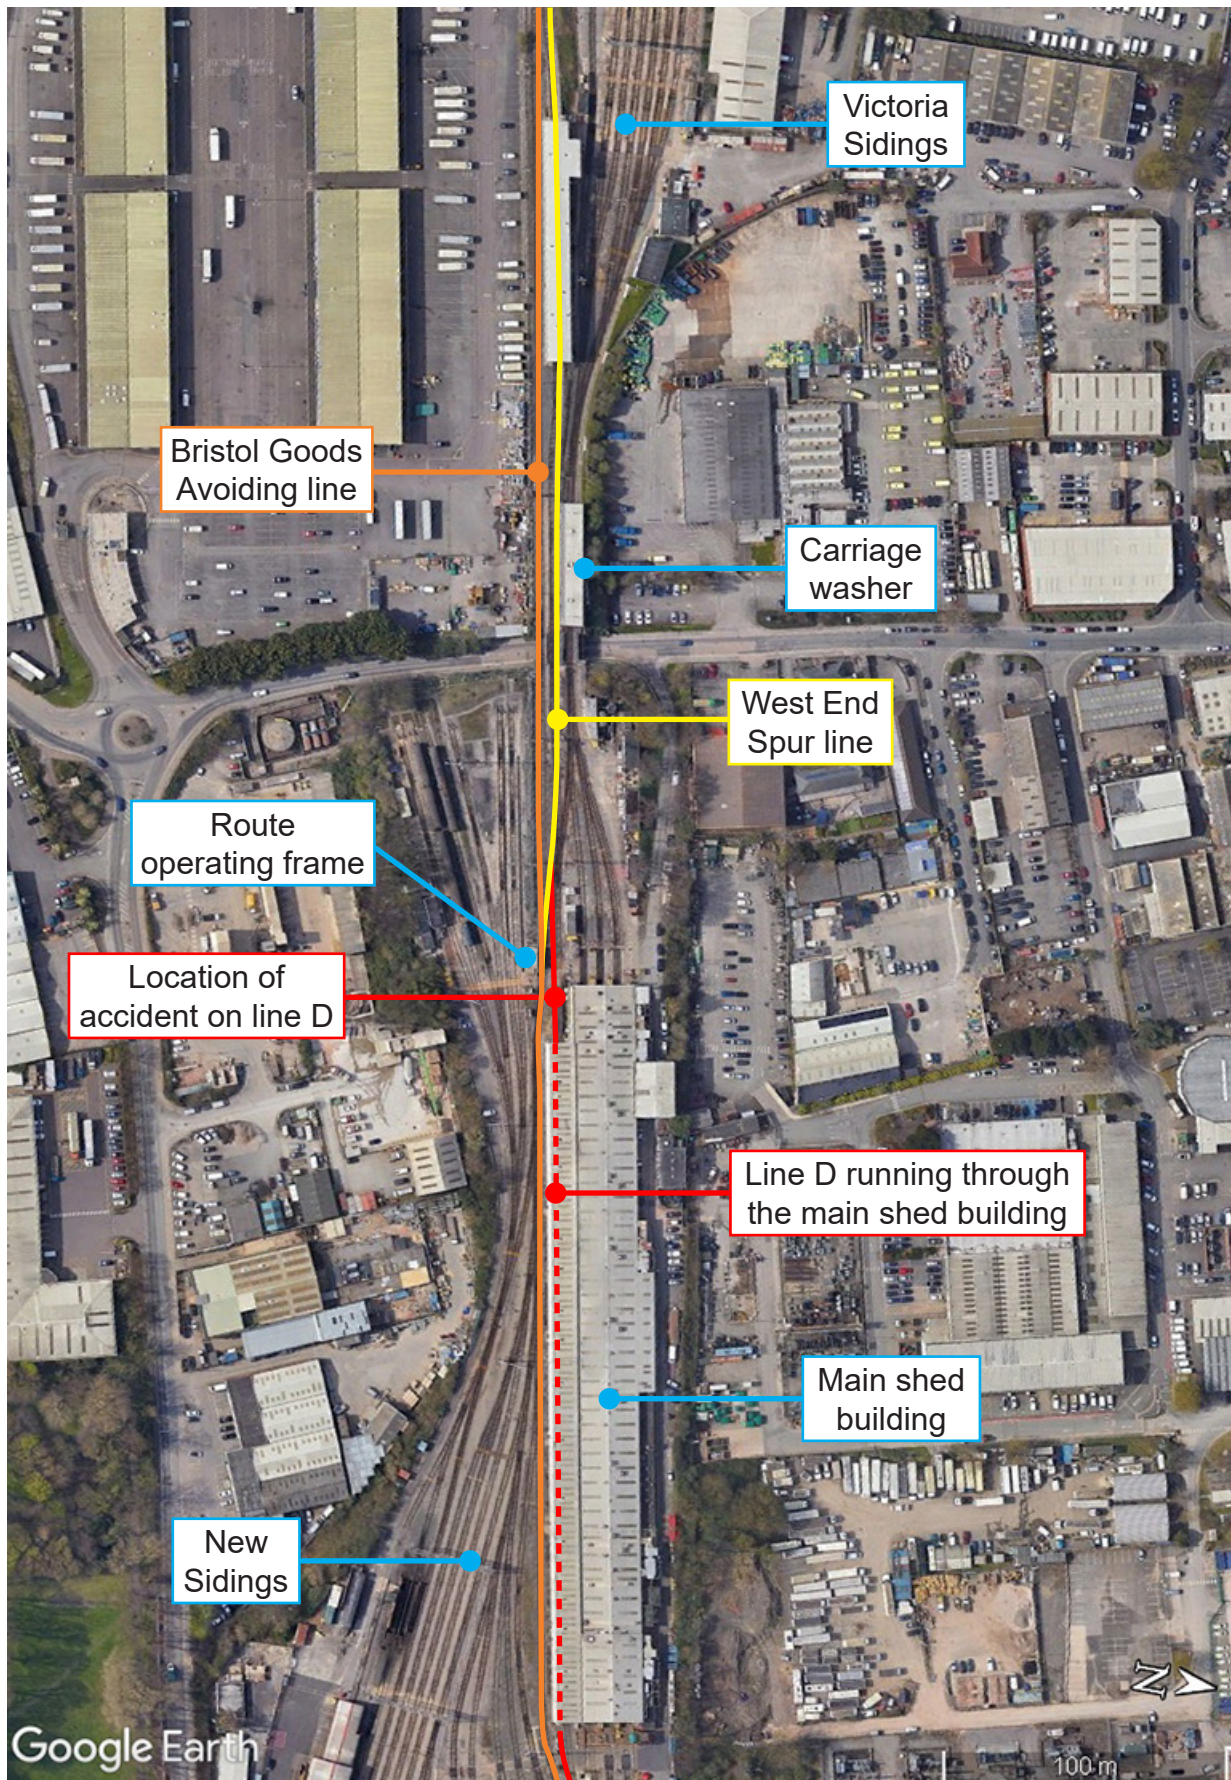
Figure 2: Overview of the location where the accident happened (courtesy of Google with RAIB annotations).

- 3 At about 13:03 hrs on 26 September 2023, a member of staff responsible for shunting trains at St Philips Marsh depot, Bristol, was struck by a train that was exiting the depot's main shed building (figures 1 and 2). The train was travelling at 10 mph (16 km/h) at the time. After hearing the train strike something, the driver applied the brakes and stopped the train.

- 10 The train involved in the accident was a two-car class 158 diesel multiple unit, number 158771 (figure 5). It had arrived onto the depot earlier that morning from Bristol Temple Meads station.
- 11 At the time of the accident, the unit was moving out of the main shed building along line D (figure 2). Its initial destination was the West End Spur line, where it was to stop behind PM6 signal, then reverse direction to go to the New Sidings (figure 6).

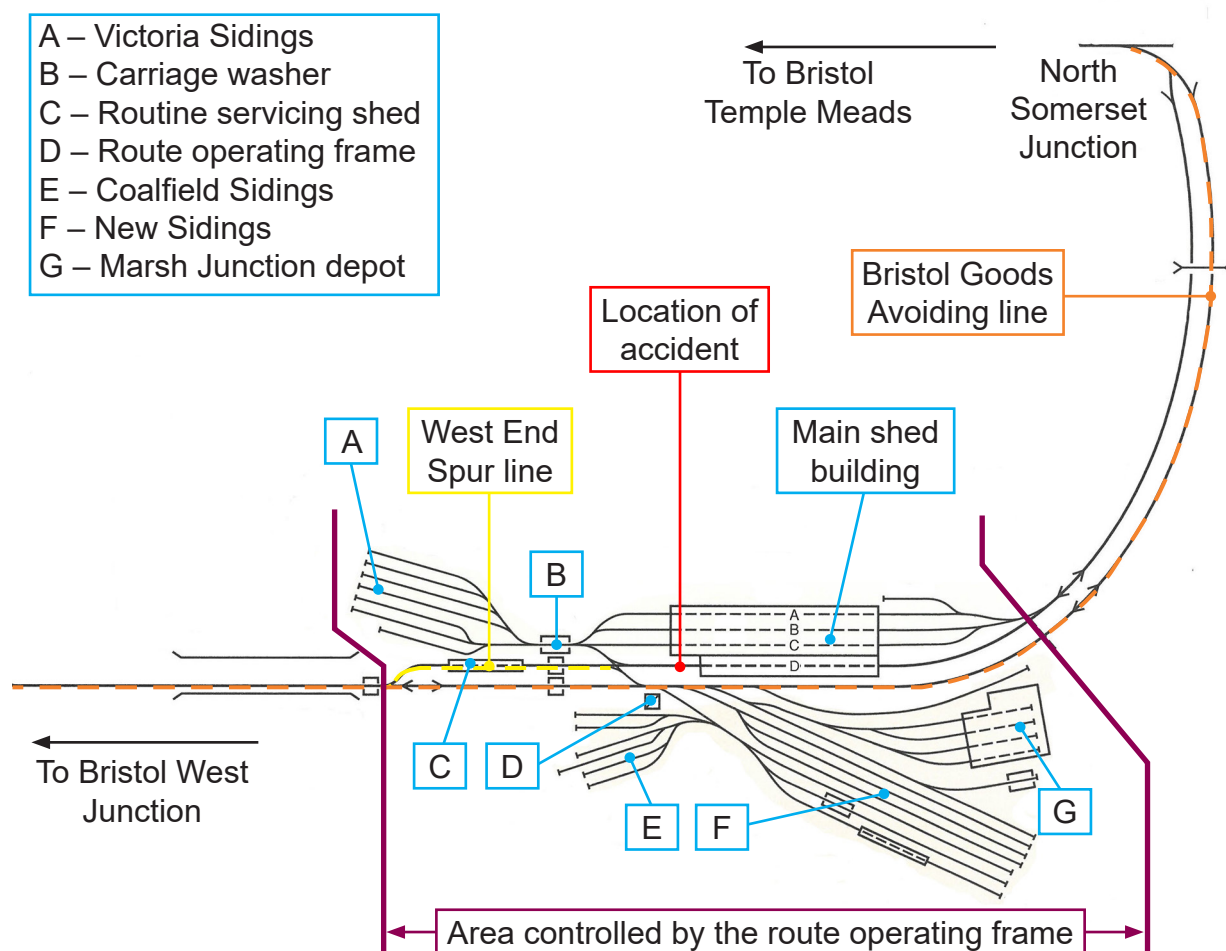
Figure 3: Depot layout.

- 5 St Philips Marsh depot is in Bristol. It provides a train maintenance, servicing and cleaning facility for class 158, 165 and 166 diesel multiple units operated by Great Western Railway (GWR). It comprises three shed buildings and three sets of sidings (figure 3).

- 6 A bi-directional single running line runs through the depot, between North Somerset Junction and Bristol West Junction (figure 3). This is called the Bristol Goods Avoiding line from North Somerset Junction as far as the west end boundary of the depot, where its name changes to the Up/Down Through Goods line to Bristol West Junction. This line is 1.1 miles (1.8 km) long between the two junctions and has a speed limit of 10 mph (16 km/h). All the lines leading off this running line, to either a shed building or a siding within the depot, have a speed limit of 5 mph (8 km/h). Any trains moving inside the shed buildings are required to travel at extreme caution, which is defined in local instructions as a speed well below 5 mph (8 km/h).

- 7 The running line, shed buildings and sidings throughout the depot are generally level, although there is a falling gradient on the line leading into Victoria Sidings (figure 3).

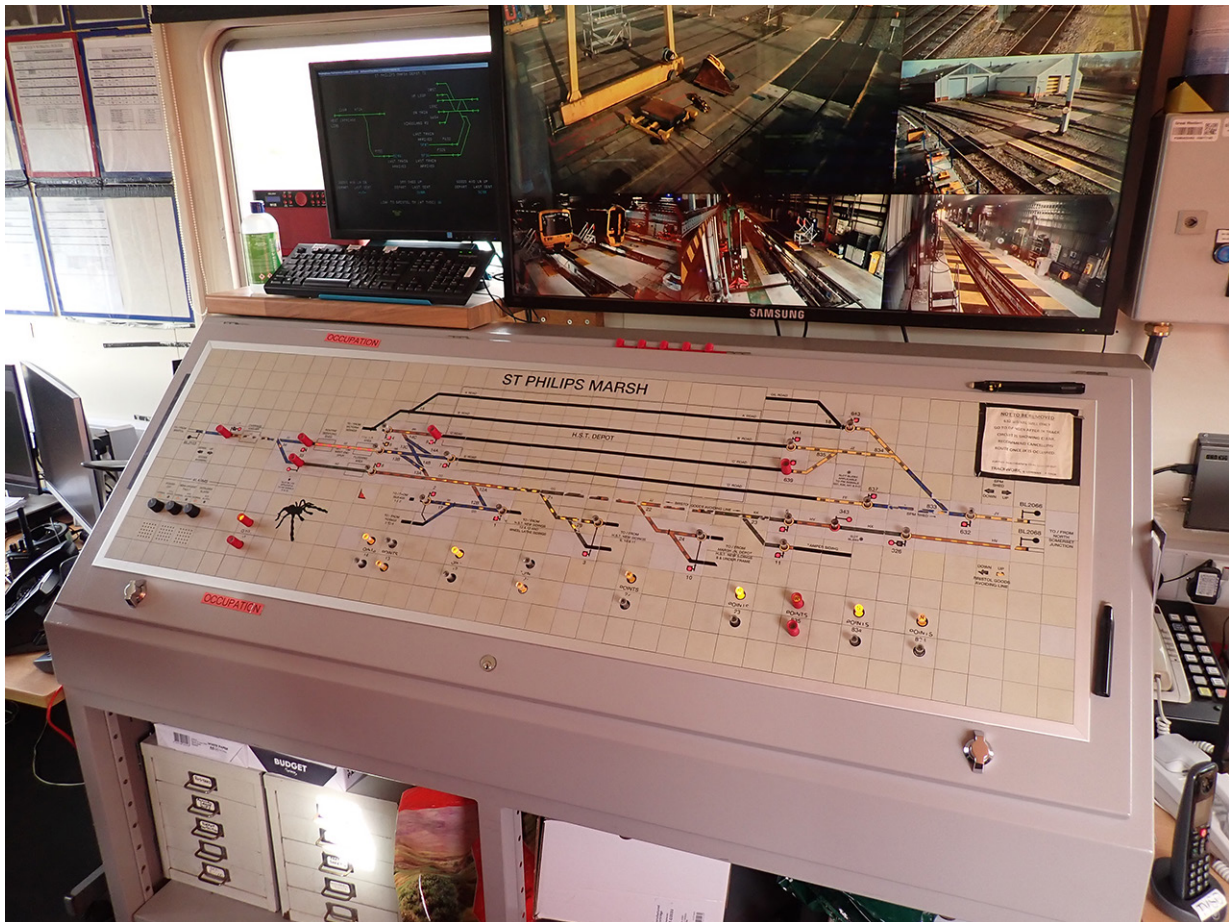
Figure 4: The route operating frame.

- 8 Train movements within the depot are controlled either by a shunter or by signals which are operated from a small signalling panel, called the route operating frame (figure 4). The route operating frame is worked by a route frame operator, who is more commonly called the mini panel operator (MPO). The role of the MPO is to manage the train movements onto, within and off the depot. The depot signalling interfaces at both ends of the depot (figure 3) with signalling controlled by Network Rail's Bristol workstation signaller, who is located at Thames Valley Signalling Centre, in Didcot.

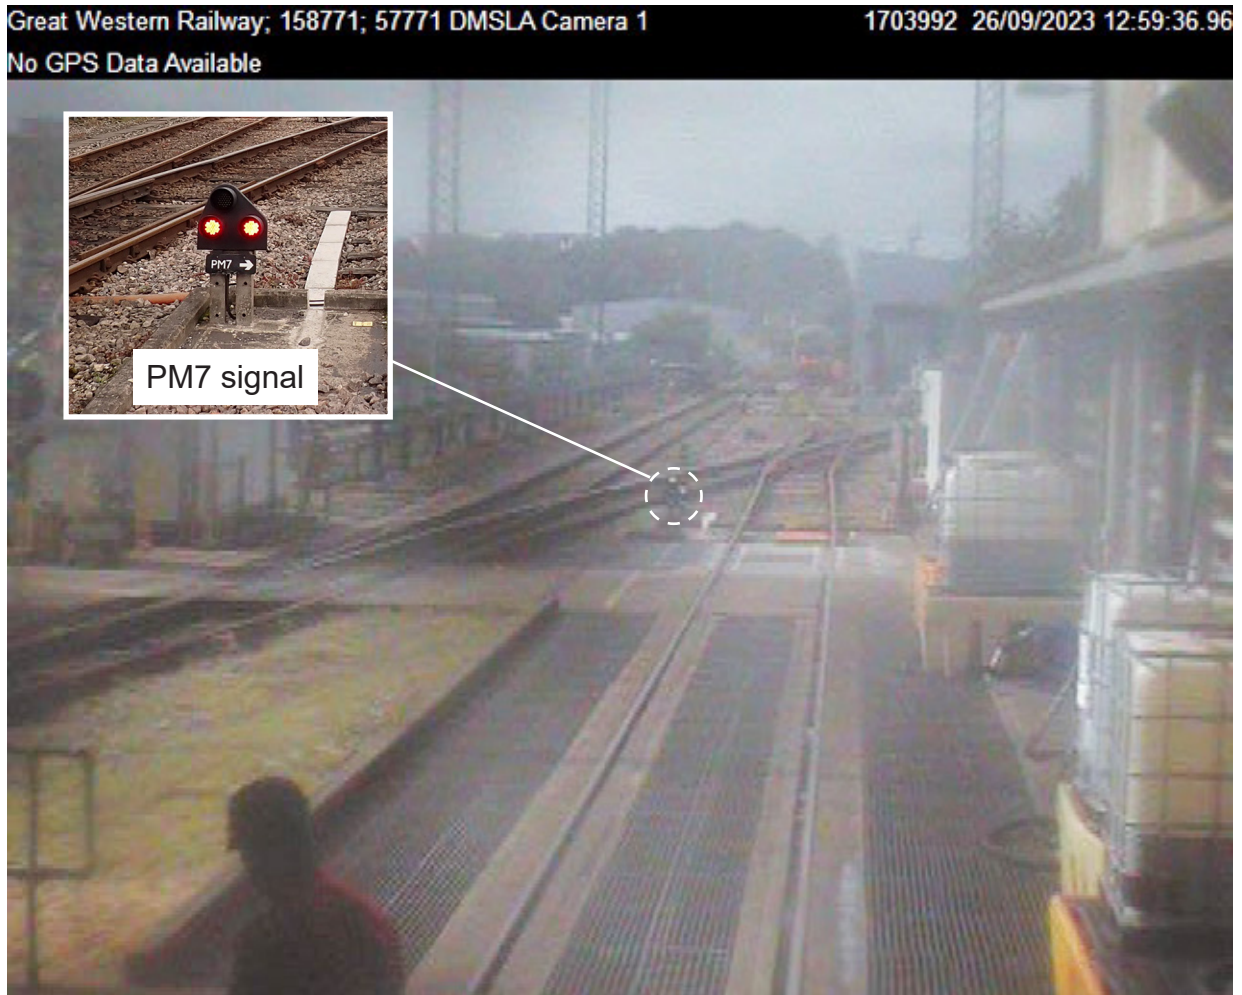
Figure 7: Forward-facing CCTV image of PM7 signal displaying a proceed aspect (courtesy of Great Western Railway) and a close-up view of PM7 signal but displaying a stop aspect.

- 21 Once they had completed their checks around the outside of the train, the shunter stopped in front of it and contacted the MPO by radio to say their train checks were complete. In response, the MPO set the route from PM7 signal, which is at the exit of the main shed building on line D, to the West End Spur line (figure 7). The signal then changed to display a proceed aspect.

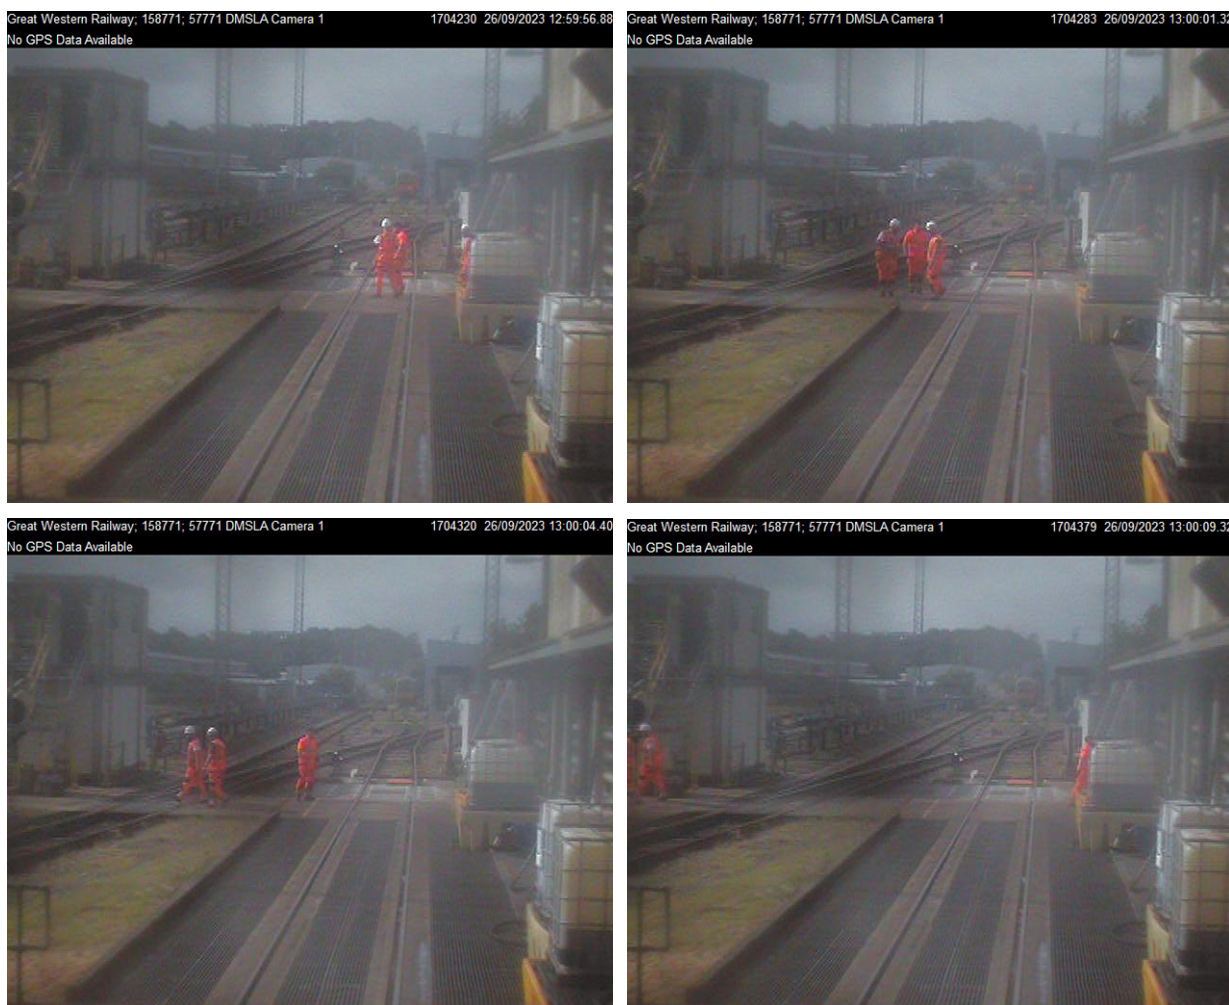
Figure 8: Forward-facing CCTV image of the contractors on the level crossing (courtesy of Great Western Railway).

- 22 About a minute before the train moved, its forward-facing CCTV shows three contractors in orange high-visibility clothing, who were working on the adjacent line C, walking onto the level crossing at the end of the main shed building (figure 8). After stopping on the level crossing to hold a brief conversation, two of the contractors continue, while the third turns around and goes back, walking over and then clear of the track for line D. While this was happening, the driver arrived at the train.

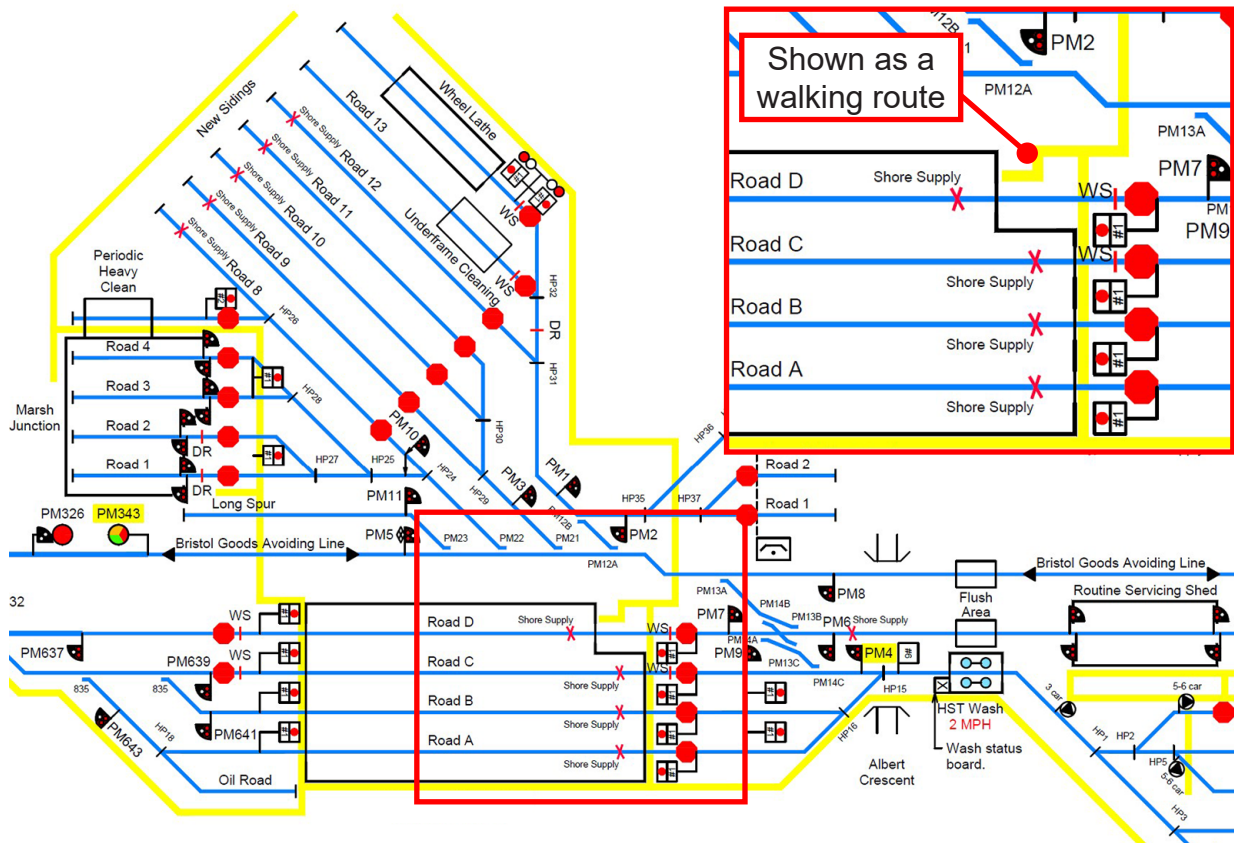
Figure 12: The depot map with the walking routes shown in yellow.

- 74 GWR stated there is no prescribed speed limit once a train is inside a shed building. However, GWR explained that it expected that movements into, within and out of shed buildings would be carried out at '*extreme caution*', so much slower than 5 mph (8 km/h). The depot map (figure 12) included an annotation that stated that the maximum speed inside a shed building should be 3 mph (5 km/h) but GWR explained that this was not an official instruction.

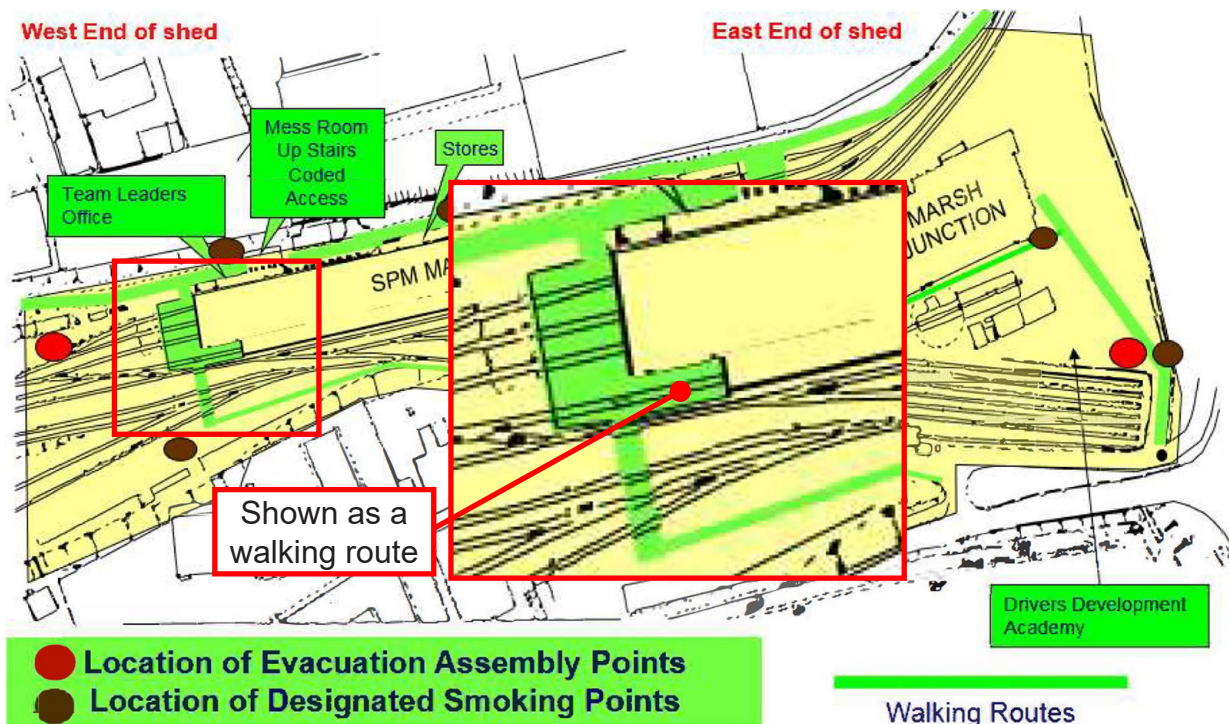
Figure 13: The authorised walking route map for St Philips Marsh depot with the authorised walking routes shown in green.

- 47 GWR advised that, while this area was shown as an authorised walking route on its authorised walking route map, and repeated in the site induction, this was an error. It considered that only the area covered by the concrete apron for the level crossing, running across the end of the main shed building, is actually an authorised walking route. The driver held a similar view that this area was not an authorised walking route, which meant they did not expect anyone to be there when they were moving a train.

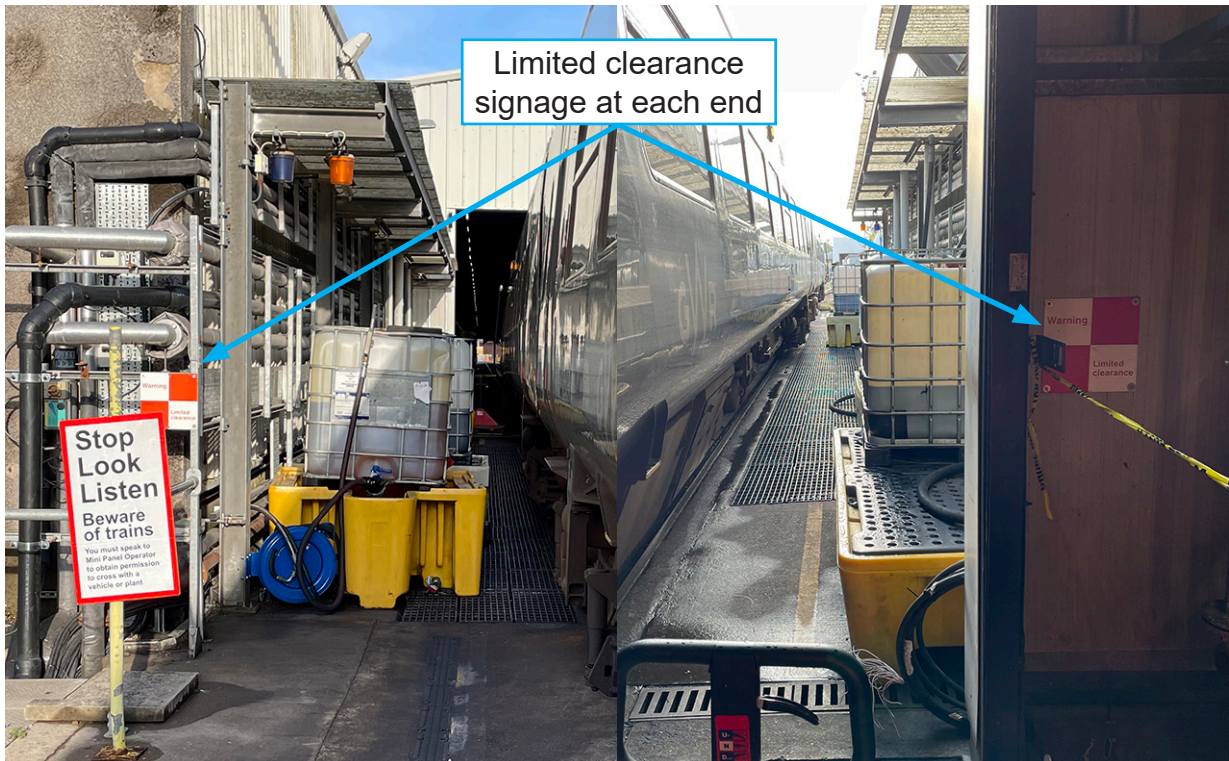
Figure 19: The limited clearance signage at each end of the walkway.

Depot speed limit.	This would have been effective, but the speed limit was not complied with (paragraph 70) and this was not detected (see paragraph 109).
Walking routes.	Where the shunter walked was not an authorised walking route, although various GWR documents showed it as such (paragraph 46). It was considered by GWR to be a walkway, so could be used by PTS holders such as the shunter. However, the driver did not know this and so was not expecting anyone to be there when a train was moving (paragraph 47).
High-visibility clothing.	Appropriate high-visibility clothing was worn by the shunter (figure 11), but they were still not seen by the driver (paragraph 86).
Limited clearance signage.	Signage was in place at either end of the walkway to indicate that it was a limited clearance area (figure 19), so a PTS competency holder would know there was no position of safety (paragraph 60) on that side of the track for the length of the structure. The intermediate bulk containers stored on that side further limited the available space on the side where the shunter was struck (figure 9).

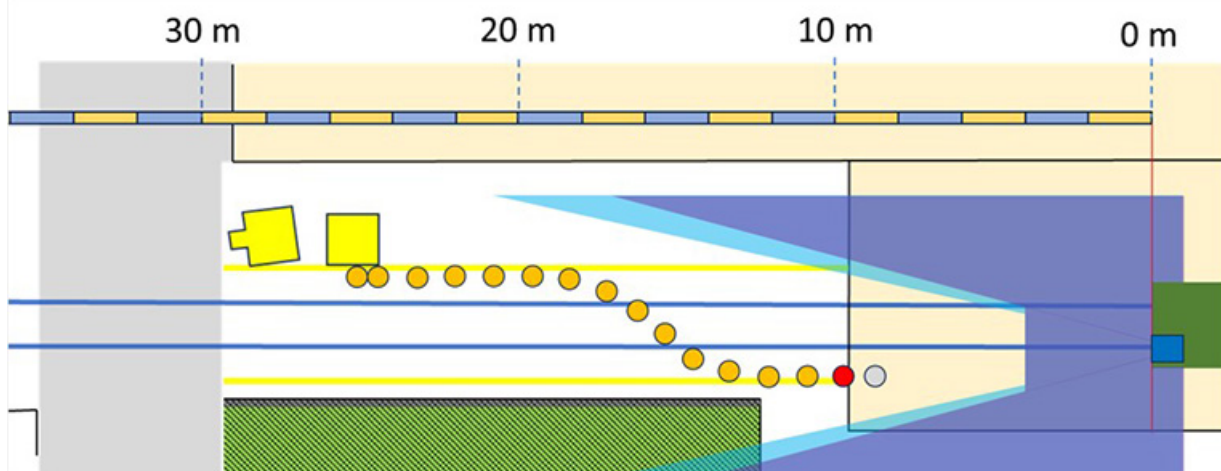
Figure C3: Shunter and train positions at 13:01:01 hrs.

At 13:01:01 hrs, the train had moved 0.0 metres, its speed was 0 mph (0 km/h), the driver had by now moved the traction handle to notch 6, and the shunter was walking out of the main shed building through the roller shutter door

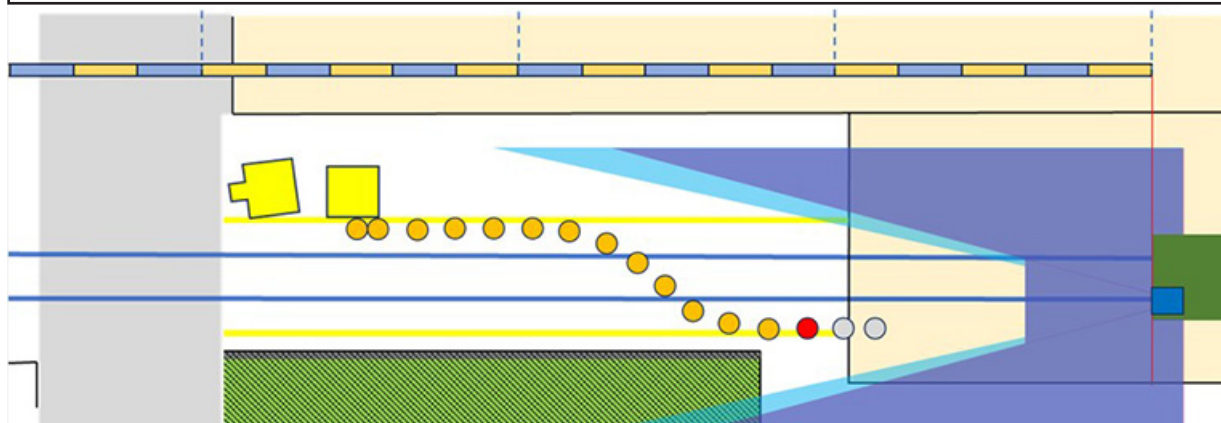
Figure C4: Shunter and train positions at 13:01:02 hrs.

At 13:01:02 hrs, the train had moved 0.0 metres and its speed was 0 mph (0 km/h)

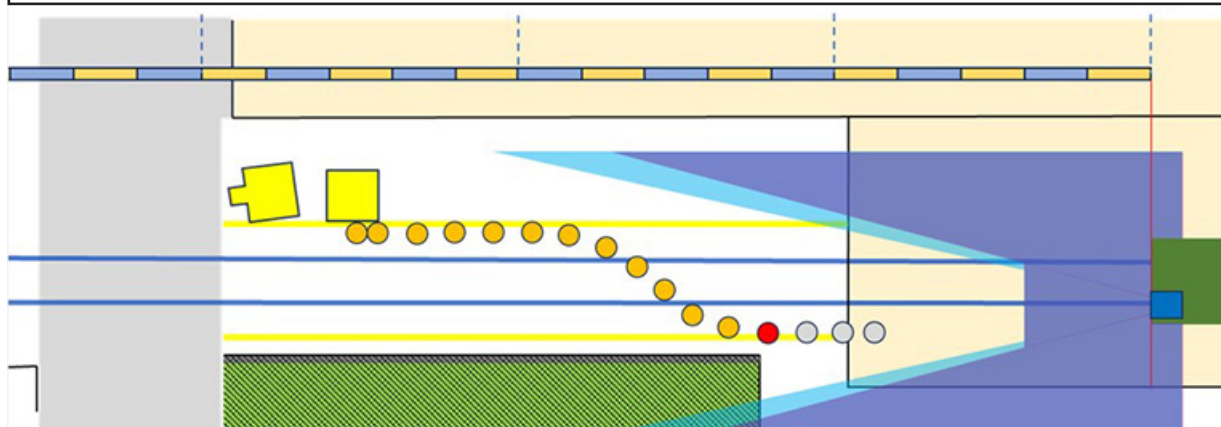
Figure C5: Shunter and train positions at 13:01:03 hrs.

At 13:01:03 hrs, the train had moved 0.0 metres and its speed was 0 mph (0 km/h)

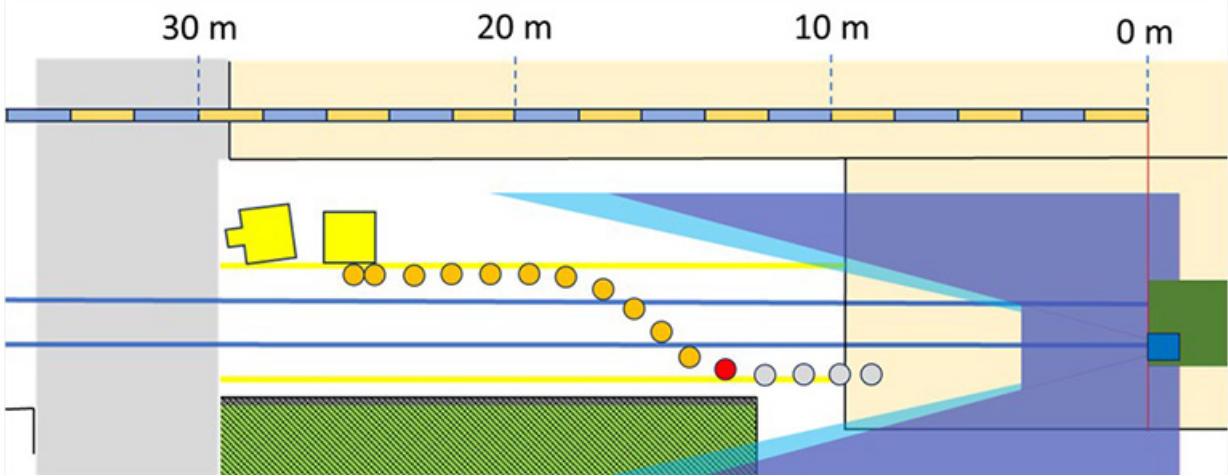
Figure C6: Shunter and train positions at 13:01:04 hrs.

At 13:01:04 hrs, the train had moved 0.0 metres, its speed was 0 mph (0 km/h), and the shunter started to move diagonally to the right

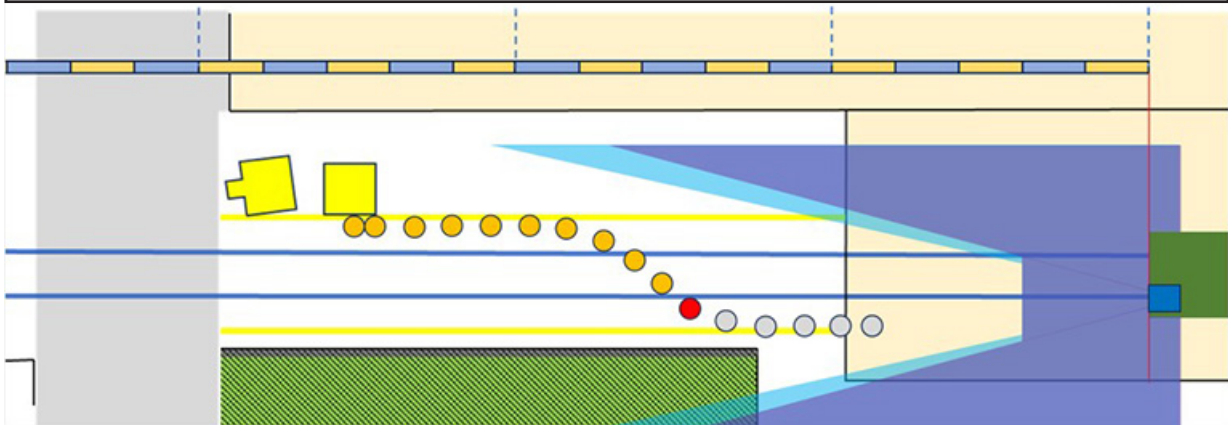
Figure C7: Shunter and train positions at 13:01:05 hrs.

At 13:01:05 hrs, the train had moved 0.0 metres, its speed was 0 mph (0 km/h), but the first sign of the train starting to move was visible on its forward-facing CCTV footage

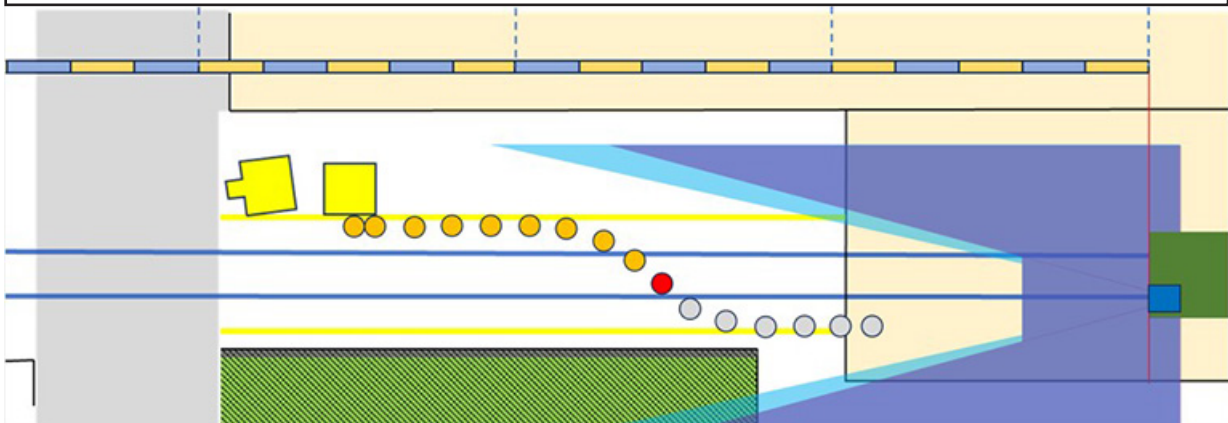
Figure C8: Shunter and train positions at 13:01:06 hrs.

At 13:01:06 hrs, the train had moved 0.0 metres, its speed was 2 mph (3 km/h), the first sign of the train starting to move was recorded by the OTDR, and the shunter was now between the running rails

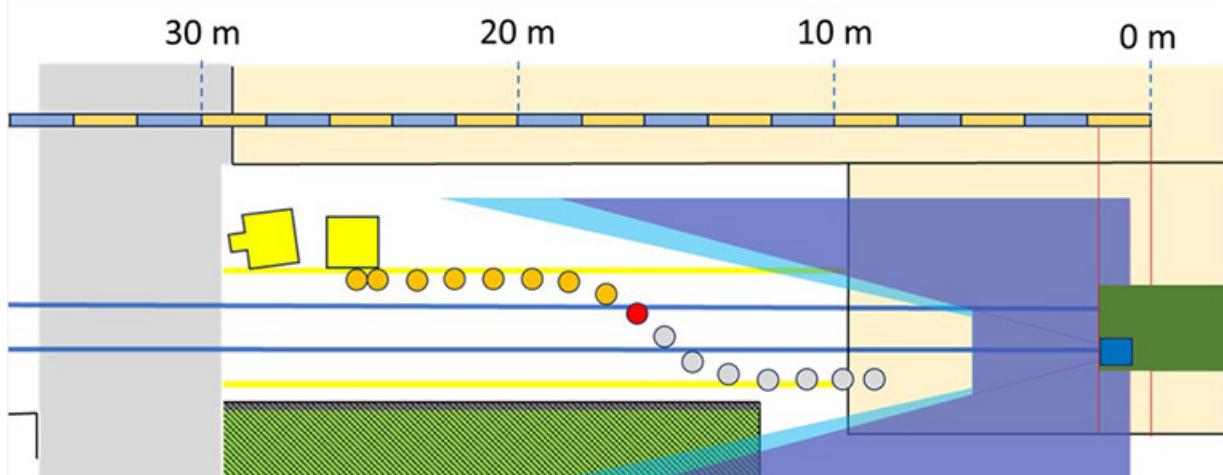
Figure C9: Shunter and train positions at 13:01:07 hrs.

At 13:01:07 hrs, the train had moved 1.6 metres and its speed was 3 mph (5 km/h)

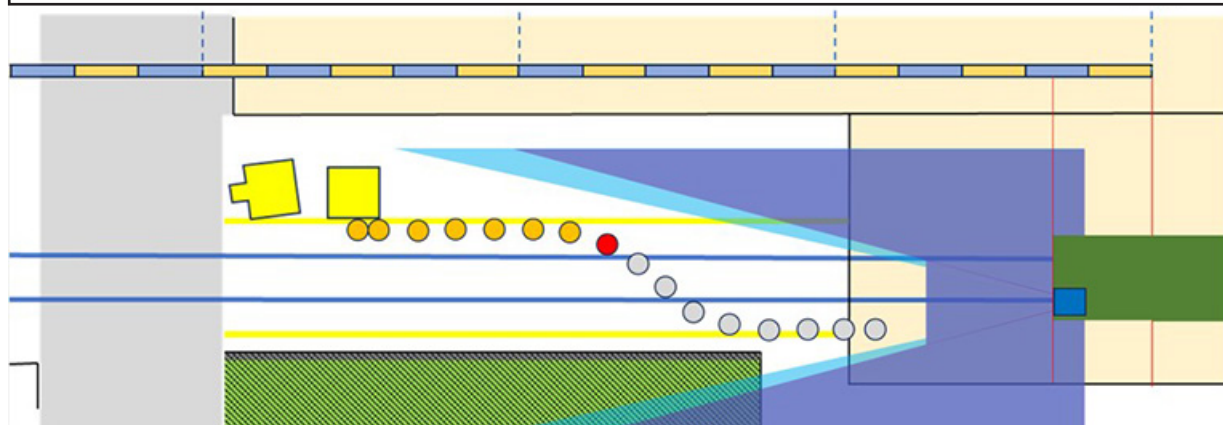
Figure C10: Shunter and train positions at 13:01:08 hrs.

At 13:01:08 hrs, the train had moved 3.2 metres, its speed was 4 mph (6 km/h), and the shunter was now on the right-hand side of the track

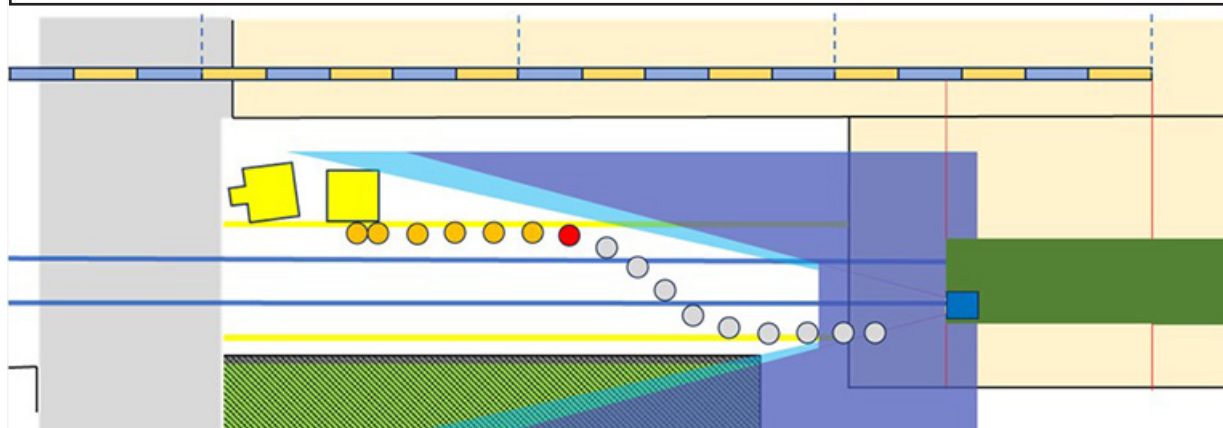
Figure C11: Shunter and train positions at 13:01:09 hrs.

At 13:01:09 hrs, the train had moved 6.4 metres and its speed was 5 mph (8 km/h)

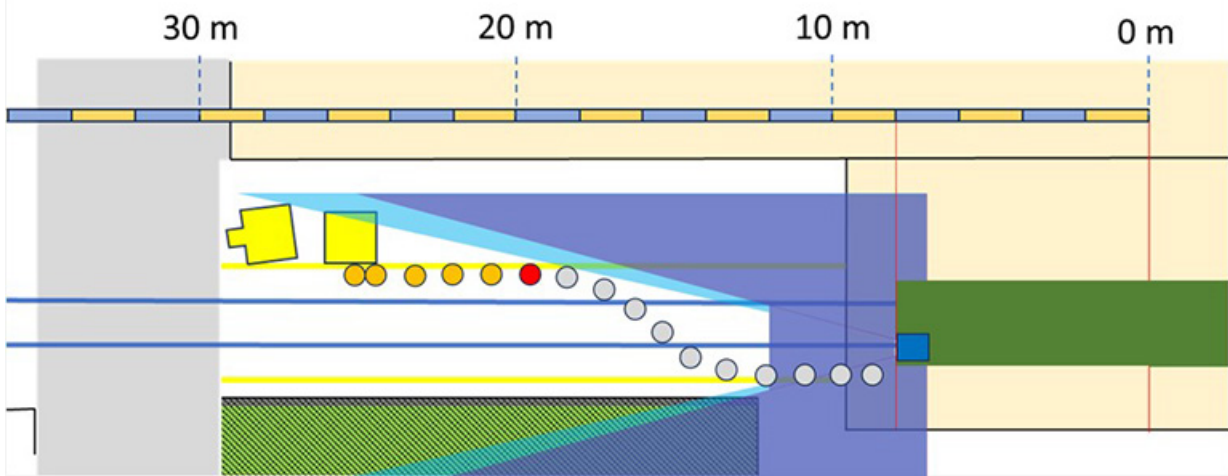
Figure C12: Shunter and train positions at 13:01:10 hrs.

At 13:01:10 hrs, the train had moved 8.0 metres, its speed was 6 mph (10 km/h), and the shunter was walking parallel with the track along its right-hand side

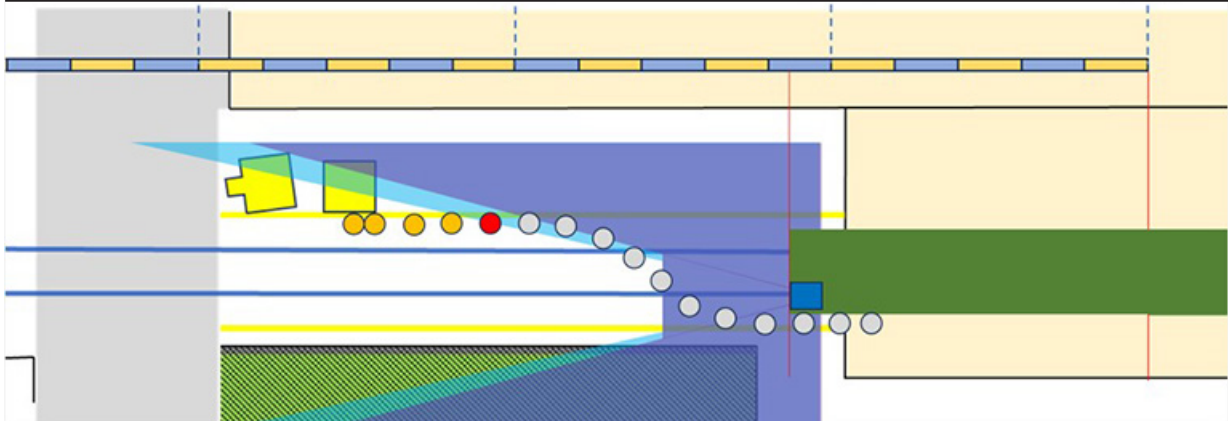
Figure C13: Shunter and train positions at 13:01:11 hrs.

At 13:01:11 hrs, the train had moved 11.3 metres, so the front cab had now exited the main shed building, its speed was 8 mph (13 km/h), and the shunter was no longer fully visible from the driver's position

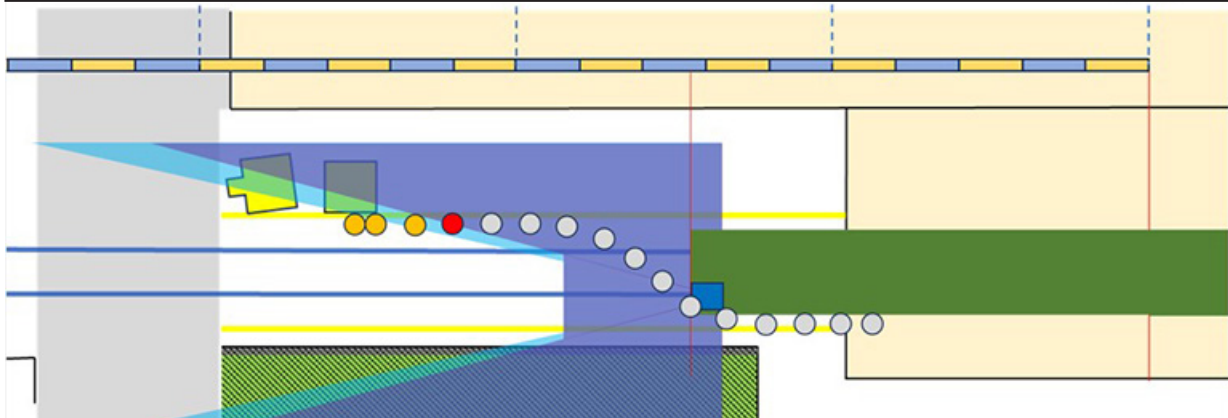
Figure C14: Shunter and train positions at 13:01:12 hrs.

At 13:01:12 hrs, the train had moved 14.5 metres, its speed was 9 mph (14 km/h), the driver had moved the traction handle to notch 5, and the shunter was now only partially visible from the driver's position

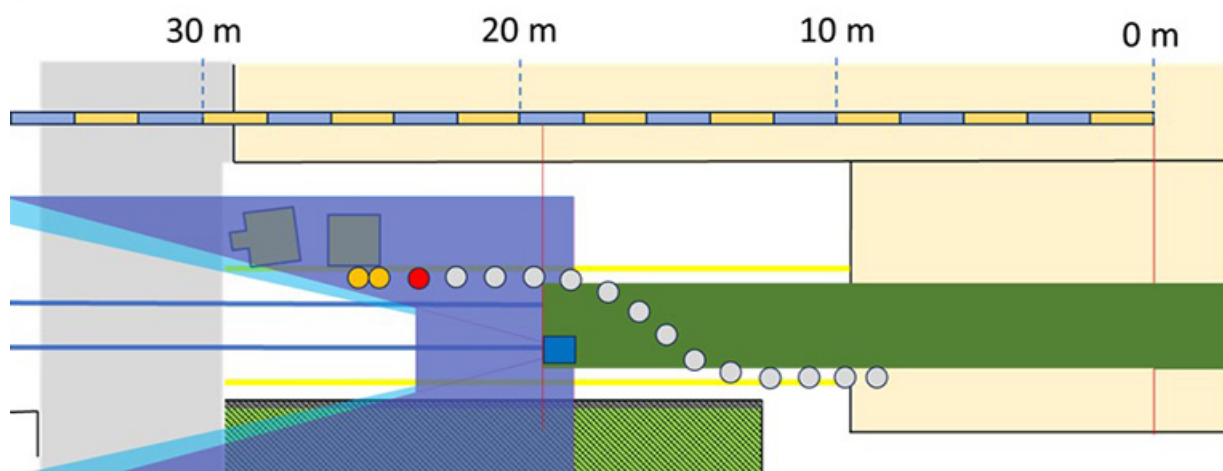
Figure C15: Shunter and train positions at 13:01:13 hrs.

At 13:01:13 hrs, the train had moved 19.3 metres, its speed was 10 mph (16 km/h), the driver had moved the traction handle to its off position, and the shunter was no longer visible from the driver's position

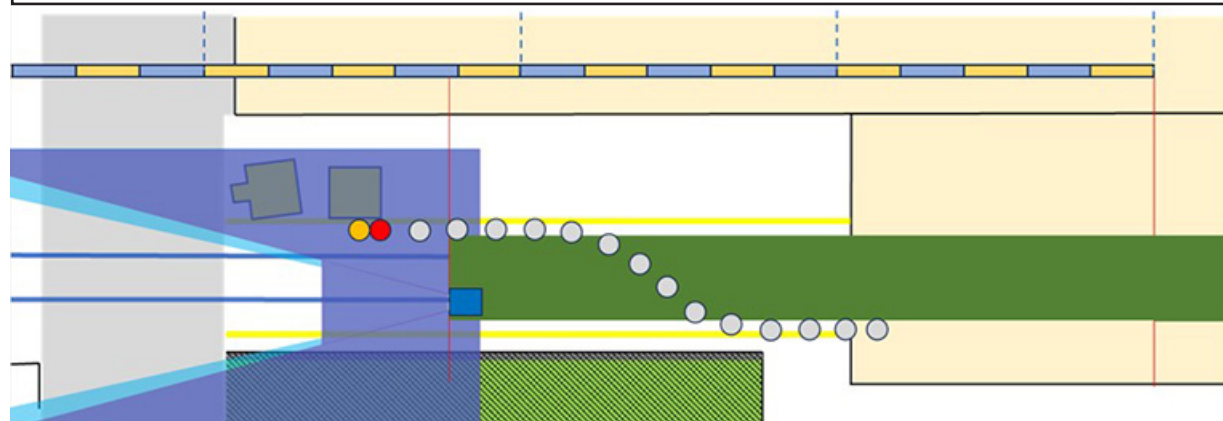
Figure C16: Shunter and train positions at 13:01:14 hrs.

At 13:01:14 hrs, the train had moved 22.5 metres and its speed had reached 11 mph (18 km/h), which was the highest speed recorded by the OTDR

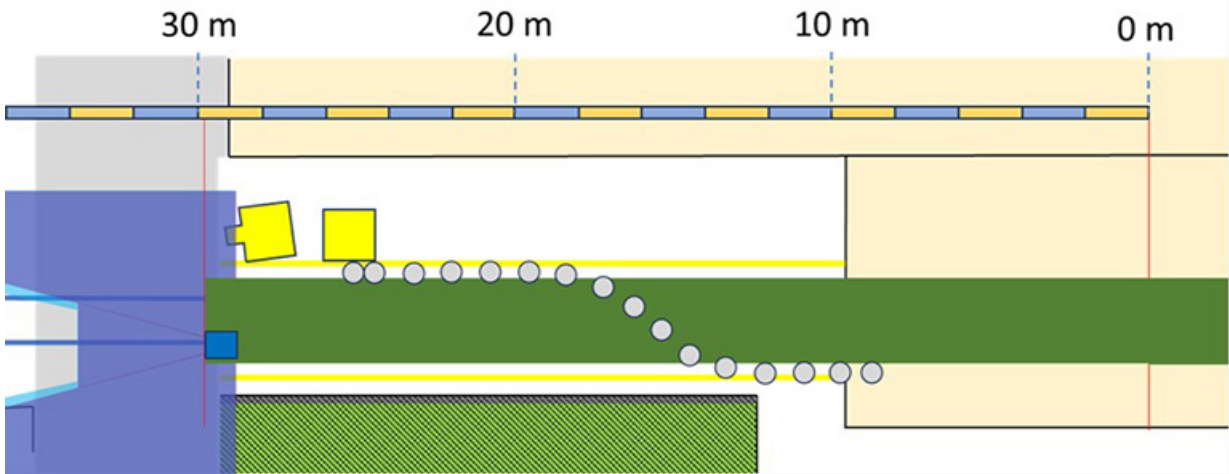
Figure C18: Train position at 13:01:15.5 hrs (the exact position of the shunter at this time is unknown).

At 13:01:15.5 hrs, the train had moved 29.8 metres, its speed was 10 mph (16 km/h), and the driver had applied the brakes
