## Accident

<b>Aircraft Type and Registration:</b>	Piper PA-28-180, G-AYUH	
<b>No &amp; Type of Engines:</b>	1 Lycoming O-360-A4A piston engine	
<b>Year of Manufacture:</b>	1970 (Serial no: 28-7105042)	
<b>Date &amp; Time (UTC):</b>	21 August 2023 at 0820 hrs	
<b>Location:</b>	Near Stanley Hall, Halstead Hall, Essex	
<b>Type of Flight:</b>	Private	
<b>Persons on Board:</b>	Crew - 1	Passengers - None
<b>Injuries:</b>	Crew - 1 (Fatal)	Passengers - N/A
<b>Nature of Damage:</b>	Aircraft destroyed	
<b>Commander's Licence:</b>	Private Pilot's Licence	
<b>Commander's Age:</b>	72 years	
<b>Commander's Flying Experience:</b>	407 hours Last 90 days - 7 hours Last 28 days - 1 hour	
<b>Information Source:</b>	AAIB Field Investigation

## Synopsis

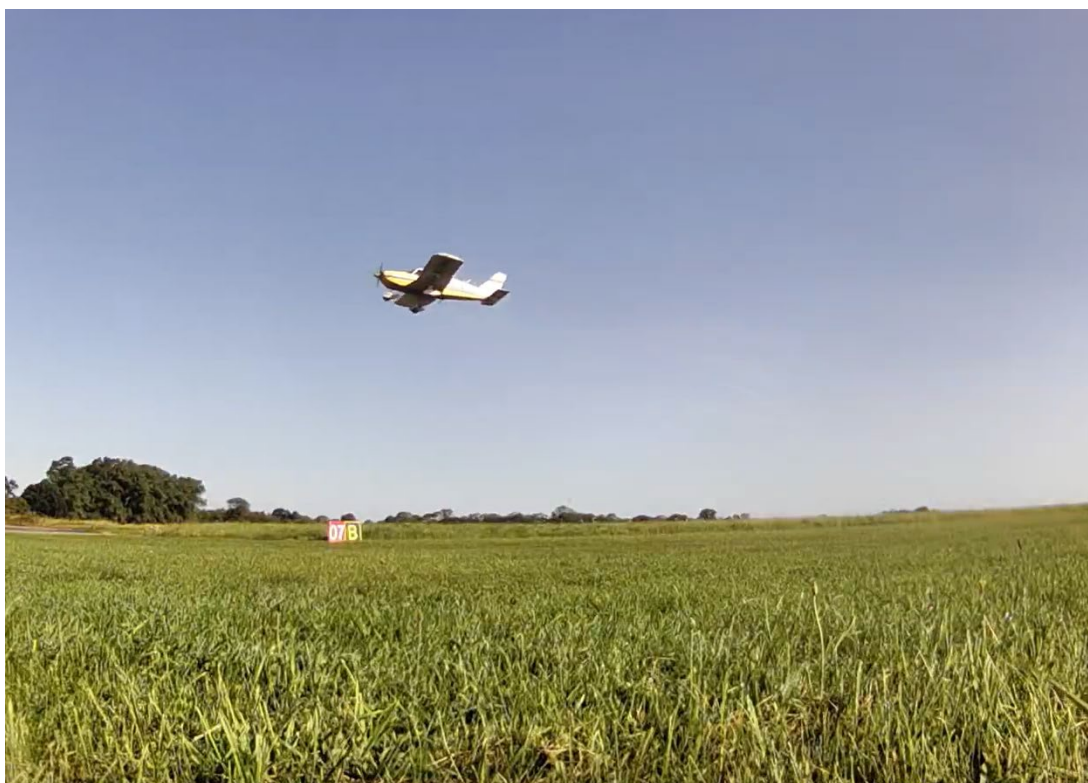
**Figure 7**

Both Old Buckenham and Earls Colne airfields had CCTV which was recorded. The CCTV at Old Buckenham Airfield showed the aircraft taking off in clear sky conditions at 0753 hrs (Figure 7). The departure appeared normal.

CCTV of G-AYUH departing from Old Buckenham (used with permission).
