Serious Incident

Aircraft Type and Registration:	Boeing 767-332(ER), N197DN	
No & Type of Engines:	2 Pratt & Whitney PW4060 turbofan engines	
Year of Manufacture:	1997 (Serial no: 28454 LN: 683)	
Date & Time (UTC):	10 February 2023 at 1130 hrs	
Location:	Prestwick Airport	
Type of Flight:	Commercial Air Transport (Passenger)	
Persons on Board:	Crew - 10	Passengers - 211
Injuries:	Crew - None	Passengers - None
Nature of Damage:	Contained engine failure, fractured water drain tube	
Commander's Licence:	Airline Transport Pilot's Licence	
Commander's Age:	62 Years	
Commander's Flying Experience:	21,000 hours (of which 12,000 were on type) Last 90 days - 180 hours Last 28 days - 50 hours	
Information Source:	AAIB Field Investigation

Synopsis

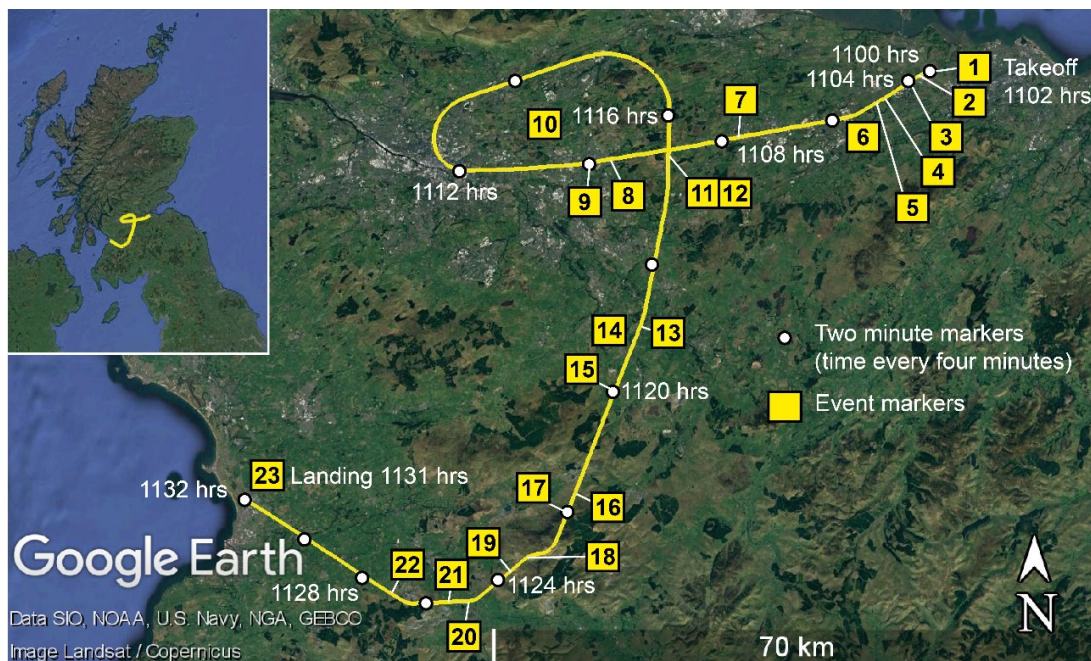
Figure 6

While the aircraft was maintaining 6,000 ft amsl on a long right base leg, the commander throttled back the right engine, which reduced some vibration he had started to notice (Figure 6, point 16). They selected FLAPS 1 (Figure 6, point 17) which briefly generated an abnormal noise on the CVR. The commander commented “THAT’S A BIG VIBRATION”, then requested selection of FLAPS 5. ATC instructed them to turn right onto a heading of 240°, with 21 miles to touchdown. Around this time a passenger videoed what looked like flames coming from under the right wing (Figure 2 and Figure 6, point 18). The commander briefly considered changing to landing FLAPS 20, asking the co-pilot for the associated V_{REF} .

Flight path with marked events (see report text)

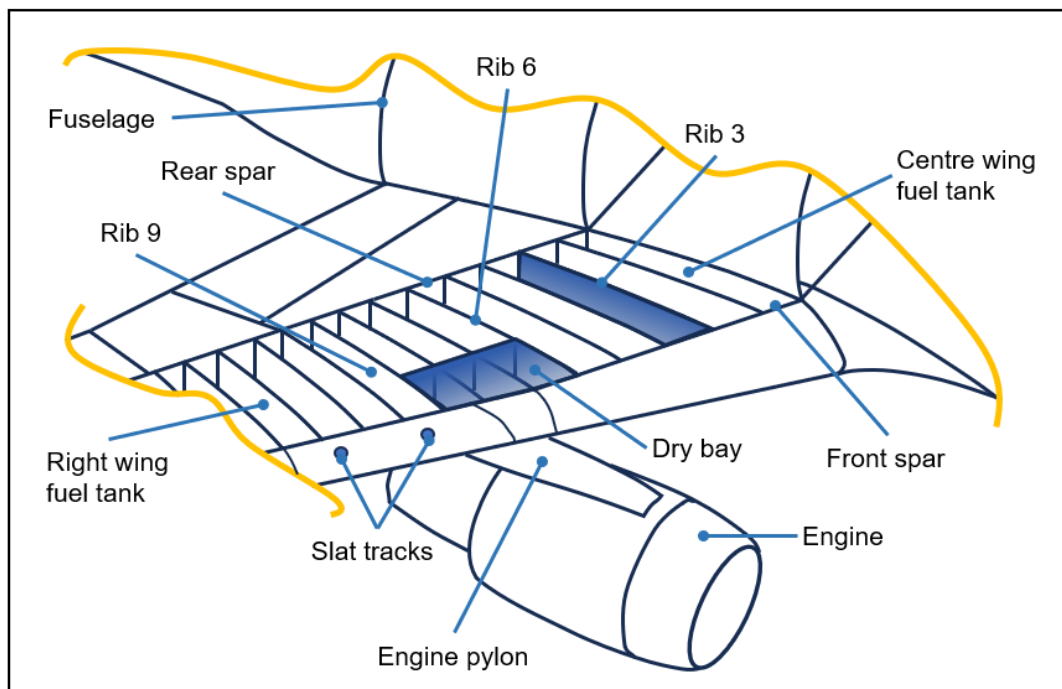
Figure 9

The internal wing structure forms three aircraft fuel tanks: a left and right wing tank with a capacity of 40,000 lbs each and a centre wing tank of 80,000 lbs. The wing fuel tank boundaries are the front and rear spar, upper and lower wing surfaces, and Rib 3 (Figure 9). Located above the engine pylon within the fuel tank boundary is a separate zone called the dry bay, which is sealed and does not contain fuel. It spans from Rib 6 to Rib 9 and is a safety feature in case of an uncontained engine rotor failure. Analysis has identified that high energy engine fragments could penetrate the wing in this area and therefore it is kept free of fuel to prevent a fuel leak. It has a drain hole at the lowest point to remove any condensation or other fluids that may collect in the bay and a removal access panel to facilitate inspections (Figure 10).

Wing scheme showing dry bay location.
(Upper and lower wing surfaces not shown for clarity)

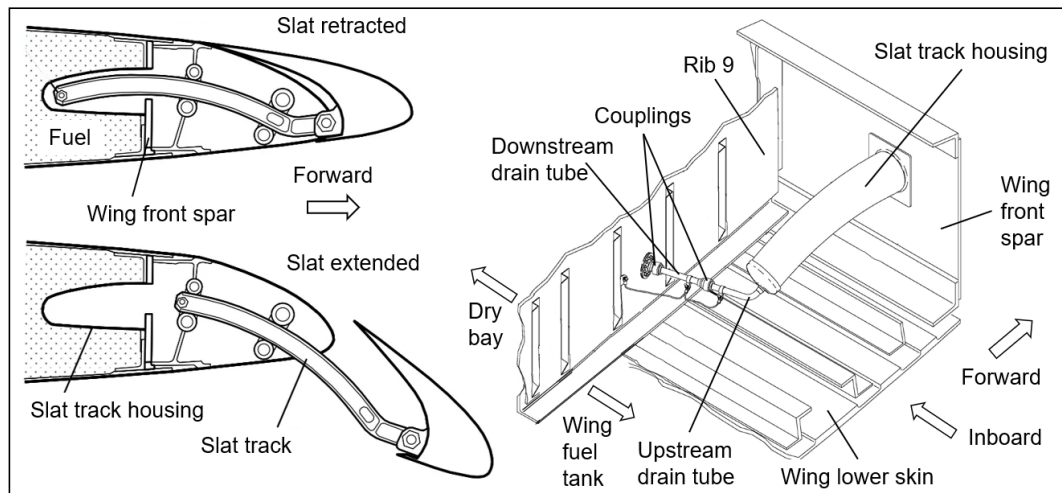
Figure 11

The wing leading edge slats extend and retract on tracks supported on rollers (Figure 11). In the retracted position the slat track protrudes through the front spar into the fuel tank. To maintain the fuel tank boundary, a slat track housing is attached to the inside of the front spar into which the track retracts. It is fitted with a drain tube to allow any fluids from the environment to drain out of the housing. If water were allowed to accumulate in the bottom of the housing and then freeze, there is a risk that the slat tracks could damage the housing, resulting in a fuel leak.

Generic slat track function (left) and the B767 inboard slat track housing (right)

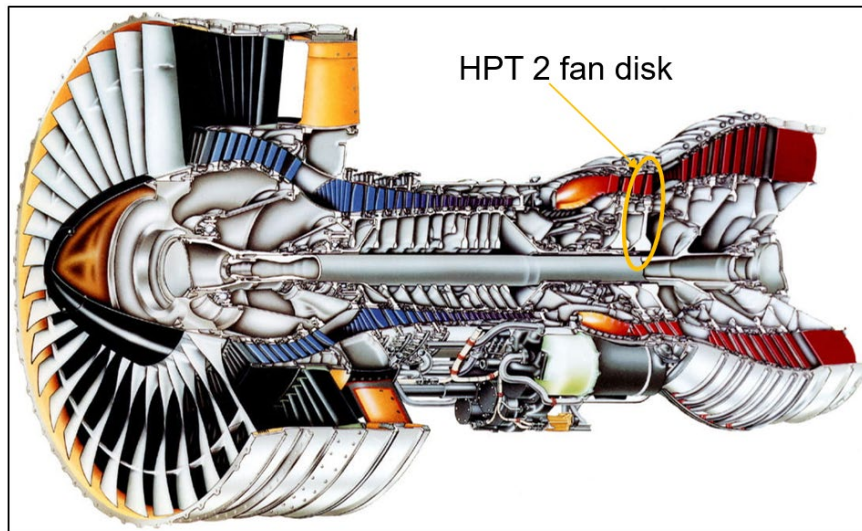
Figure 12

N197DN was fitted with two Pratt & Whitney PW4060 turbofan engines, and the engine installed on the right wing was serial number ESN 724314. It had accumulated a total of 90,814 hours and 15,560 cycles in operation with 1,862 hours and 331 cycles since its last maintenance shop visit. It is a conventional two shaft turbofan with a two-stage high-pressure turbine (HPT) section (Figure 12). The second stage HPT disk (HPT 2) has 82 blades and a 100% rotation speed of 9,900 rpm.

Section view of PW4060 engine showing HPT 2 disk (used with permission)
