# Collision between a train and an object left on the track at Kings Langley, Hertfordshire, 25 April 2024

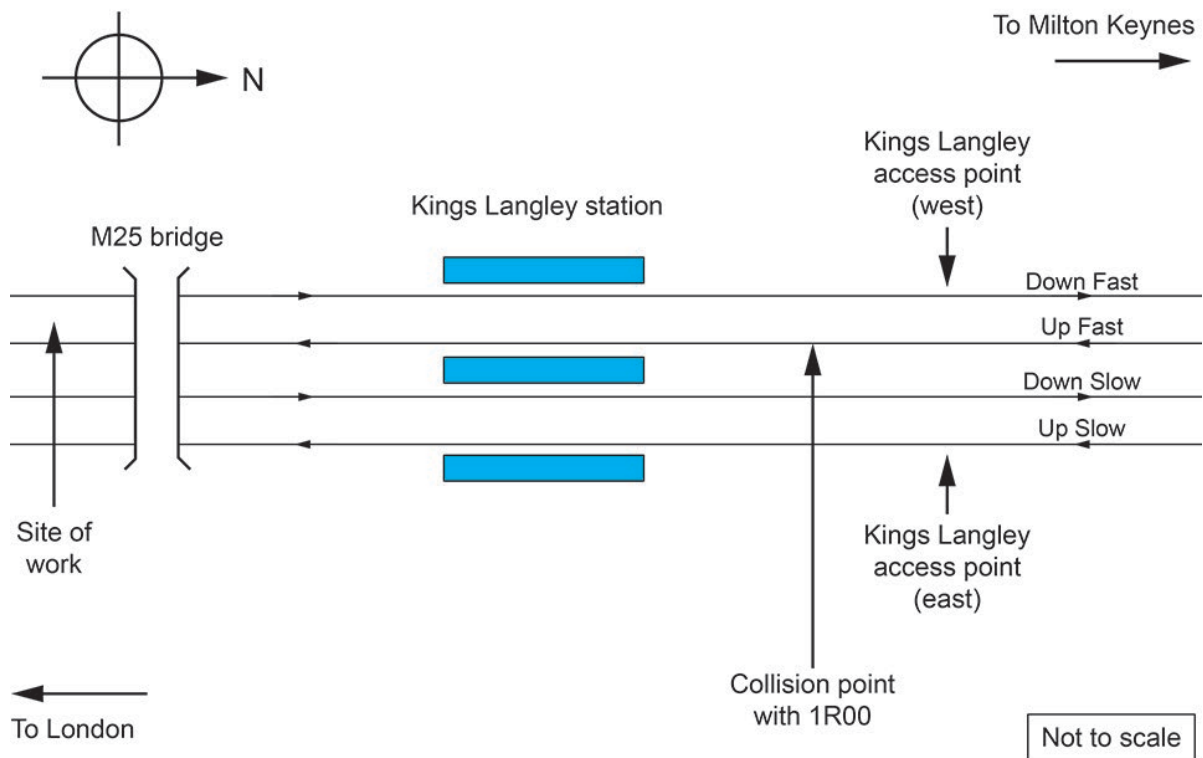
The Down and Up Fast lines at Kings Langley were under possession between 22:30 hrs on 24 April to 06:00 hrs on 25 April. Additional protection was to be provided by a possession of the Down Slow line from 00:45 hrs to 05:20 hrs on 25 April. No work was to take place on the Down Slow line, but the blockage of that line would give road-rail vehicles additional room to manoeuvre when on-tracking onto the adjacent Up Fast line. The Up Slow line remained open throughout, with a site warden being appointed to prevent track workers getting too close to the open line.

**Line map of the access point and site of work.**

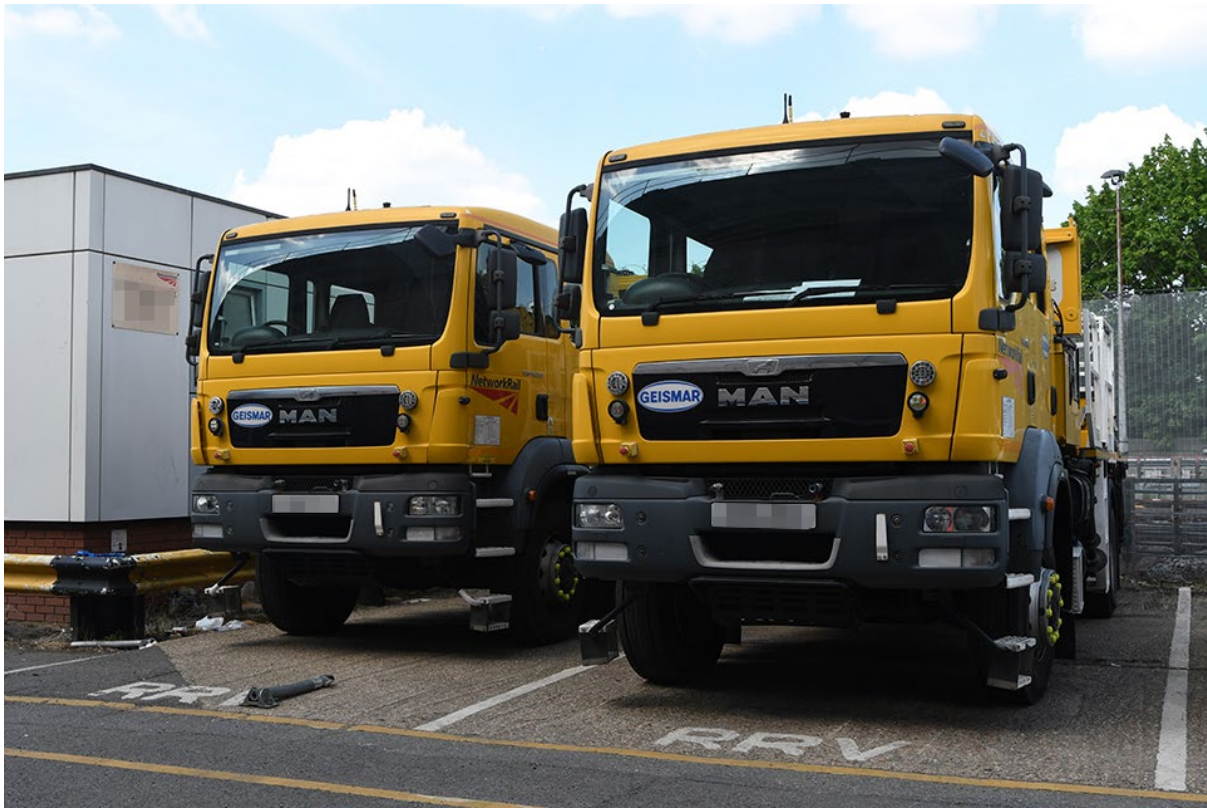
The rectification work needed the use of two road-rail vehicles known as mobile elevated work platforms (MEWPs) which were required to operate side by side. The MEWPs were to access the track at Kings Langley access point at the northern end of the site of work. This access point has access gates on the both the eastern and western sides of the railway. On this occasion, only the western access gate was useable due to the Up Slow line remaining open throughout the possession.

**A pair of road-rail vehicles with mobile elevated work platforms as used on the WCML for OHLE equipment work.**
