Accident

Aircraft Type and Registration:	Boeing 737-8AS, EI-EGD
No & Type of Engines:	2 CFM56-7B26/3 turbofan engines
Year of Manufacture:	2010 (s/n 34981)
Date & Time (UTC):	4 October 2023 at 1320 hrs
Location:	London Stansted Airport
Type of Flight:	Commercial Air Transport (Passenger)
Persons on Board:	Crew - 6 Passengers - 103
Injuries:	Crew - None Passengers - None
Nature of Damage:	Right wing leading edge damaged
Commander's Licence:	Airline Transport Pilot's Licence
Commander's Age:	42 years
Commander's Flying Experience:	10,803 hours (of which 7,915 were on type) Last 90 days - 102 hours Last 28 days - 41 hours
Information Source:	Air Accident Report Form submitted by the commander and subsequent enquiries by the AAIB

Synopsis

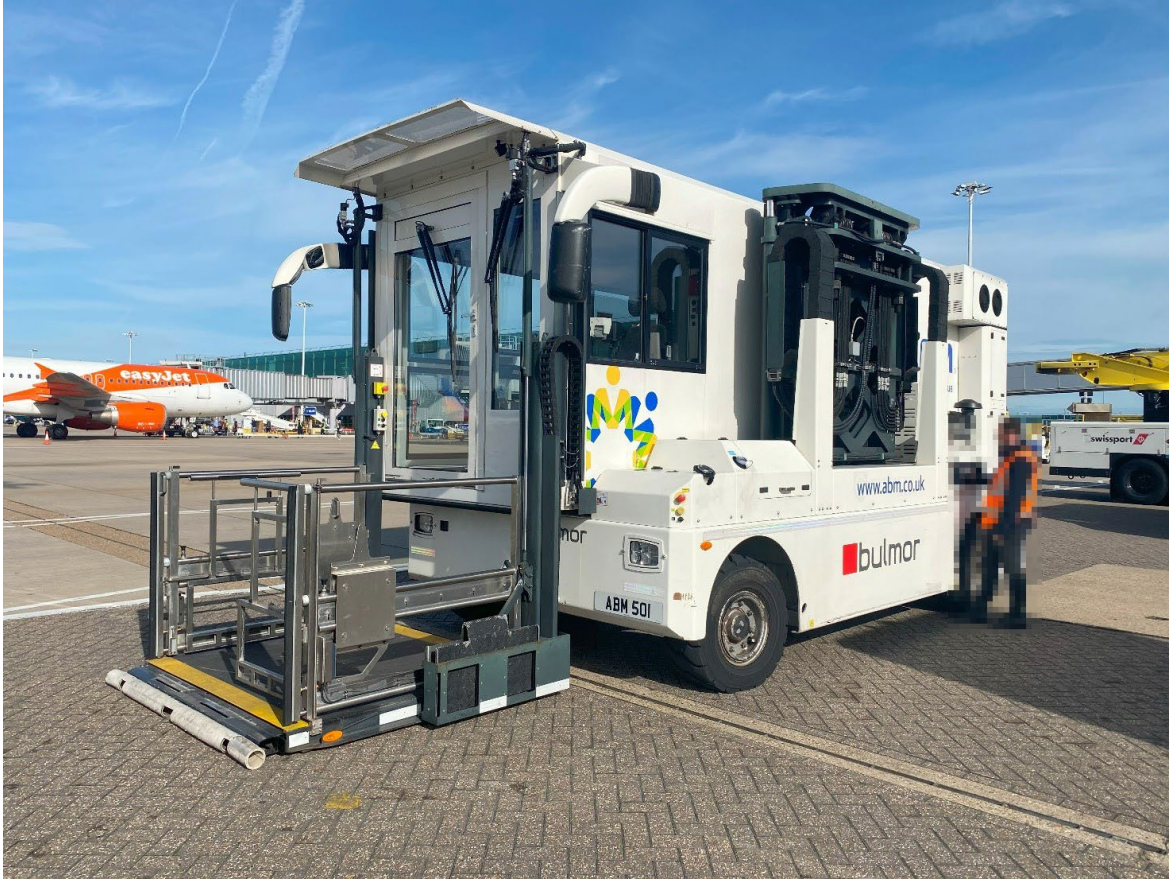
Figure 3

The Bulmor SideBull OMNI 135 (Figure 3) was used to transport passengers requiring assistance between the terminal building and aircraft. This vehicle type can engage with aircraft under the operation of one driver. The vehicle at the time was serviceable with pre-use inspections having been completed on the day and several days prior.

Example Bulmor SideBull OMNI 135 vehicle

The vehicle provided a wide direct field of view through the windows as shown in Figure 4 with some obscuration caused by the vehicle structure. Vision to the rear was enhanced with multiple mirrors and the camera system.

The vehicle provided a good overall field of view and the obscuration caused by the vehicle structure was not sufficient to hide EI-EGD. The aircraft was visible through the windows and the vehicle design did not contribute to the accident.
