AAIB Bulletin

8/2024

Aircraft Type and Registration:	Grumman FM2, Wildcat, G-KINL
No & Type of Engines:	1 Wright Aeronautical Corp CT7-9B piston engine
Year of Manufacture:	1942 (Serial no: 5744)
Date & Time (UTC):	6 July 2023 at 1615 hrs
Location:	Heveningham Hall, Suffolk
Type of Flight:	Private
Persons on Board:	Crew - 1 Passengers - None
Injuries:	Crew - 1 (Serious) Passengers - N/A
Nature of Damage:	Windscreen and canopy broken, propeller, fin and rudder disrupted
Commander's Licence:	Commercial Pilot's Licence
Commander's Age:	63 years
Commander's Flying Experience:	4,238 hours (of which 2 were on type) Last 90 days - 28 hours Last 28 days - 17 hours
Information Source:	AAIB Field Investigation

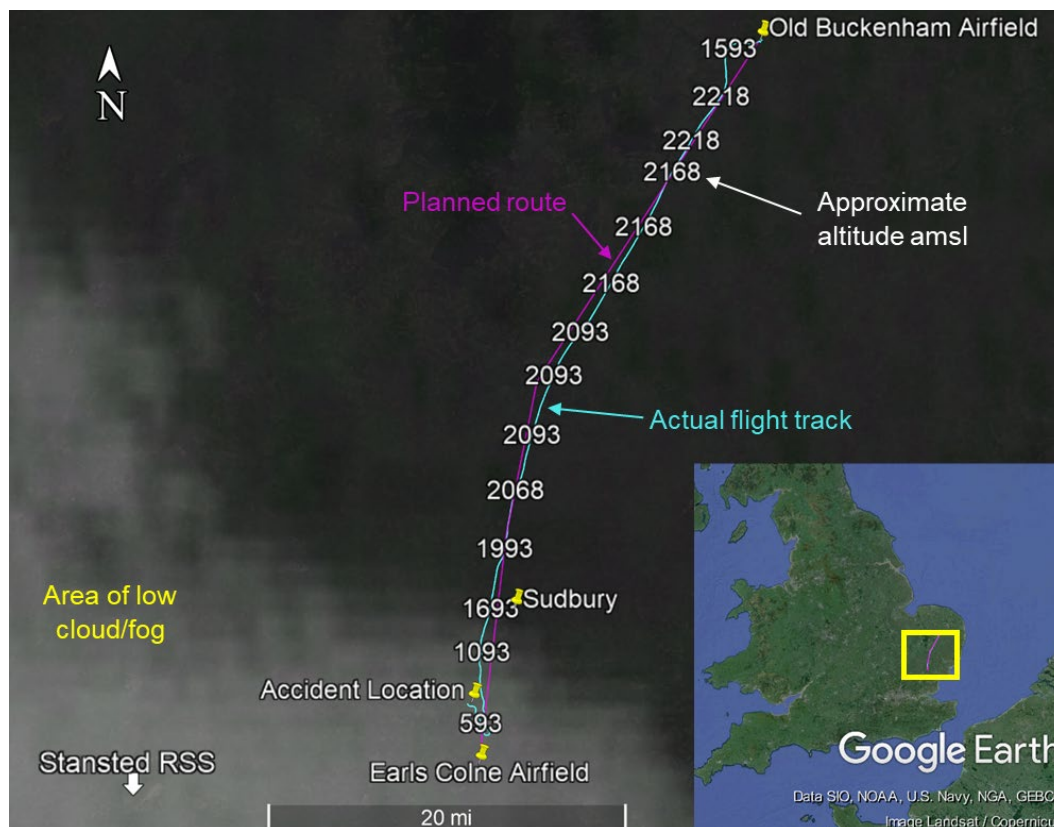
Figure 1 shows the aircraft's planned route and its actual track flown. A visible satellite image provided from the Met Office, showing the approximate location of low cloud and/or fog at 0745 hrs, is overlaid.

Planned route and actual flight track, with fog/cloud overlaid.

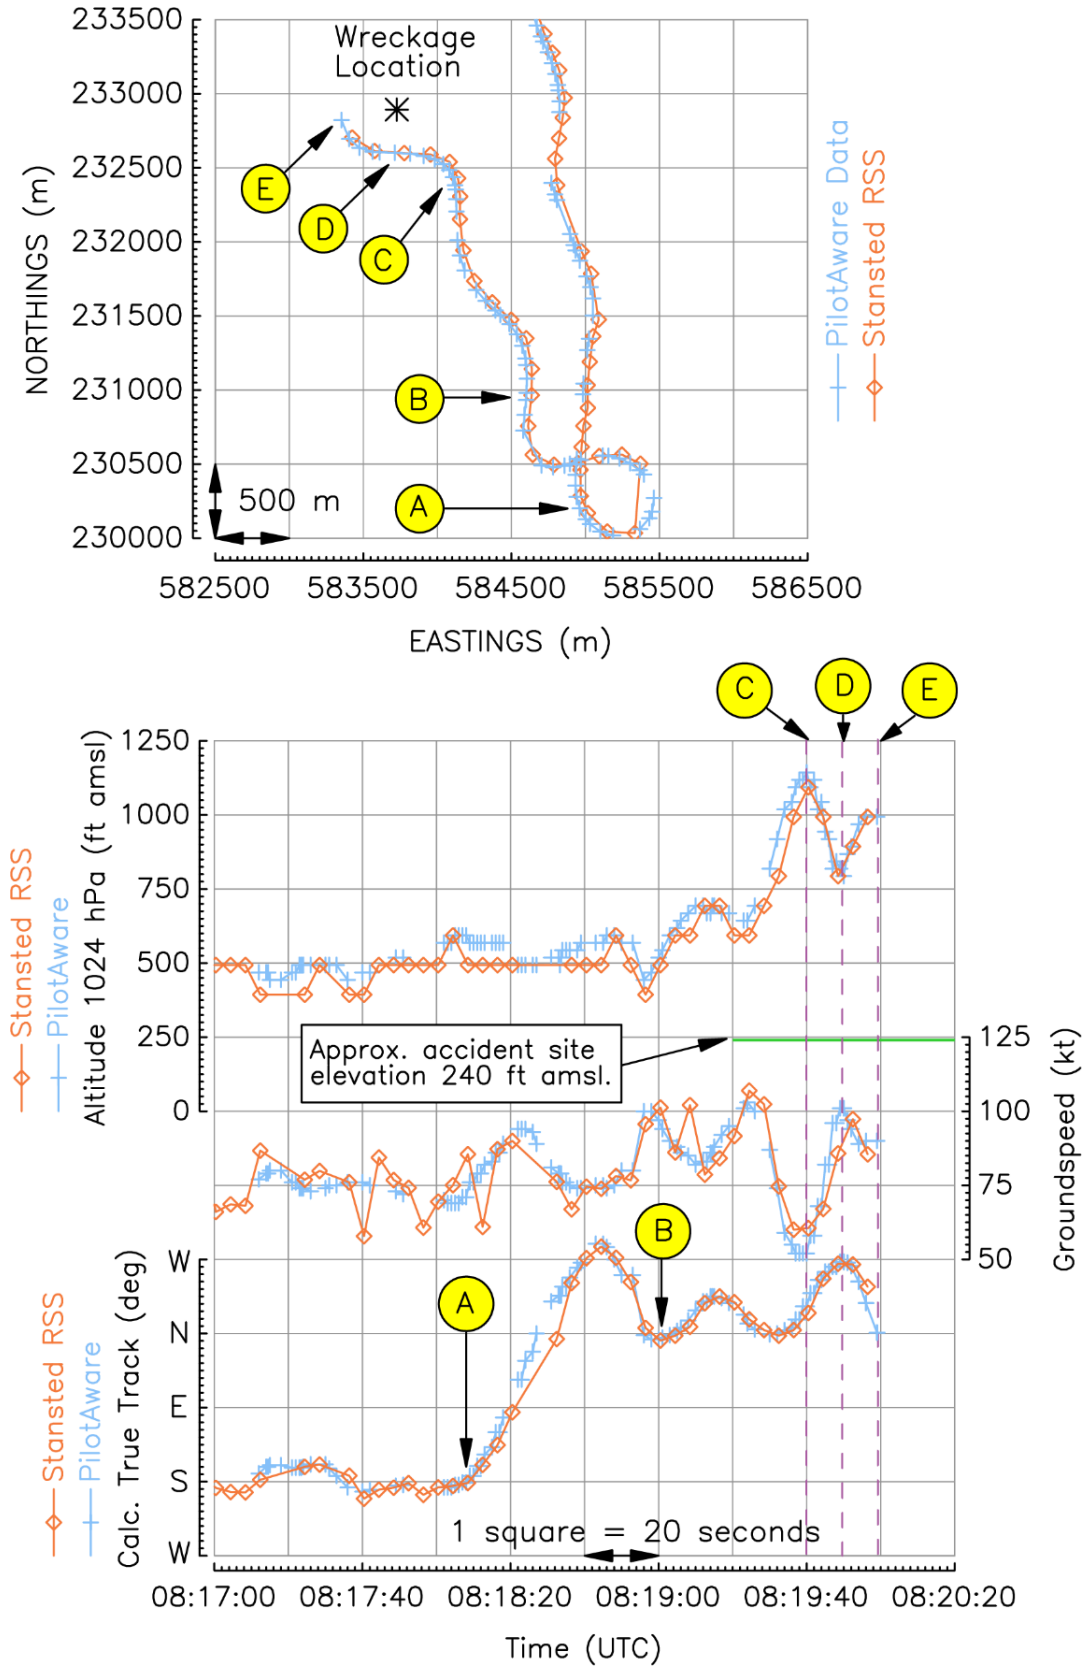
Figure 6

The start of G-AYUH's left turn over Colne Engaine is indicated by point A. G-AYUH then exited the turn flying west, later turning right to fly north in the direction it arrived from (point B). G-AYUH continued in this general direction and climbed to reach about 1,100 ft amsl, approximately 20 seconds before the last recorded position.

At point C, the calculated groundspeed from online tracking data was 52 kt and from radar it was 60 kt. The latter value is considered to be an overestimate due to errors which are normally expected in radar position measurements. The data indicates the aircraft then commenced a left turn and its altitude started to decrease, whilst groundspeed increased.

Altitude, groundspeed and heading from radar and PilotAware data, with an insert showing a plan view of the aircraft's recorded positions.

The aircraft's track began to move towards the north from a westerly heading, marked by point D in Figure 6, at up to $10^\circ/\text{s}$ ³; the calculated groundspeed reached a maximum of about 100 kt at this point. This coincided with the aircraft entering a second climb from an altitude of about 800 ft amsl with reducing groundspeed.

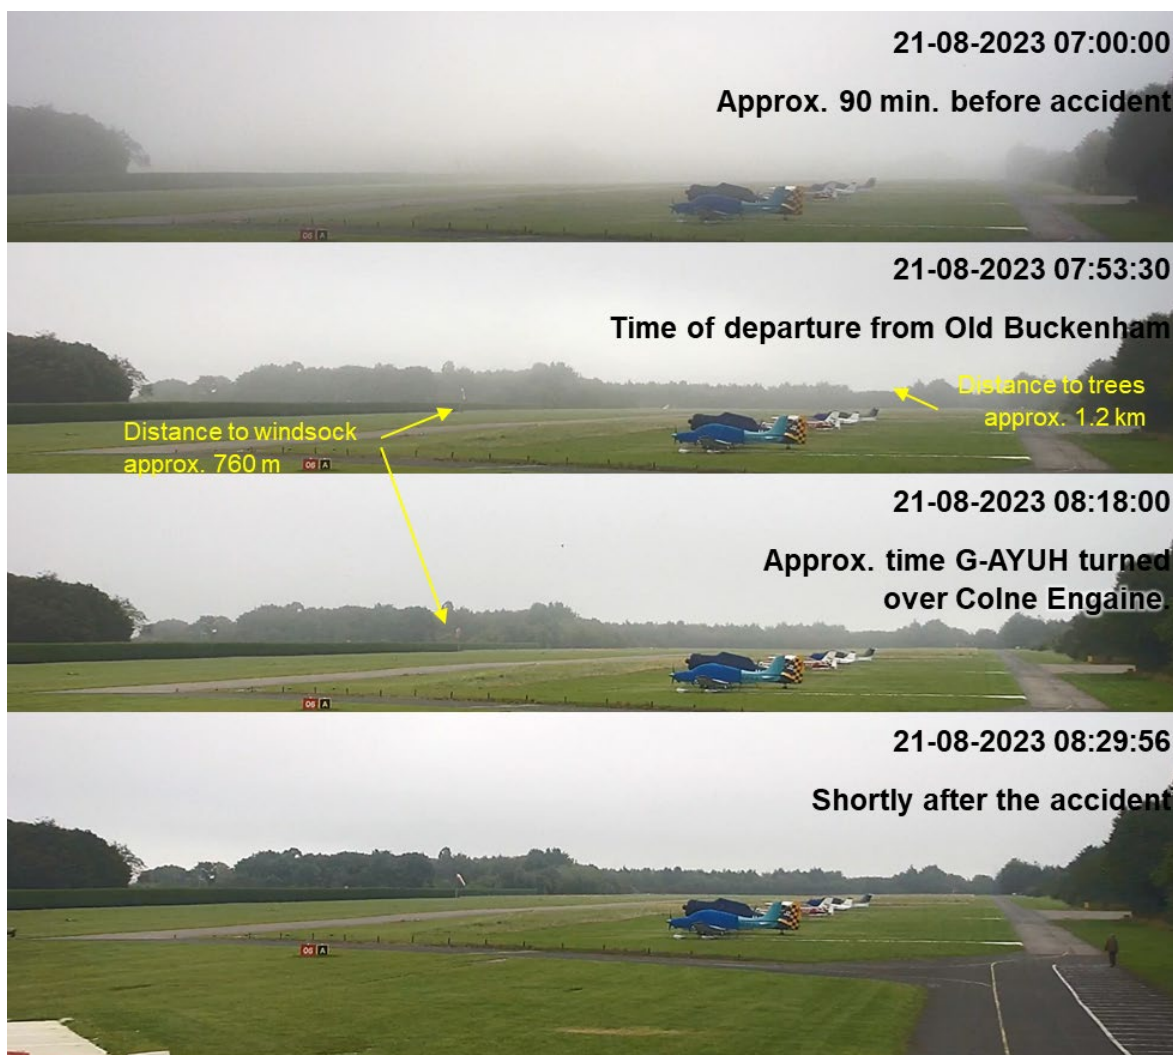
Figure 8

CCTV at Earls Colne Airfield (Figure 8) did not show the aircraft but provided evidence of the meteorological conditions at the following times; when the radio operator arrived at the airfield; when the pilot took off from Old Buckenham; at the approximate time the aircraft turned around over Colne Engine (about 2 minutes before the accident), and approximately 10 minutes after the accident. The timestamps shown are converted to UTC from the embedded video timestamps.

Land features annotated in yellow correspond to distances referenced on a 'Visibility Indicators' chart which was affixed to a window in the radio room.

Snapshots from CCTV footage at Earls Colne, showing changing visibility in the area.

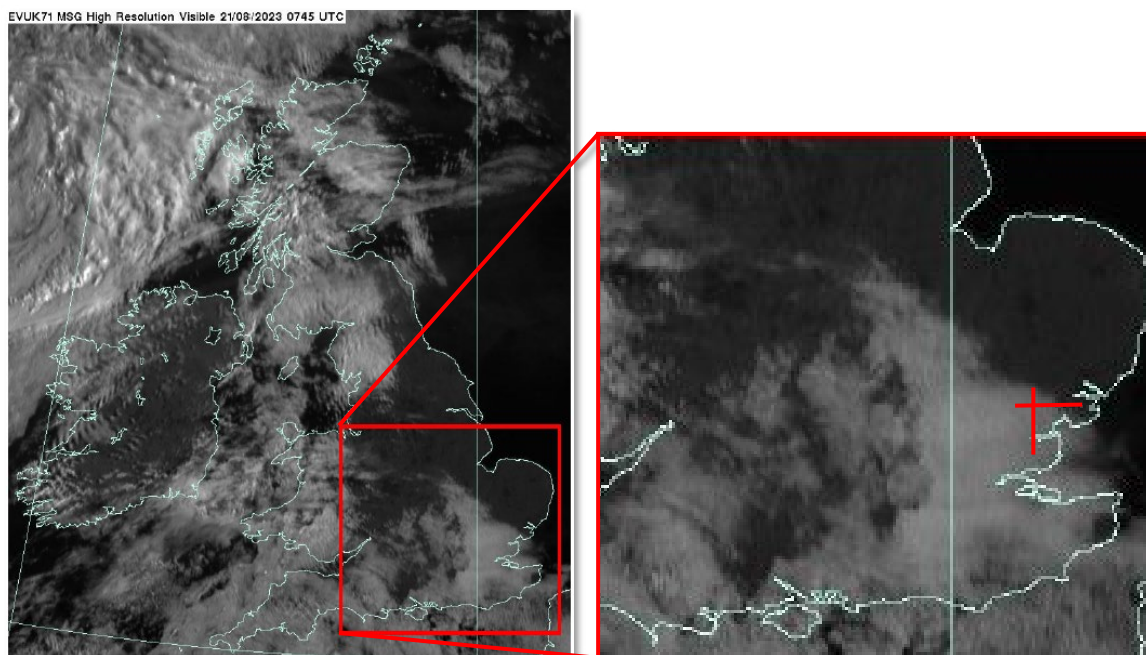
Figure 11

A visible satellite image taken at 0745 on 21 August 2023 (Figure 11) shows that the frontal edge of the cloud had moved across the area of Earls Colne.

Visible satellite image taken at 0745 hrs on 21 August 2023 – intersection of red lines on right image shows approximate position of Earls Colne Airfield (© Met Office)

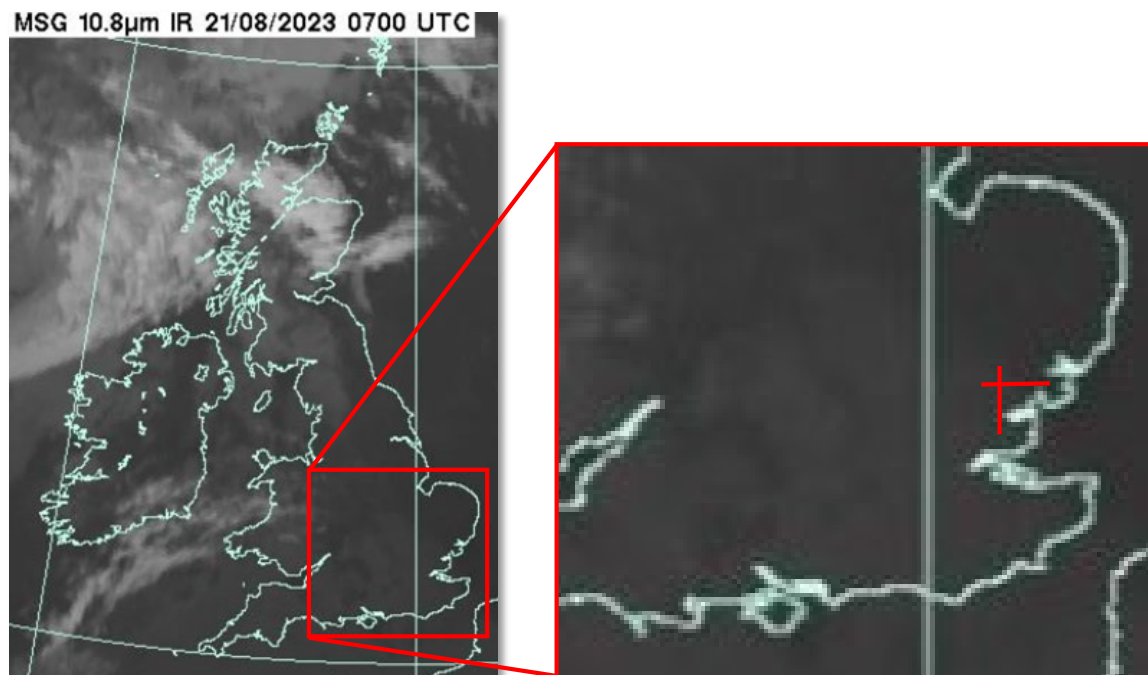
Figure 12

An infra-red satellite image taken 0700 hrs on 21 August 2023 (Figure 12) also shows cloud across the area of interest, but it appears less distinct than the visible satellite image. This indicates that the temperature of the cloud tops was close to the surrounding surface temperature, so at a very low level. The Met Office informed the AAIB that this is indicative of the presence of fog.

Infra-red satellite image taken at 0700 hrs on 21 August 2023 - intersection of red lines on the right image shows the approximate position of Earls Colne Airfield (© Met Office)

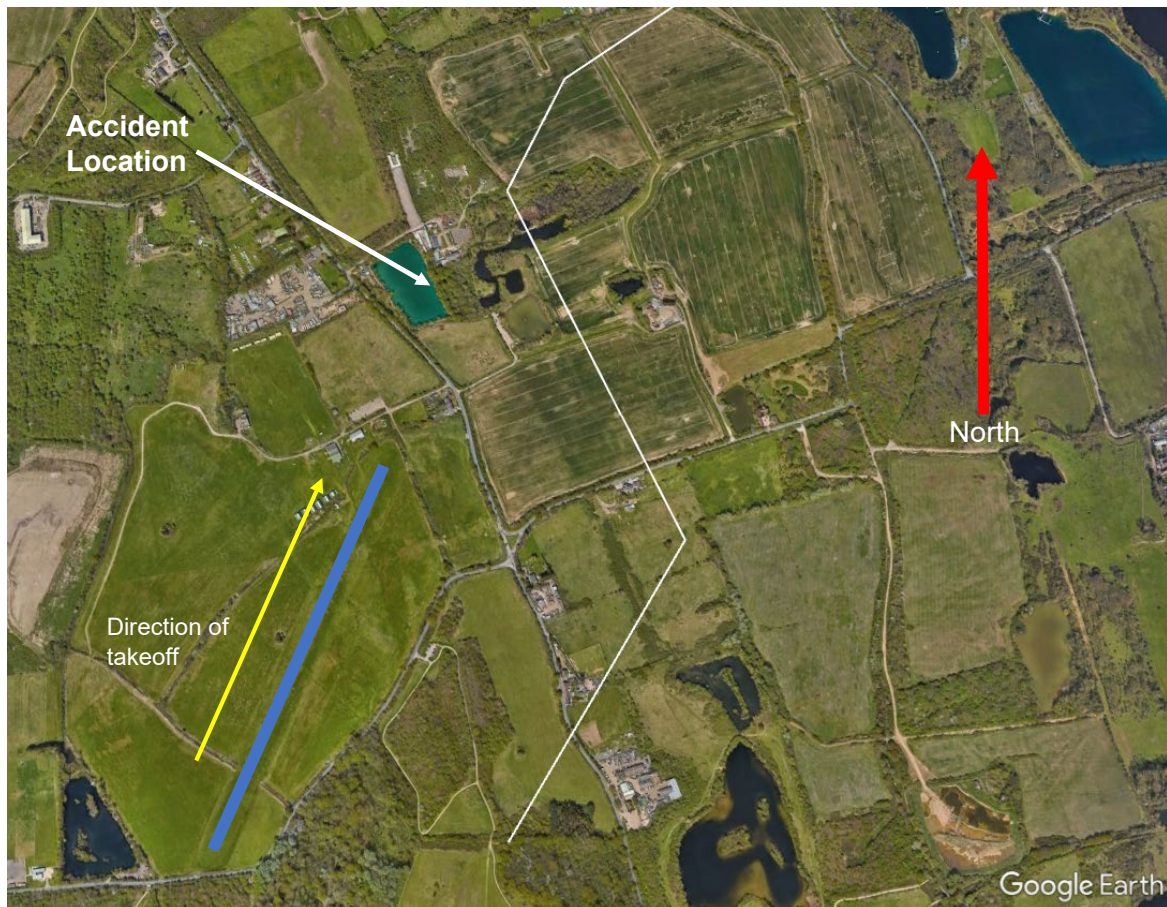
Figure 5

Damyns Hall is an unlicensed airfield with a main grass runway orientated 030°/210° and 650 m long (Figure 5 runway highlighted in blue). The runway slopes down towards the threshold on Runway 03. Pylon power cables run 0.7 nm to the north-east of the airfield as shown in Figure 5.

Aerial view of Damyns Hall Aerodrome highlighting the power cables to the northeast (highlighted in white). Runway 03/21 is marked in blue

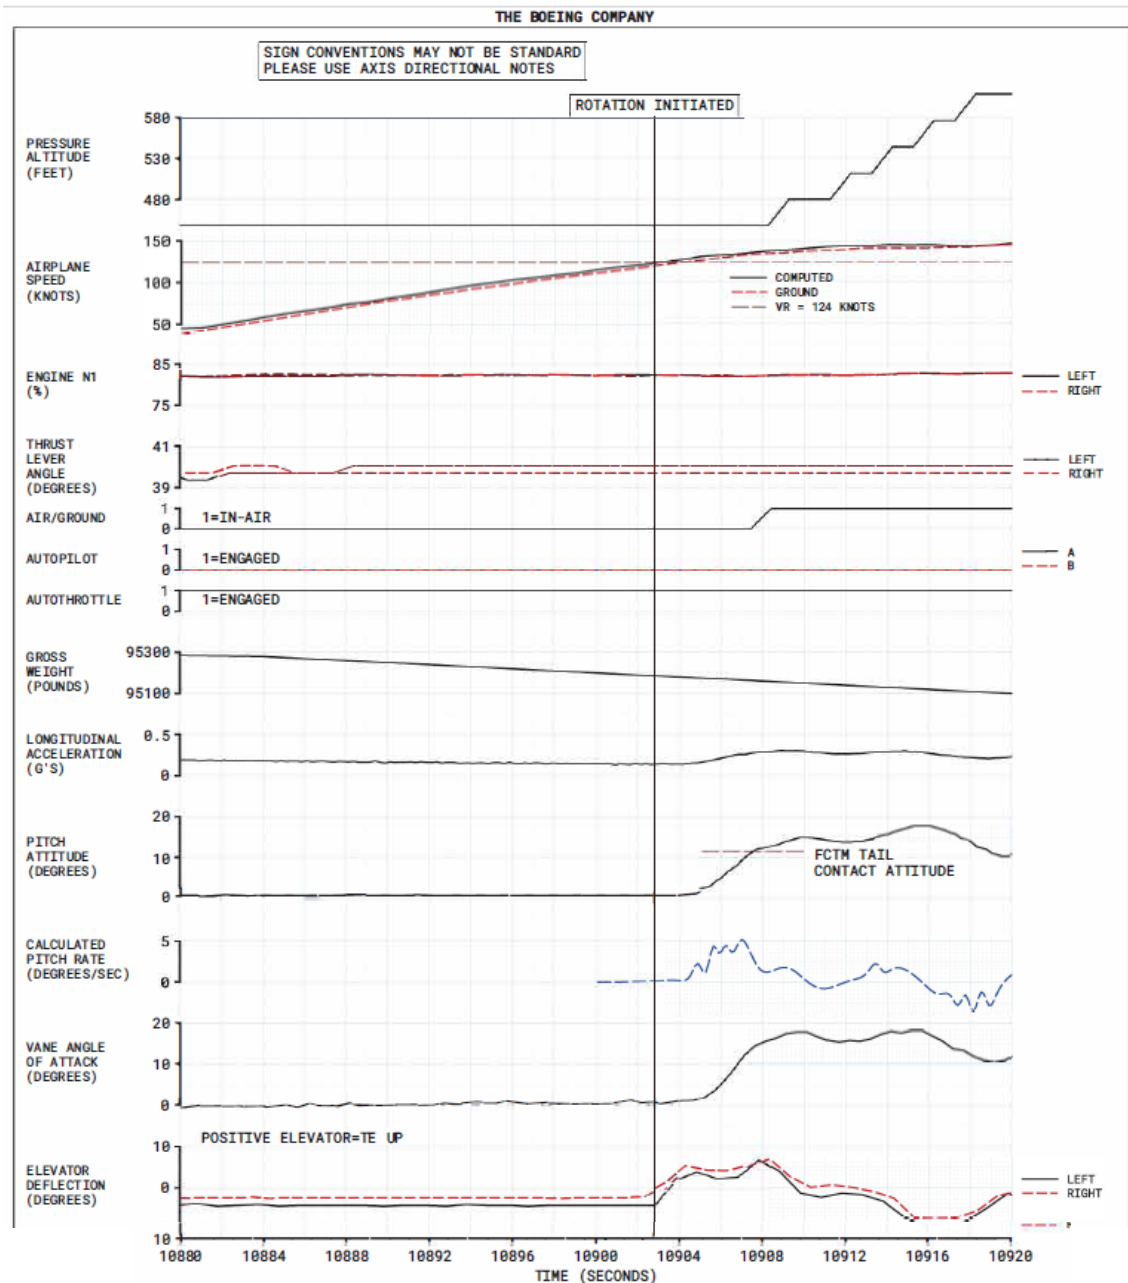
Figure 4

The FDR information was not recovered but information from the Quick Access Recorder (QAR) was downloaded and analysed by the manufacturer. An extract from the information is shown at Figure 4.

Extract of QAR information.
