Accident

Aircraft Type and Registration:	Vans RV-6A, G-RVSH	
No & Type of Engines:	1 Lycoming IO-360-A1AD (Modified) piston engine	
Year of Manufacture:	2004 (Serial no: PFA 181A-13026)	
Date & Time (UTC):	3 September 2023 at 1406 hrs	
Location:	Truro Airfield, Cornwall	
Type of Flight:	Private	
Persons on Board:	Crew - 1	Passengers - None
Injuries:	Crew - 1 (Fatal)	Passengers - N/A
Nature of Damage:	Aircraft destroyed	
Commander's Licence:	Private Pilot's Licence	
Commander's Age:	60 years	
Commander's Flying Experience:	261 hours (of which 115 hours were on type) Last 90 days - 6 hours Last 28 days - 3 hours	
Information Source:	AAIB Field Investigation

Synopsis

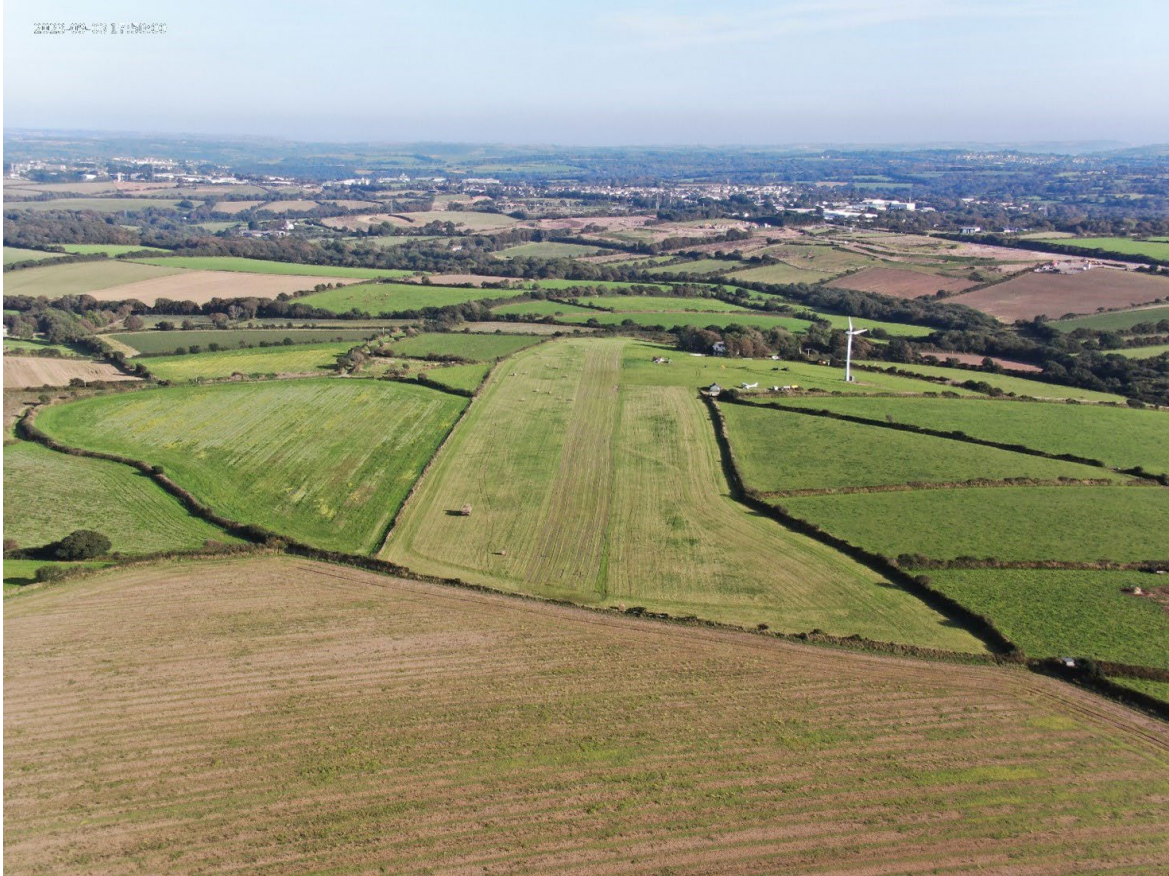
Figure 1

View of Truro in the direction of Runway 14, taken later on the same day as the accident

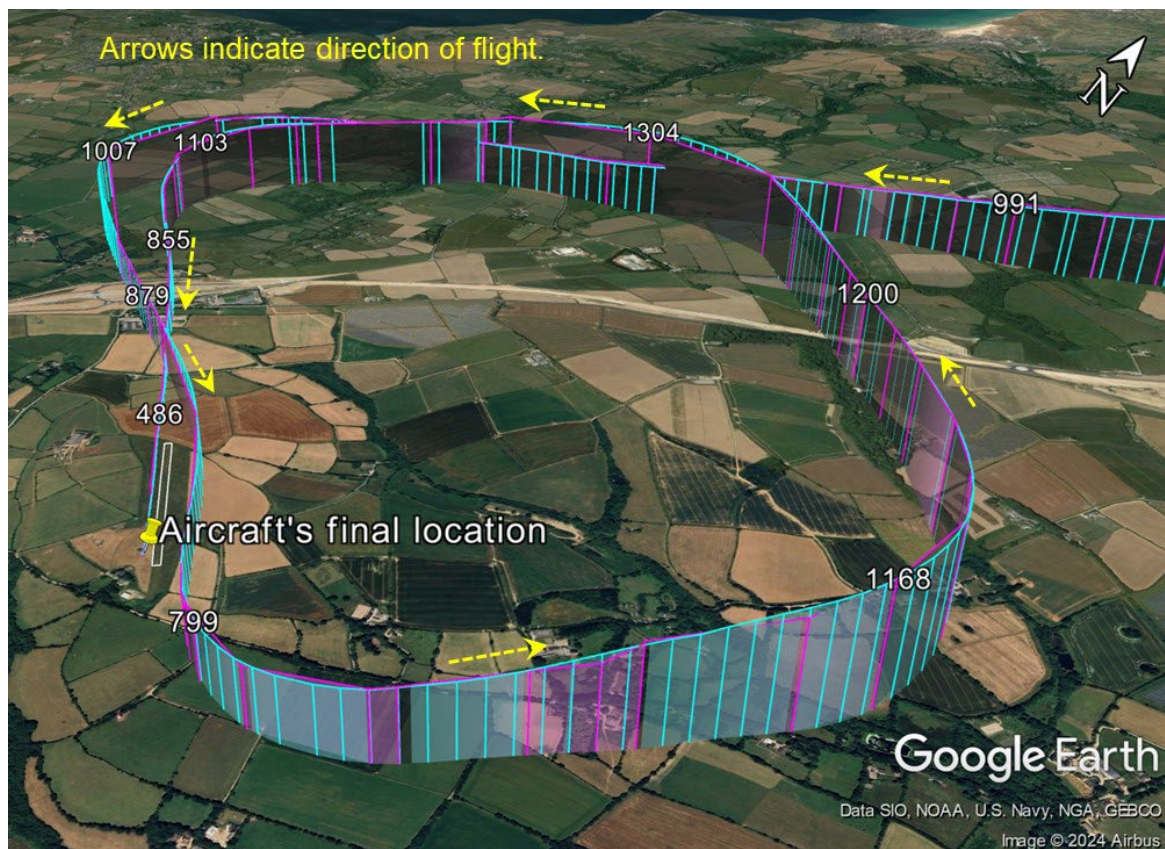
Figure 4

The iEFIS and EKP-V received GPS data from their own GPS antennas, which were collocated on top of the cockpit glareshield. The lateral difference between their recorded GPS positions during the final approach and landing was smaller than the typical error in GPS position measurement¹, and indicated that G-RVSH was offset to the right of the Runway 14 edge by about 20 m. This is illustrated in Figure 4, which shows the flight path taken by G-RVSH before landing in the direction of Runway 14. The GPS tracks corroborated the positions of the wheel track marks found on the accident site (Figure 2).

GPS tracks from EKP-V (blue) and iEFIS (purple) recordings, with altitude amsl overlaid
© 2024 Google, Image © Airbus

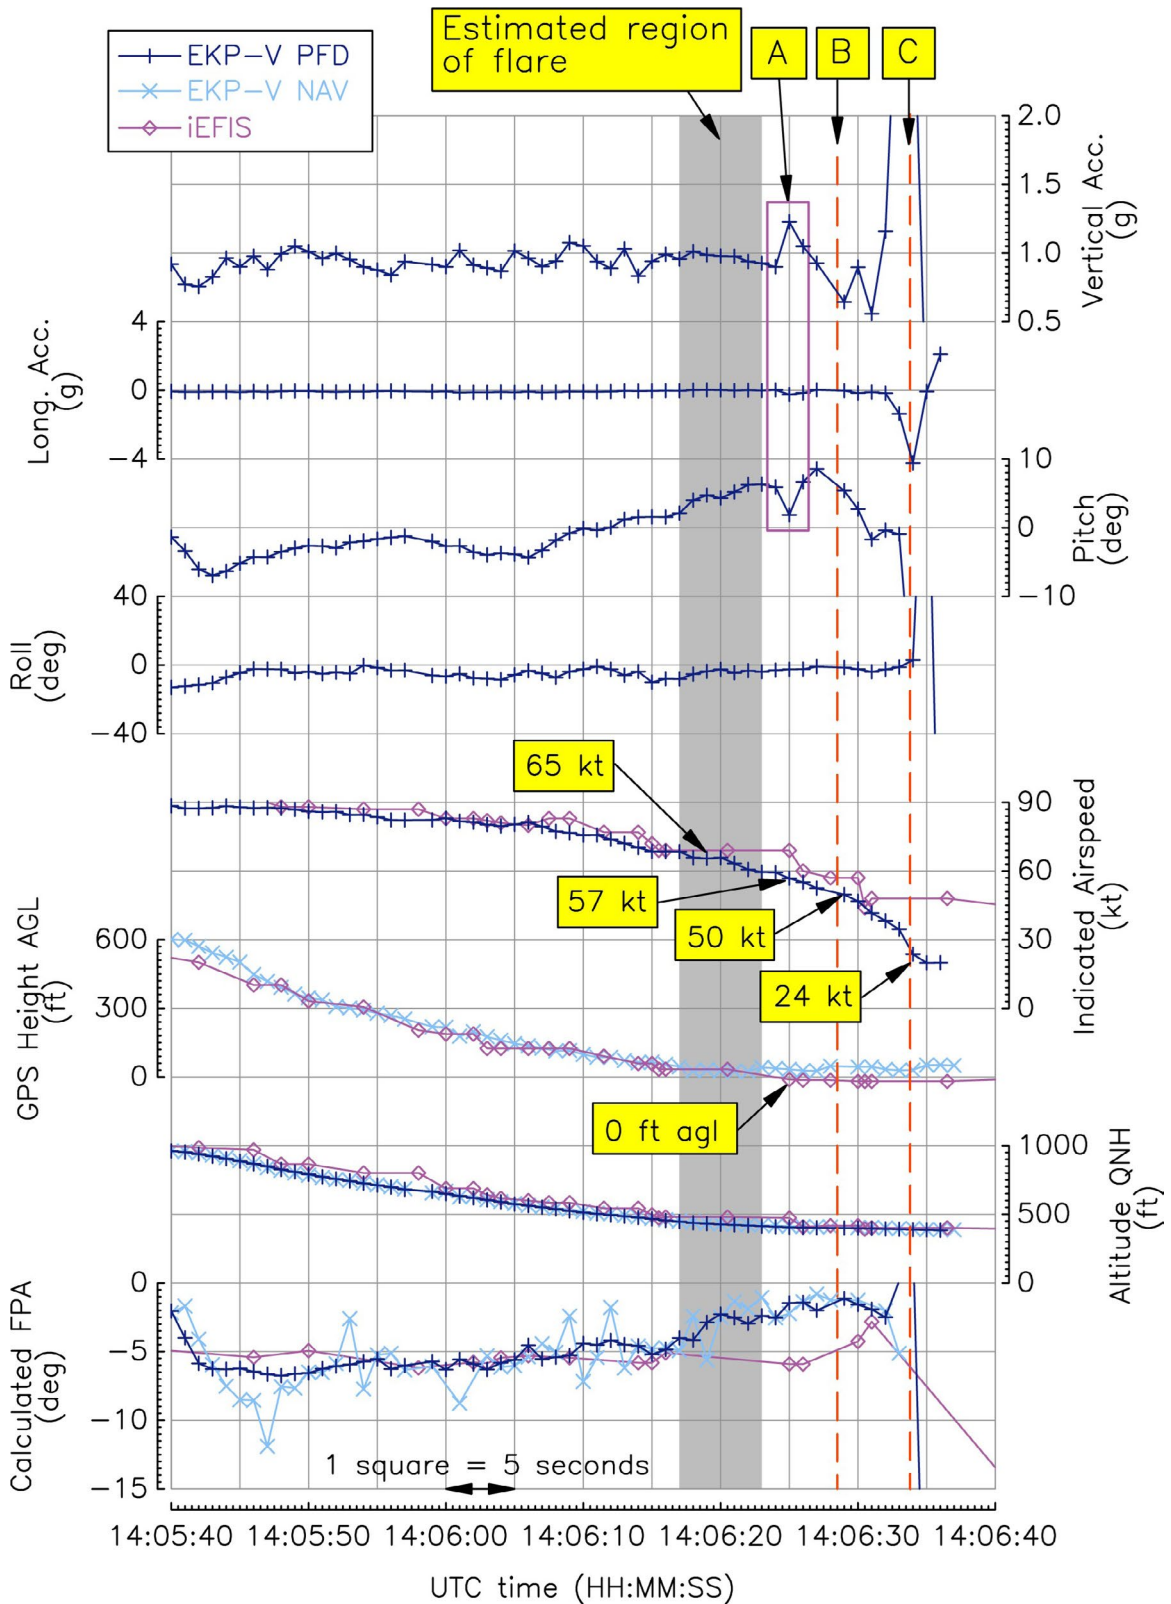
Figure 5 shows pertinent recorded parameters for the last 60 seconds of the flight. The Flight Path Angle (FPA) was calculated from the recorded data and indicates that the approach was flown at a FPA of between -5° and -7° until the flare. The accuracy of these calculations was limited by sensor measurement and calibration uncertainties, which are not known to the investigation.

Figure 5
Pertinent recorded parameters for the final 60 seconds of the flight

The airspeed was about 90 kt at the start of the approach, gradually reducing to about 65 kt where the data indicates G-RVSH began to flare (shown as the shaded region in Figure 5). The recorded GPS position at 1406:20 hrs indicates that G-RVSH was abeam Runway 14 and about a fifth of the length along it when the flare was performed.

A change in vertical and longitudinal acceleration, and temporary reduction in pitch, were recorded shown as point A in Figure 5, and the airspeed was about 57 kt. The sample rate and precision of the altitude and vertical acceleration recordings were not sufficient to determine whether this data indicates a bounce, float or ballooning. Furthermore, similar fluctuations in the recorded vertical acceleration were observed in the data throughout the flight to Truro.

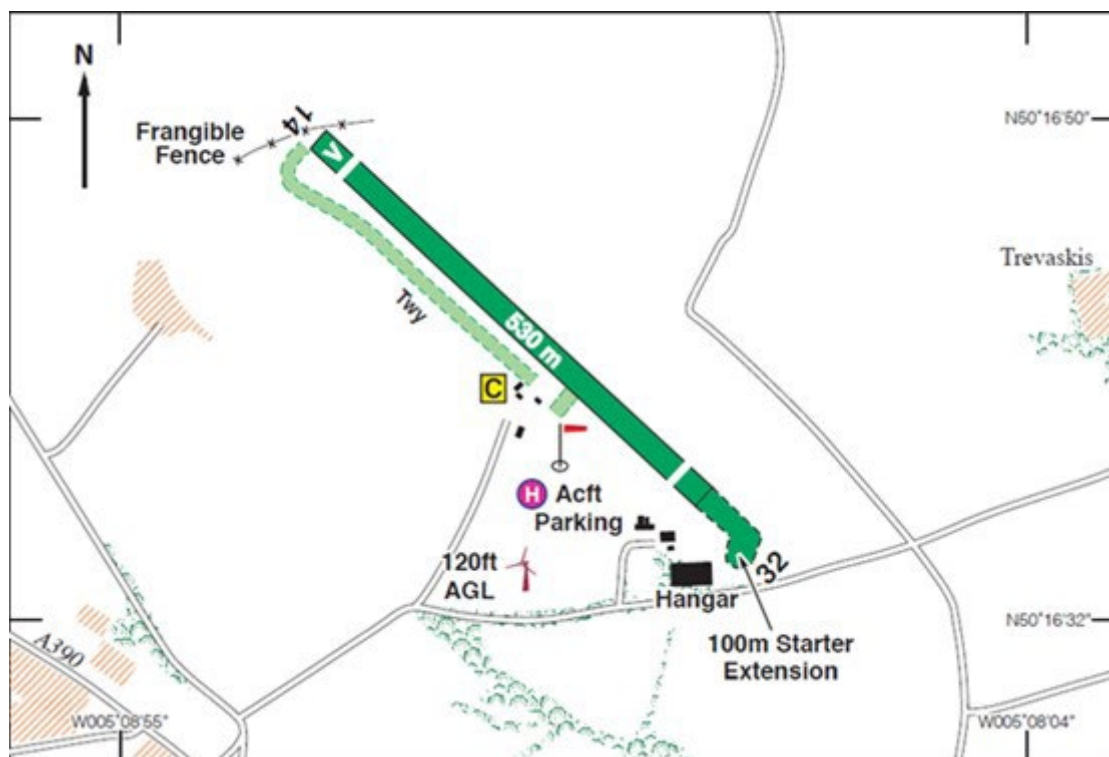
Figure 6

Truro Airfield (Figure 6) is located approximately 4 miles north-west of central Truro and has an elevation of 400 ft amsl. It has a single grass runway, 20 m wide, oriented approximately 140°/320°. Runway 14 has a 1.8% slope downhill. It is an unlicensed airstrip and, consequently, there is no requirement for any regulatory oversight.

Pooley's Plate of Truro Airfield
2023, Robert Pooley

Safety action has been taken by the airfield owner to provide more information on the Pooley's plate. A helicopter training mound has been removed from the airfield.
