# Rail Accident Report

## **Passenger train collision with a derailed locomotive at Bromsgrove 23 March 2020**

Report 14/2020  
November 2020

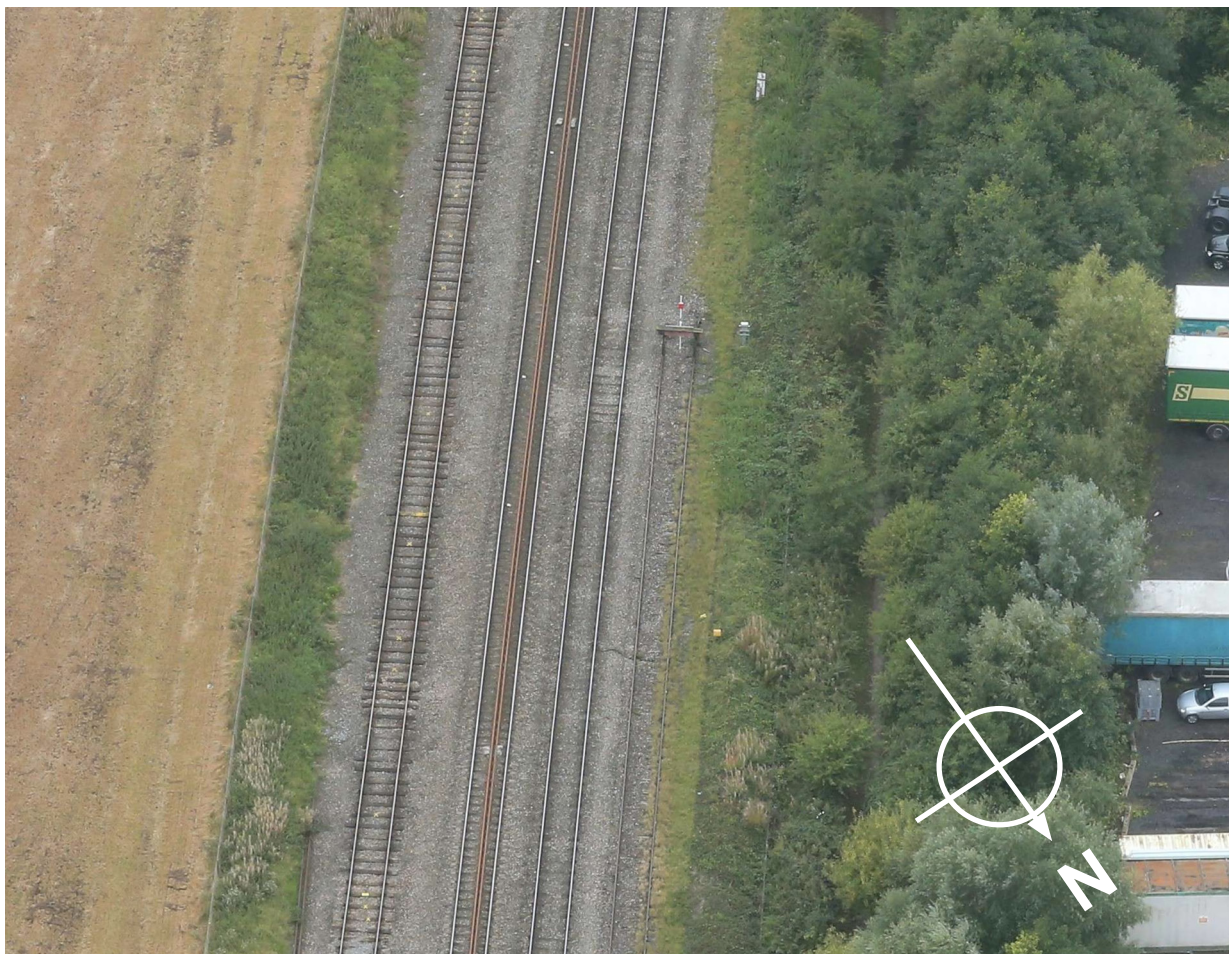
Figure 5: Location of the buffer stop (image courtesy of Network Rail)

- 18 The buffer stop consisted of a metal framework that was fixed to the jointed rails. It did not contain any sliding friction elements or hydraulic buffers. It was fitted with two permanently illuminated red lights (figure 4).
- 19 The buffer stop was installed in its current location (figure 5) around 2004, as identified from historic satellite imagery. Prior to this, the siding had ended in a buffer stop located about 90 metres further south.
