Rail Accident Report

Fatal accident at Morden Hall Park footpath crossing 13 September 2008

Report 06/2009
March 2009

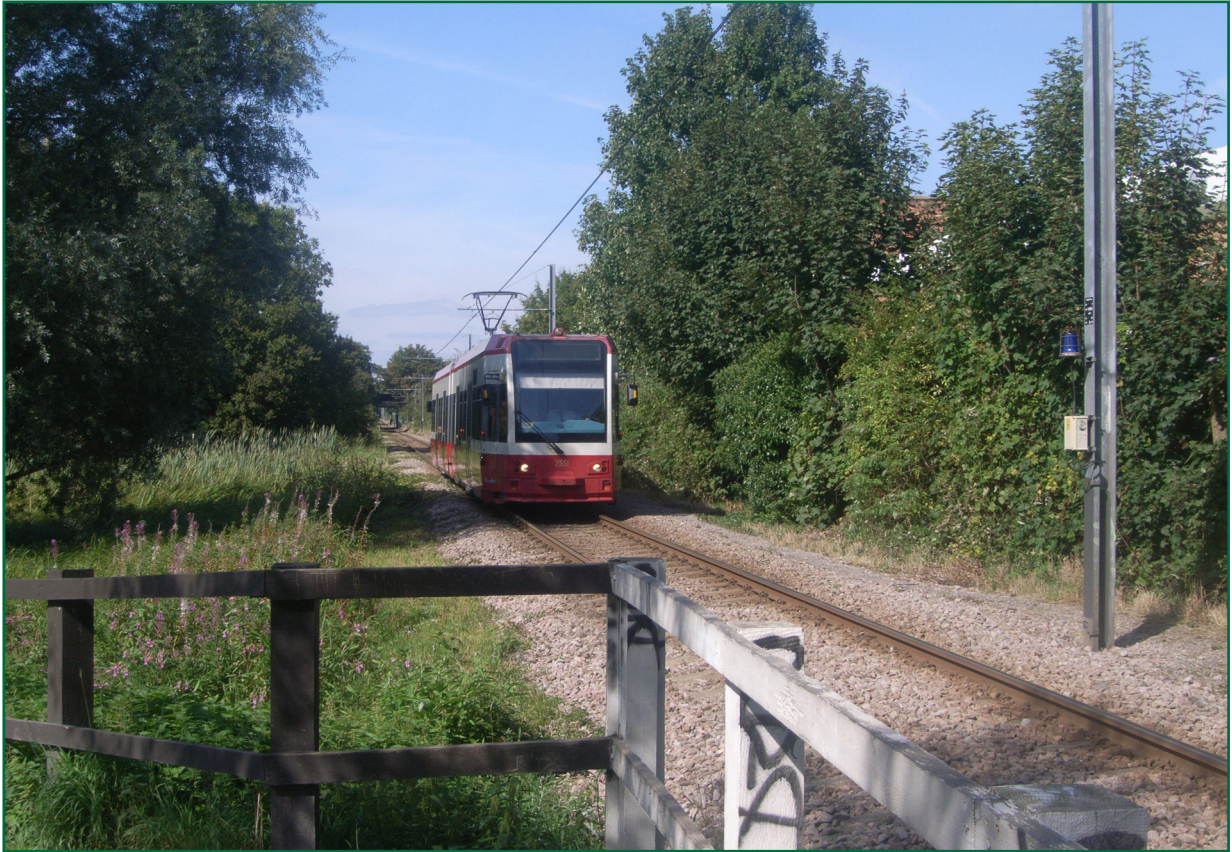
Figure 5: View towards Morden Road, north-west from crossing

- 19 The approach to the crossing from the south-west is along a fenced, curving path 2.6 m wide (Figure 3). Before 2006, this approach was by a narrower path which ran directly towards the tramway at right angles to the track. In the winter of 2005/06 the layout of the approach paths was altered as part of a project to re-route the Wandle Trail around the edge of the wetlands which are an important feature of the park (Figure 4). The re-routed path curves round to approach the tramway at an angle of about 40°, and then bends sharply to enter the chicane, which is parallel to the tramway. Visibility along the tramway in both directions is unobstructed for several hundred metres in both directions from the point when a potential user reaches the centre of the chicanes (Figures 5 and 6).
