Rail Accident Investigation Branch

Rail Accident Report

Derailment at Knaresborough 7 November 2015

Report 16/2016
August 2016

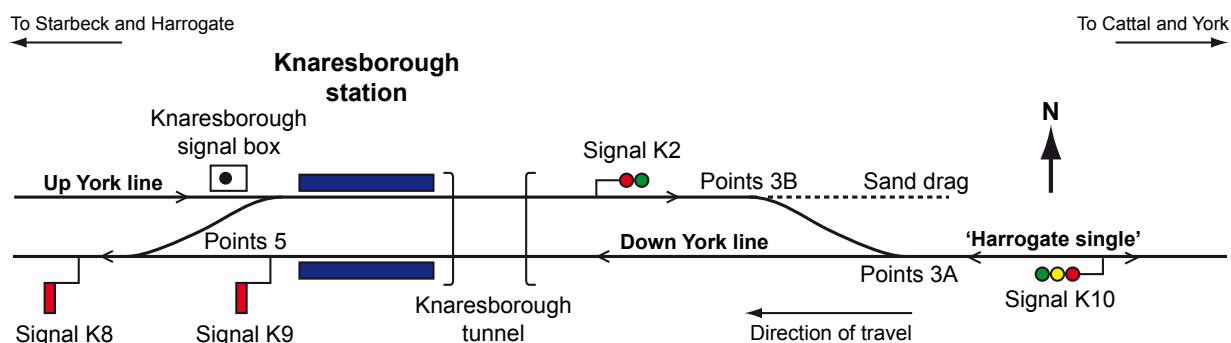
Figure 3: Overview of site showing geographical relationship of key features

7 Points 3A, on which the derailment took place, are where the single line between Cattal and Knaresborough becomes double track (a crossover). For a train travelling from Cattal to Knaresborough, such as train 2C07, points 3A enable the train to move onto the Down York line heading towards Harrogate and Leeds. For a train travelling from Knaresborough to Cattal, points 3B¹ and 3A enable the train to move from the Up York line onto the single line.

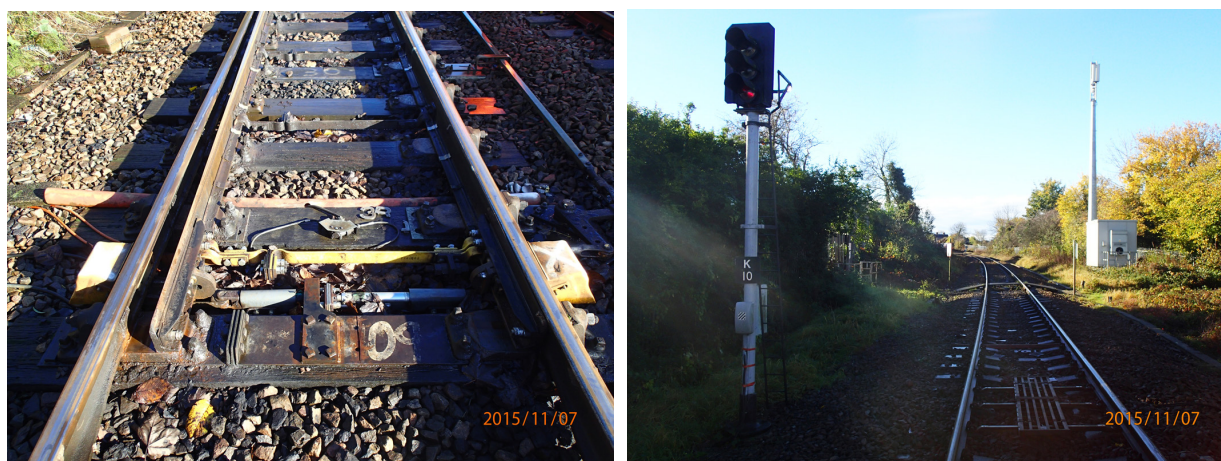
Figure 4: Points 3 in the 'normal' position and signal K10

- 14 Points 3A are of the *E-type*, using *flat bottom rails* laid vertically. The points are fitted with an electrical '*clamp lock*' machine and a mechanical *back drive* used to move the *switch rails* from one position to the other. When in the '*normal*' position, the points are set for a train approaching from the single line to remain on the DownYork line. When in the '*reverse*' position, the points are set for a train approaching from the Up York line moving onto the single line.

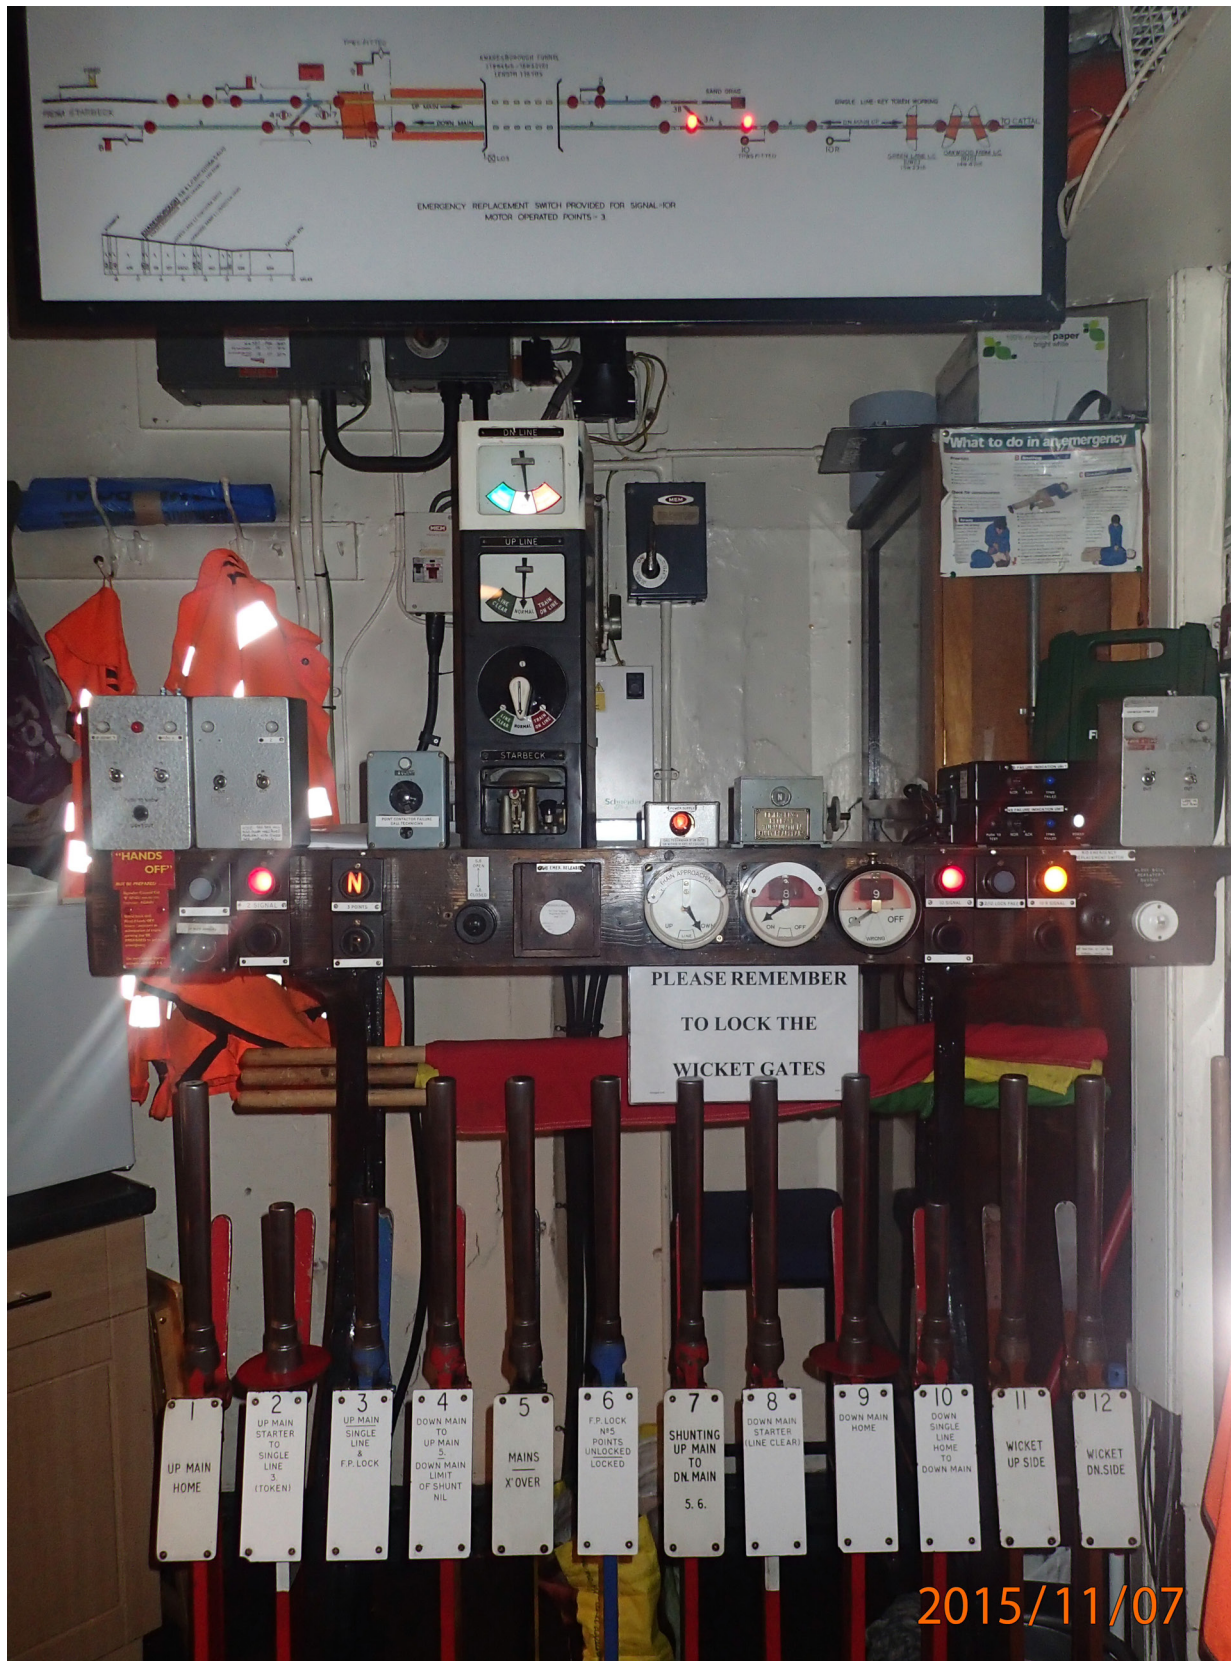
Figure 5: Knaresborough signal box lever frame

- 16 Knaresborough signal box is fitted with a frame containing 12 mechanical levers. The levers are used to operate the points and signals controlled by the signal box. The area controlled by the box spans from Oakwood Farm crossing to the east to signal K8 on the DownYork line to the west.

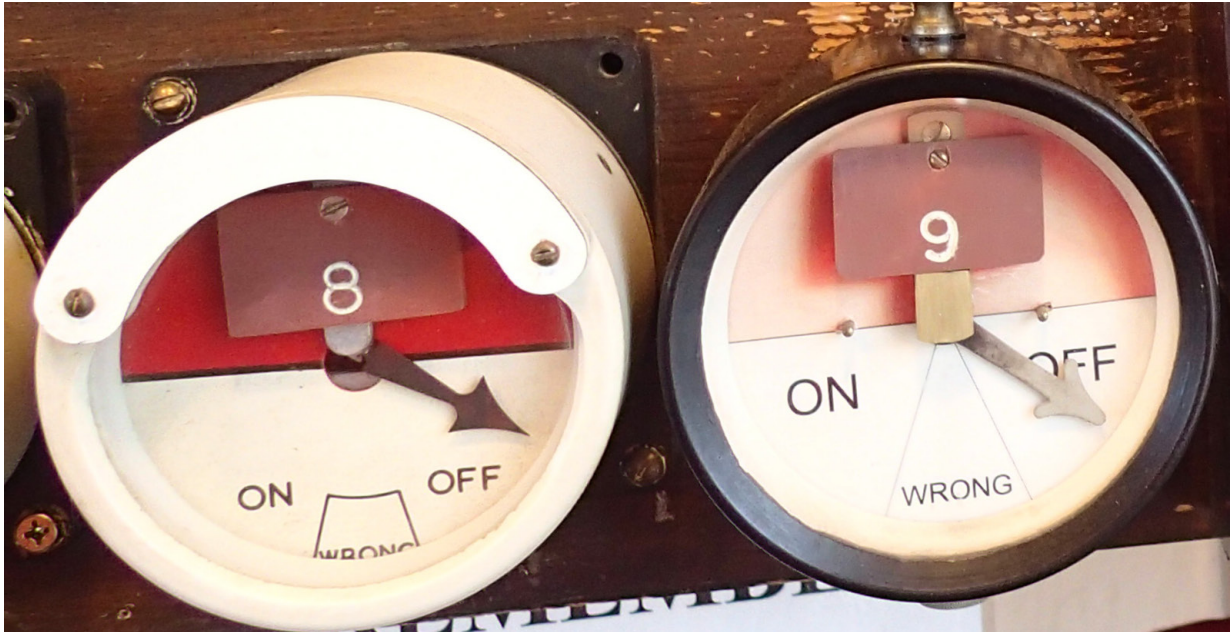
Figure 6: Signal aspect indication at Knaresborough signal box for signals K8 and K9 (semaphore)

- 24 Mechanically operated semaphore signals are moved by a wire which pulls the arm to the 'clear' (or 'off') position when the signaller reverses the corresponding lever. An indicator, located on the shelf above the signal lever provides the signaller with confirmation of the position of the semaphore arm (figure 6).
