# Rail Accident Report

**Serious operational irregularity at Bagillt user worked crossing, Flintshire, involving an abnormally heavy road vehicle  
17 August 2018**

Report 11/2019  
August 2019

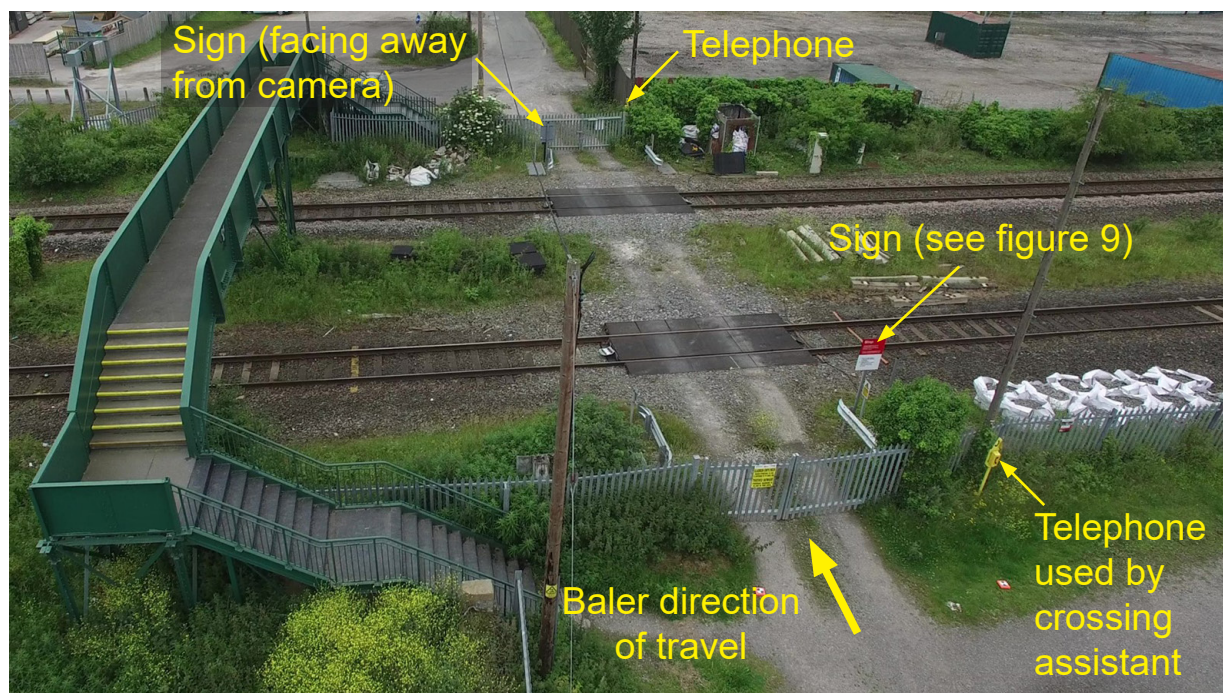
Figure 5: Telephones and signs at Bagillt UWC-T

- 16 Bagillt UWC-T has a pair of gates on each side of the railway situated 24.5 metres apart (figure 4). The crossing is equipped with a telephone outside each pair of gates which connect to the signaller's workstation supervising the crossing (figure 6, paragraph 19). Signs positioned inside the gates on both sides of the crossing tell users with vehicles or animals that they must telephone the signaller to obtain permission before opening the gates, crossing the railway and closing the gates. Vehicle users are required to obtain permission because sighting distances along the railway are not sufficient for users to see trains in time to determine if it is safe to cross.

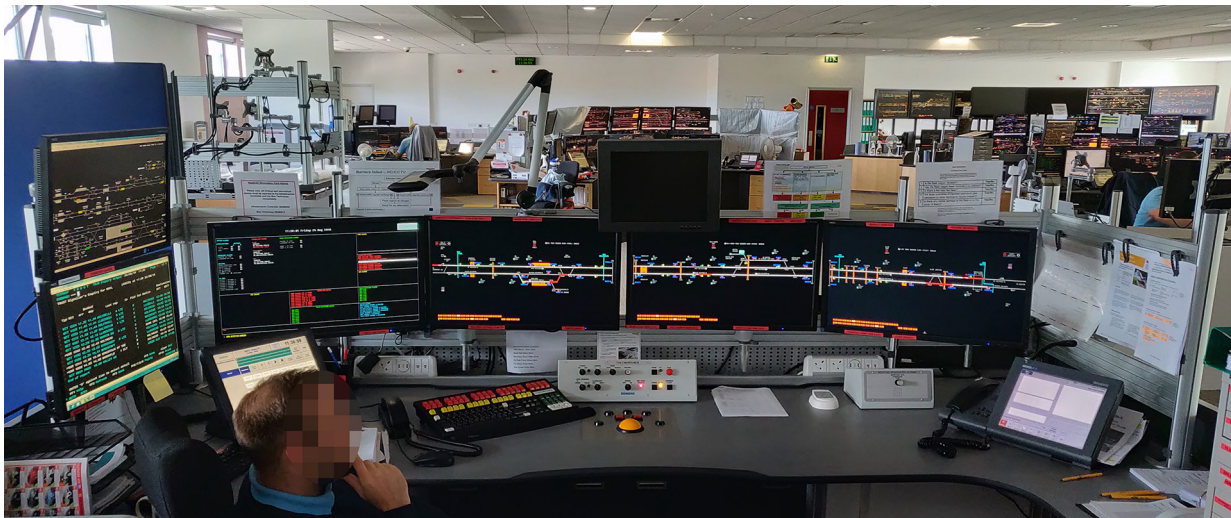
Figure 6: Rhyl workstation

- 19 Bagillt UWC-T is supervised by the signaller at the Rhyl workstation located in the WROC in Cardiff (figure 6). This workstation controls approximately 45 route-kilometres of the Chester to Holyhead railway including Flint station. The signaller controls train movements in both up and down directions by using a pointer to click on symbols in a track layout displayed on display screens. The track layout shows the individual sections of track which change from white to red when occupied by a train (figure 7). The track layout display is not to scale and does not include any indication of distances between features on the display.
