## Accident

<b>Aircraft Type and Registration:</b>	UAS Malloy Aeronautics T150	
<b>No &amp; Type of Engines:</b>	8 Electric motors	
<b>Year of Manufacture:</b>	2023 (Serial no: 120)	
<b>Date &amp; Time (UTC):</b>	27 June 2023 at 1443 hrs	
<b>Location:</b>	Field in South Scarle, Lincoln	
<b>Type of Flight:</b>	Training	
<b>Persons on Board:</b>	Crew - None	Passengers - None
<b>Injuries:</b>	Crew - N/A	Passengers - N/A
<b>Nature of Damage:</b>	Destroyed	
<b>Commander's Licence:</b>	General Visual line of sight Certificate (GVC)	
<b>Commander's Age:</b>	45 years	
<b>Commander's Flying Experience:</b>	150 hours (of which 2 were on type) Last 90 days - 5 hours Last 28 days - 5 hours	
<b>Information Source:</b>	AAIB Field Investigation

## Synopsis

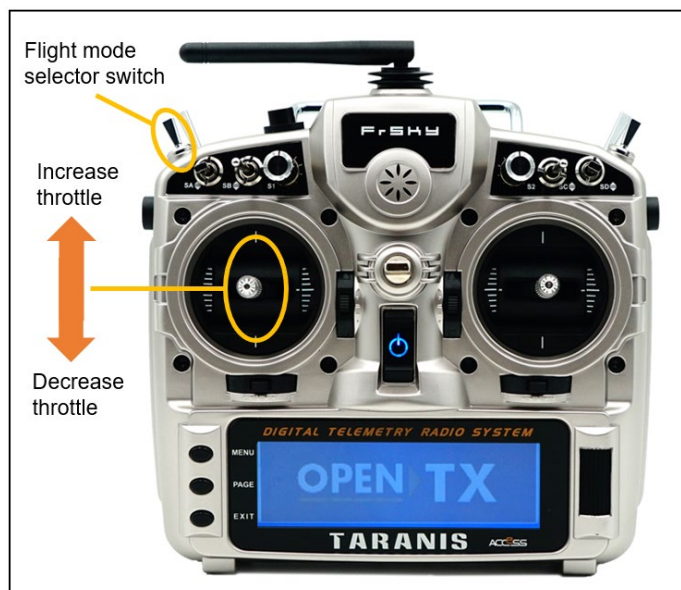
**Figure 4**

On the accident flight the RP operated the aircraft with a FrSky Taranis X9D plus transmitter (Figure 4) and was supported by a GCS operator. The transmitter operates on 2.4 GHz and has a variety of customisable switches and features. The left stick controlled the throttle and yaw with the right stick for pitch and roll. It is possible to adjust the length of the sticks to suit individual operators. The transmitter is fitted with a three-way toggle switch which enabled the RP to manually change between a selection of the pre-programmed flight modes. There are 20 different automated flight modes available within the aircraft firmware which can be combined with the automated mission flight profiles. On the accident flight the selectable flight modes were Altitude Hold (ALT HOLD), STAB and LOITER mode.

FrSky Taranis X9D plus transmitter

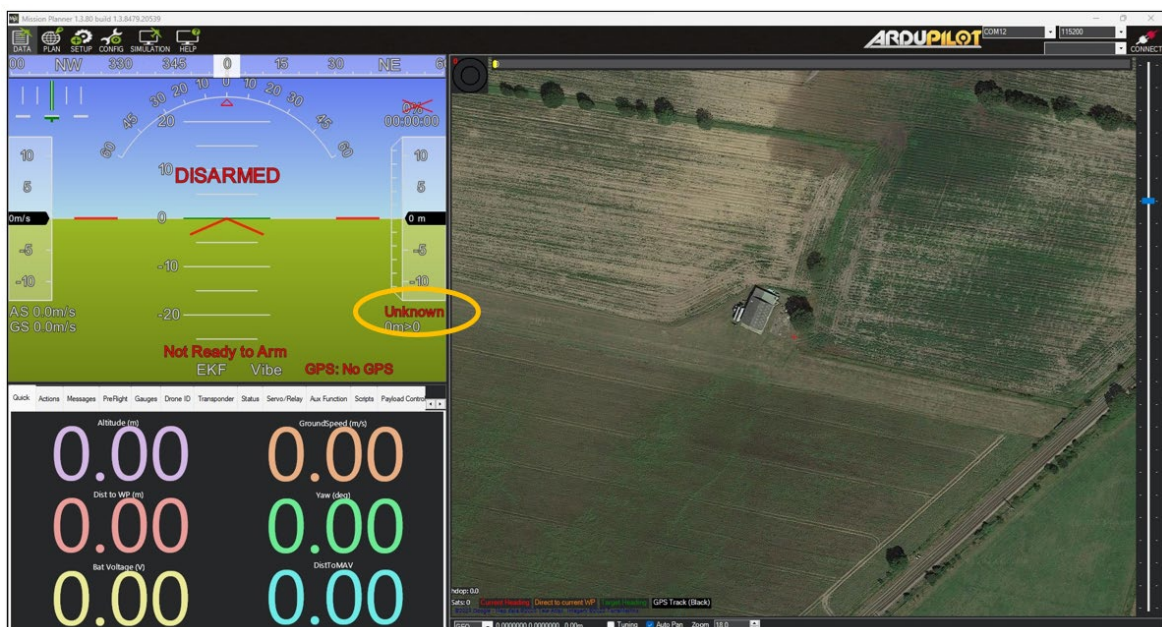
**Figure 5**

To assist the RP a GCS operator is employed to monitor the continuous data feed from the aircraft and provide warnings, information and updates via radio headsets. The GCS laptop uses the open source ARDU Pilot Mission Planner software and the user interface is shown in Figure 5.

ARDU Pilot Mission Planner interface
