GRENFELL TOWER INQUIRY: PHASE 2 REPORT

REPORT of the PUBLIC INQUIRY into the
FIRE at GRENFELL TOWER
on 14 JUNE 2017

Volume 4
Part 6 – The refurbishment of Grenfell Tower

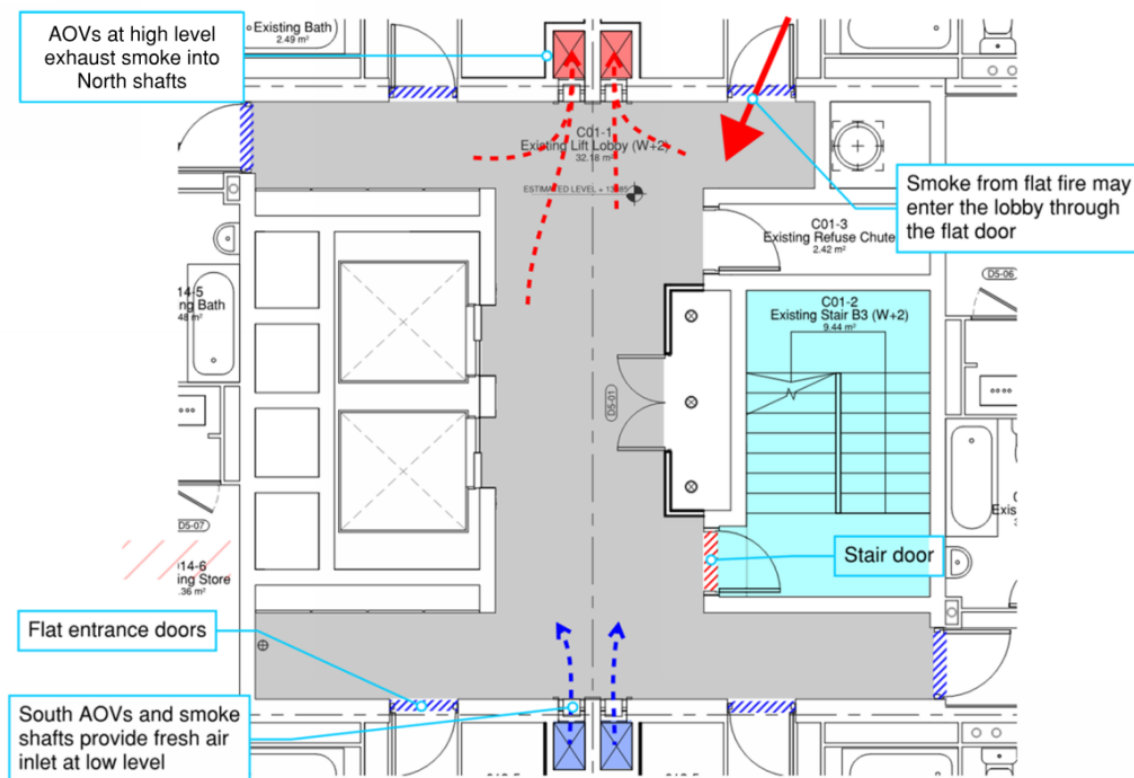
Figure 60.1 – Operation of the original smoke ventilation system on the fire floor

60.5 The following diagram shows how the system was intended to work:²³³⁹

60.6 Accordingly, the system operated by ventilating the lobby area with the intention of protecting the escape route through the lobby.

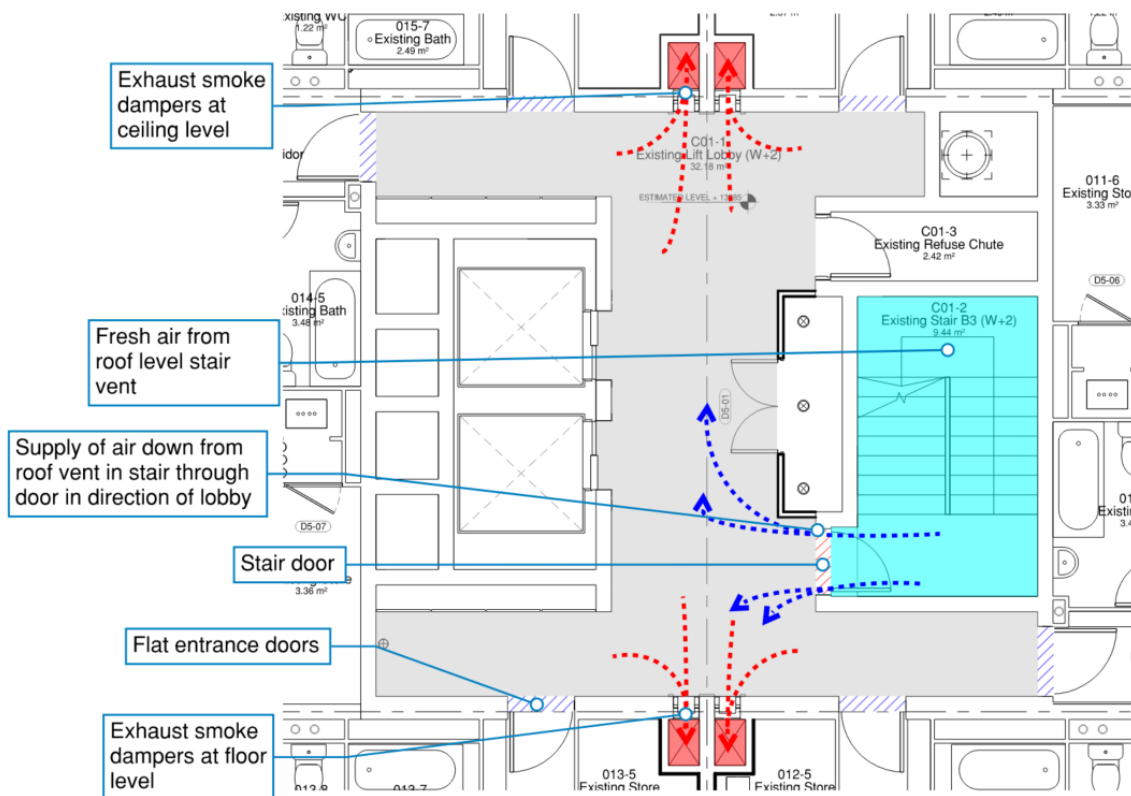
Figure 60.2 - Design intent of the smoke extract system in Grenfell Tower for Level 2 to Level 23

60.33 Below is an illustration of the way in which the new smoke ventilation system was intended to operate. The blue lines indicate fresh air from the roof vent at the top of the stairs entering the lobby through the door to the stairs; the red lines indicate the movement of smoke and hot gases out of the shafts on the north and south sides of the lobby.²³⁹³
