GRENFELL TOWER INQUIRY: PHASE 1 REPORT

REPORT of the PUBLIC INQUIRY into the
FIRE at GRENFELL TOWER
on 14 JUNE 2017

Chairman: The Rt Hon Sir Martin Moore-Bick
October 2019

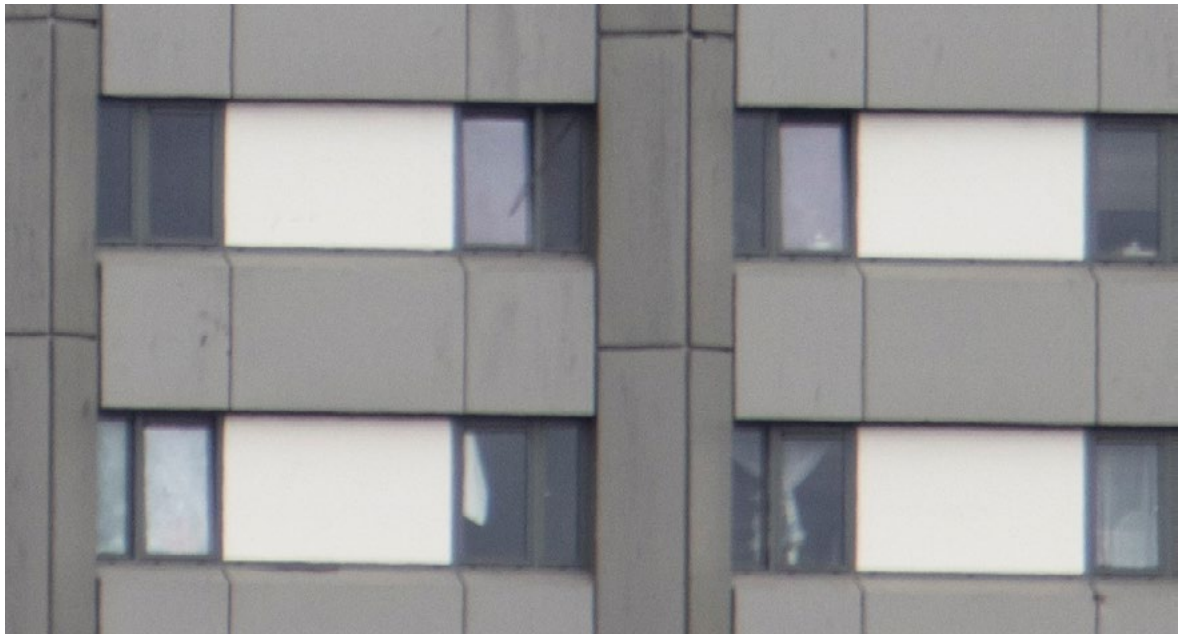
Figure 6.2

- 6.15 On the columns, the cassette panels were longer in shape, each one extending from halfway up the spandrel panel below the window, to halfway up the spandrel panel above the window, as can be seen from the image above. This meant that there was a continuous panel at the junction between the windows and the column.¹⁵ The column panels were also fixed to the face of the concrete columns using steel angle pieces and cladding rails.¹⁶ The columns were clad with one panel per face, i.e. two panels for the internal columns and three panels on the corner columns. There were gaps of between 15mm and 30mm between the panels, both on the spandrels¹⁷ and the columns,¹⁸ some of which can be seen in the image above.¹⁹

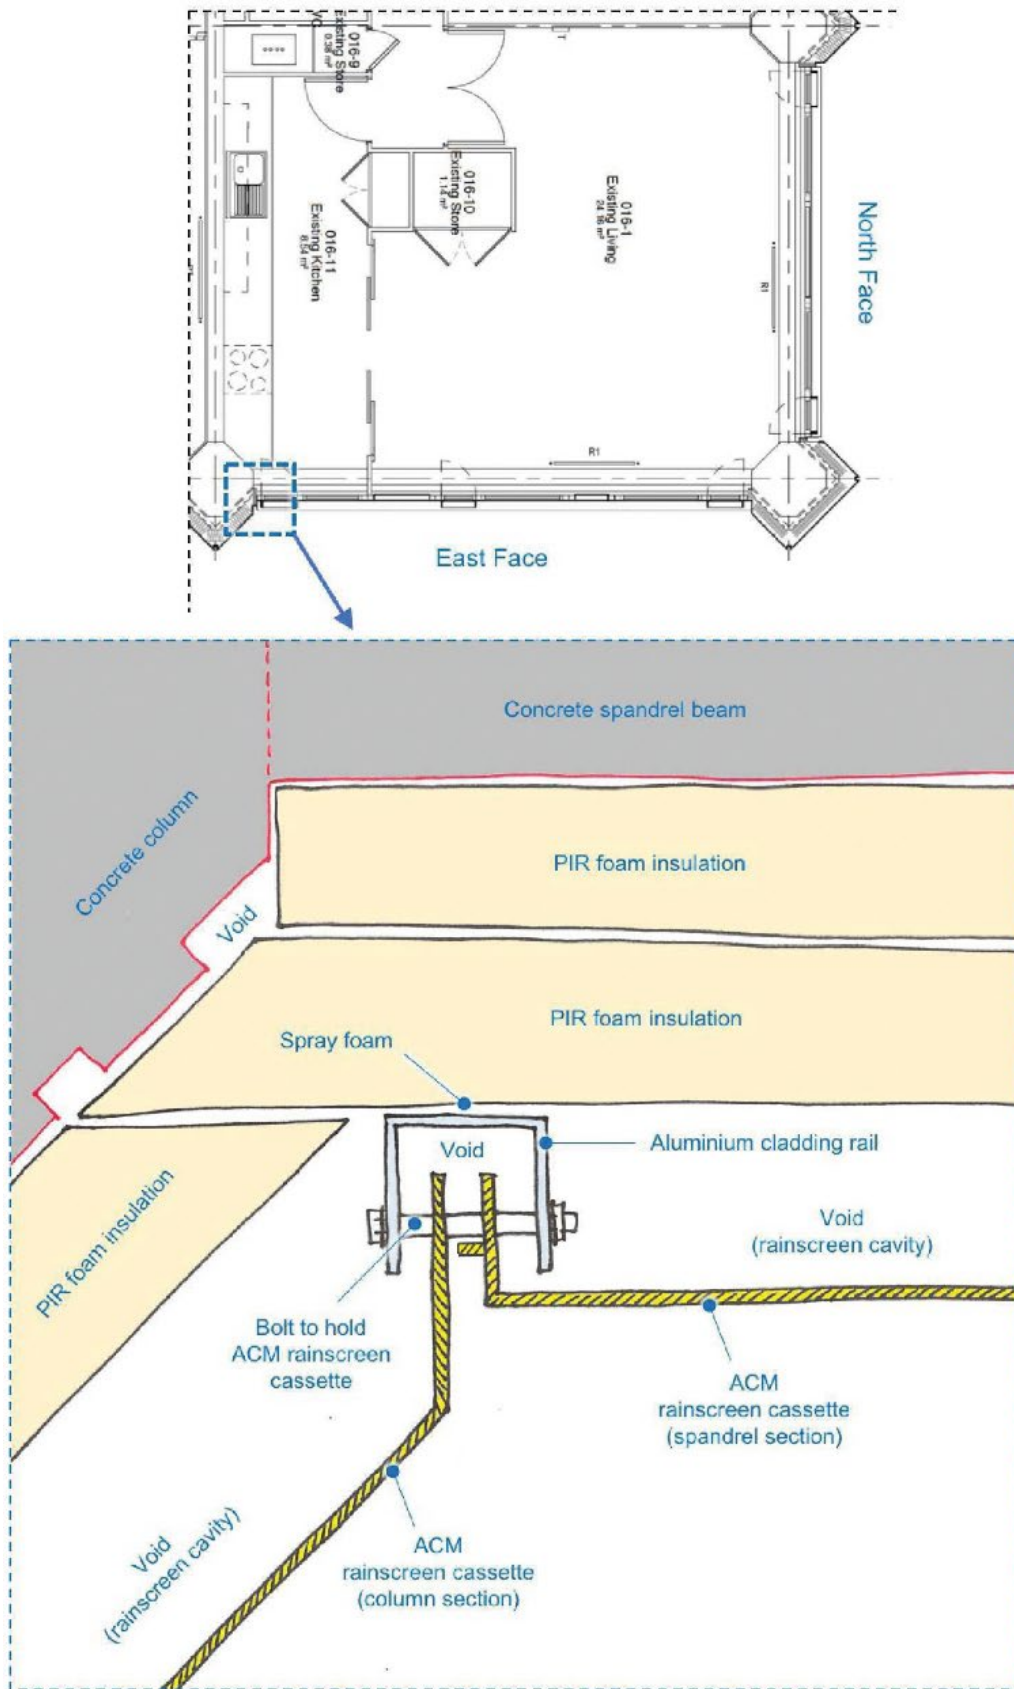
Figure 6.3

- 6.17 Behind both the spandrel and the column ACM panels was a layer of insulation fixed directly to the building. On the spandrels this consisted of two 80mm layers of insulation board, either Celotex RS5000 polyisocyanurate (PIR) polymer foam or (in very limited quantities) Kingspan K15 phenolic polymer foam, depending on the particular location. On the columns, the insulation consisted of one 100mm layer of Celotex RS5000 PIR. A small number of Kingspan K15 insulation boards have also been found on the columns.²¹ In some instances an additional

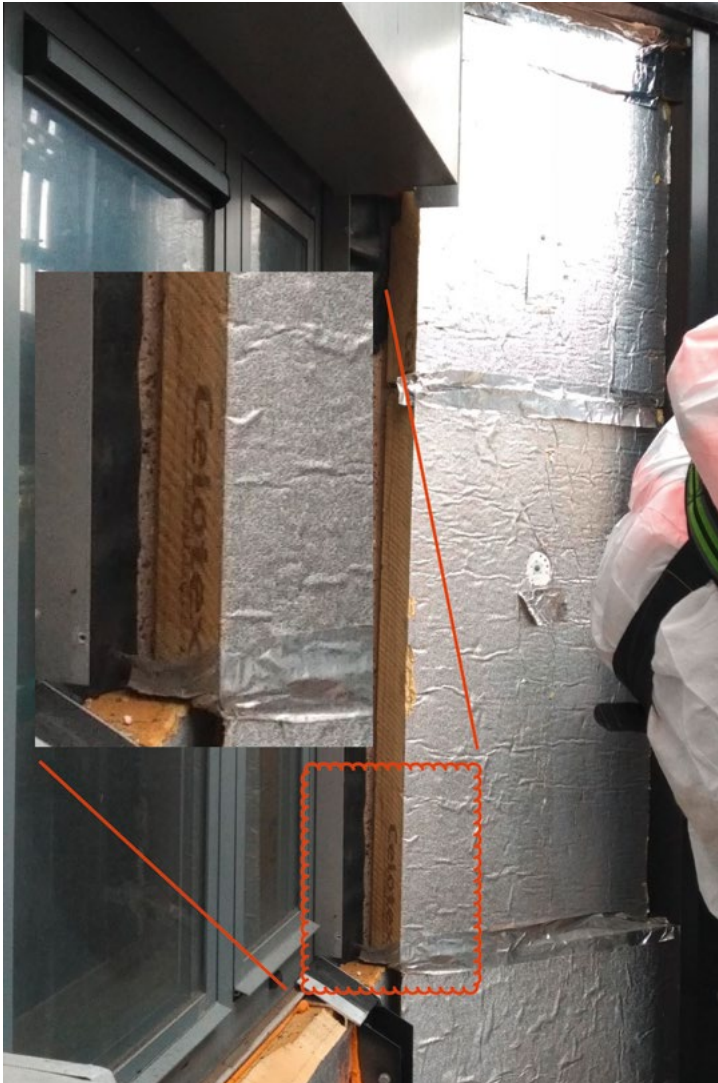
Figure 6.4

- 6.19 The front and rear faces of the insulation boards on both the spandrels and the columns were covered by aluminium foil with a thickness of less than 0.1mm.²⁷ However, the edges of the insulation boards were exposed to the atmosphere.²⁸ Although there is some evidence that foil tape was used to cover the joints between insulation boards, as shown in the photograph below,²⁹ there is currently no evidence that foil tape was used to protect the edges.

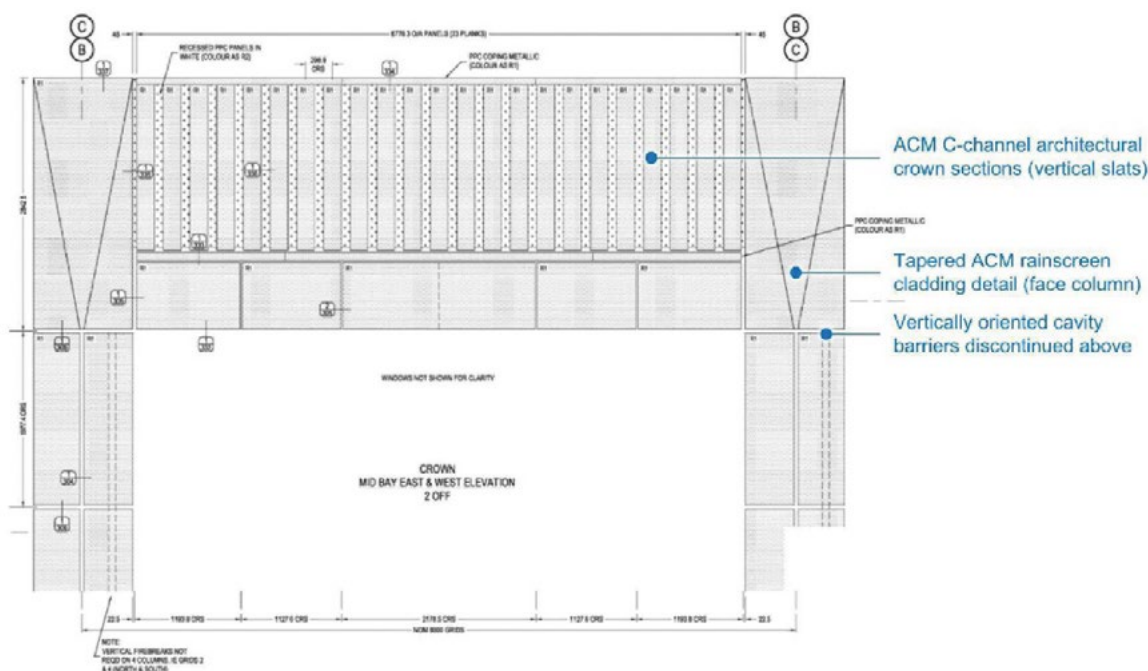
Figure 6.11

- 6.35 The refurbishment of the building also involved changes to the pre-cast concrete architectural “crown” described earlier in this report. The concrete columns and beams at the top of the tower were wrapped in a band of tall, narrow Reynobond 55 PE ACM cassettes or “fins” which extended around the perimeter of the building above level 23. The “C”-shaped fins were fixed into reverse oriented “C”-shaped aluminium channels. In addition, the tops of the columns were provided with tapered detailing using the same material. The fins and the associated structure at the crown had no functional purpose and were purely aesthetic.⁷⁵
- 6.36 Below is a design drawing of the architectural crown at roof level and showing the new “C”-shaped ACM fins and the new detailing at the top of the columns.⁷⁶
